EPRG-PRCI-APGA
23rd Joint Technical Meeting
Edinburgh, Scotland
6-10 June 2022

EFFECTS OF CATHODIC OVER PROTECTION ON RESIDUAL STRENGTH OF DAMAGED PIPES

PAPER NUMBER: 22

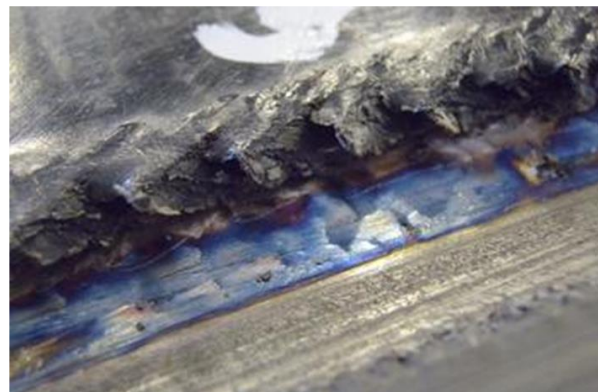
An example of damage produced for the present projects is shown in Figure 4 (left), together with the pipe external surface appearance in the gouge (Figure 4, right). The blue color indicates the high temperature reached by the pipe material (estimated in the range from 290°C to 330°C) during the damaging process and caused by the friction between the pipe steel and the impacting tooth.

Figure 4: Damage from Simulator (left) and damaged surface (right).

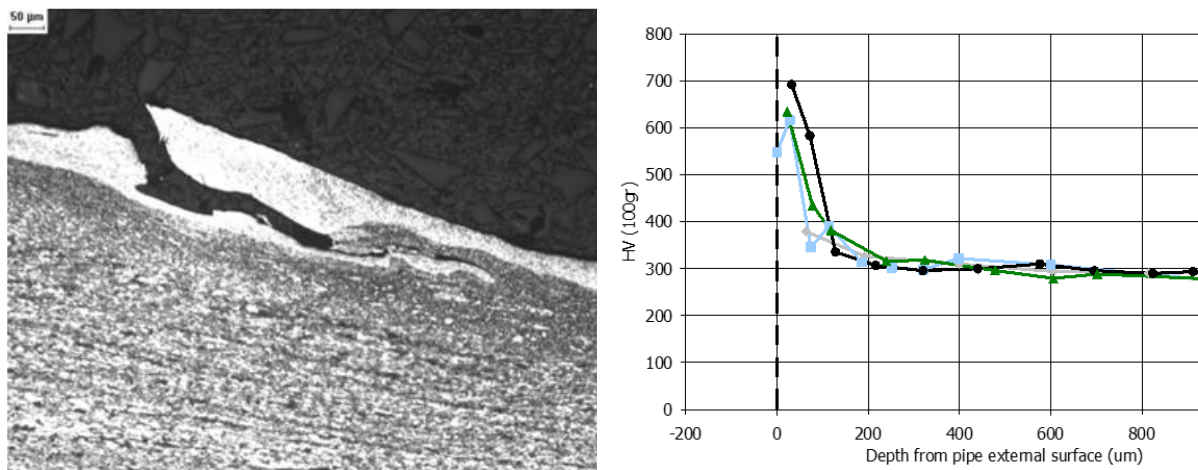
Due to the heating and quick cooling, the pipe material undergoes a local change in the microstructure, according to Figure 5 (left), where higher hardness is detected too (Figure 5, right). Highest values are due to the white tooth material attached to the pipe surface). In such conditions, cracks may be found (Figure 6) since this step, that is just after damage creation.

Figure 5: Microstructure of pipe material in Figure 4 (left), and relevant hardness measurements (right).

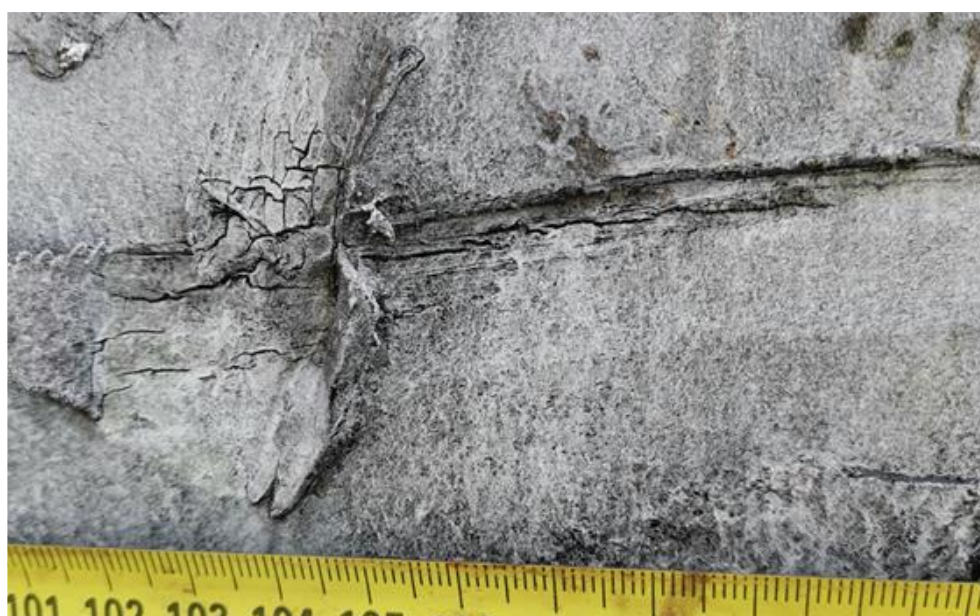
Figure 6: Cracks after damage creation.

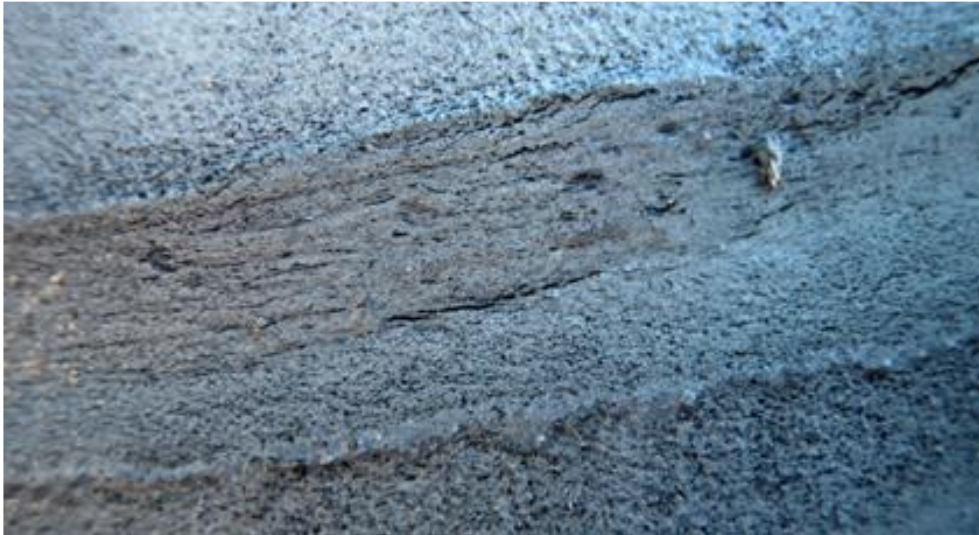
- Damage BG2 from Pipe 1:
 - NDT (Figure 9): indications of cracks are visible in the gouge;
 - Microstructure (Figure 10): appearance of the damage section at the optical microscope, both polished and etched, to emphasize cracks and microstructure. In particular, the top image shows the tooth material (bright), two layers of pipe base material altered by the damaging process, and finally the pipe base material. The tooth material has very high hardness and the pipe altered material exhibits hardness values higher than the pipe base material. In other words, the damaging process has caused local hardening of the pipe material;

Figure 9: Crack in the gouge of damage BG2 from Pipe 1.

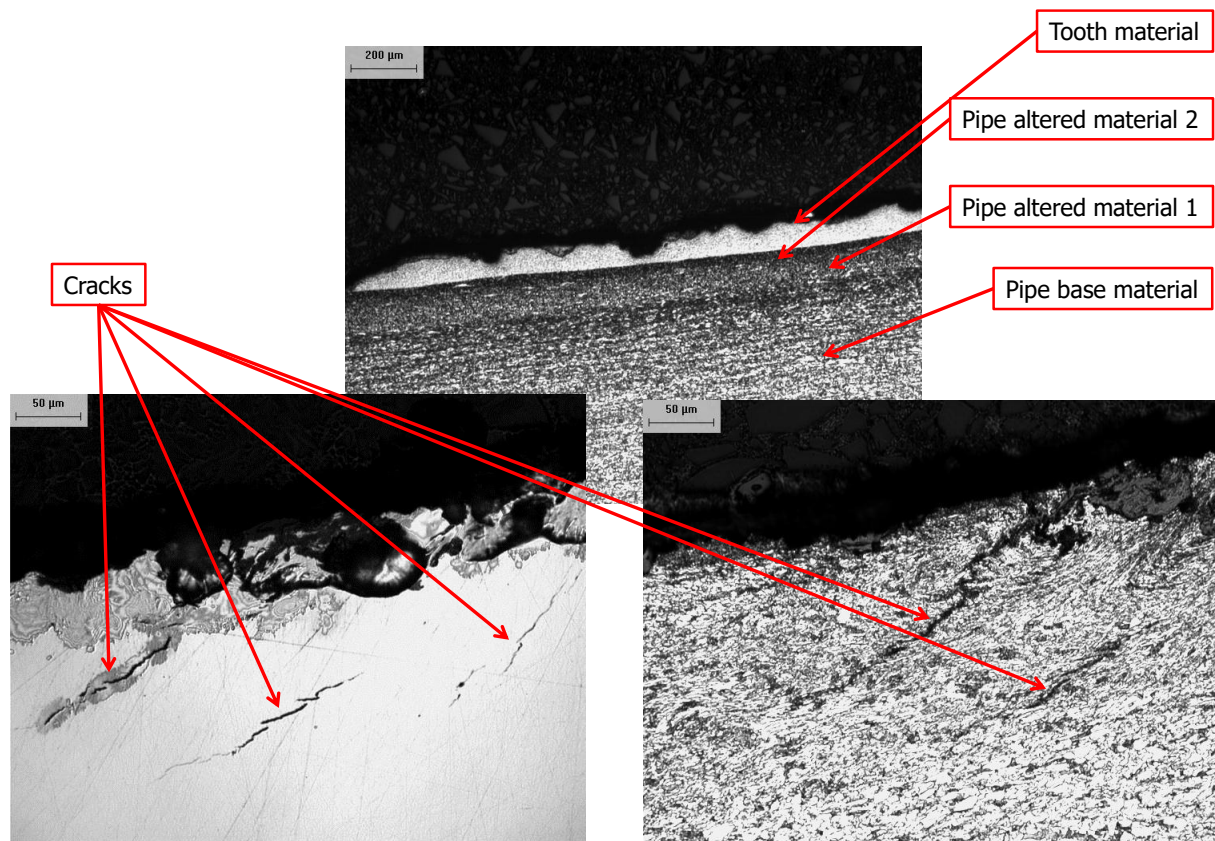
Figure 10: Cracks and pipe altered material in the gouge of damage BG2 from Pipe 1.

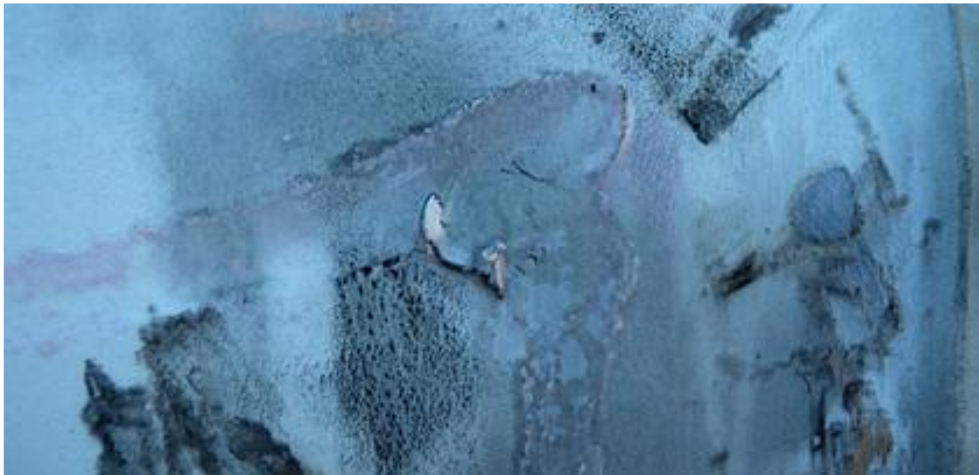
- Damage G1 from Pipe 1:
 - NDT (Figure 11): apparently just a small crack in the end of the gouge;
 - Microstructure (Figure 12): a number of cracks, both in the tooth and pipe material. It is interesting to see that one crack started in the tooth material and extended in the pipe hardened material;

Figure 11: Crack in the gouge of damage G1 from Pipe 1.

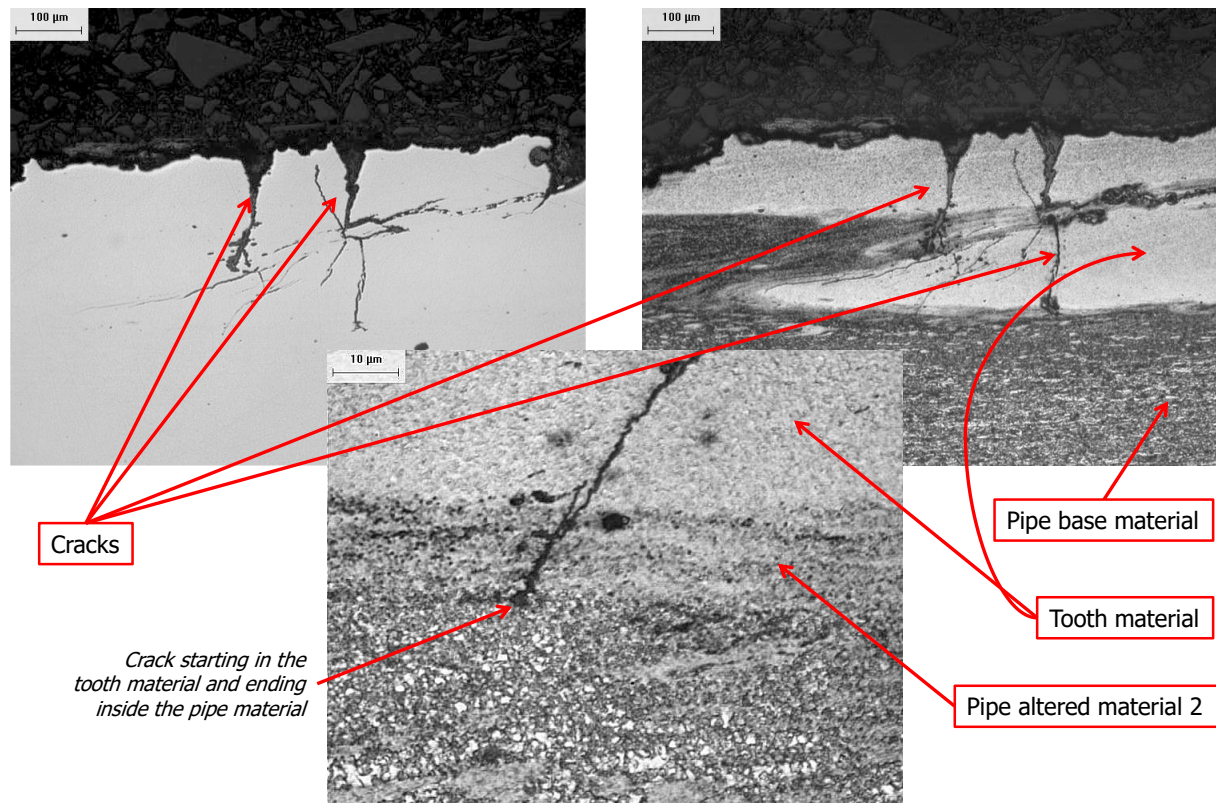
Figure 12: Cracks and pipe altered material in the gouge of damage G1 from Pipe 1.

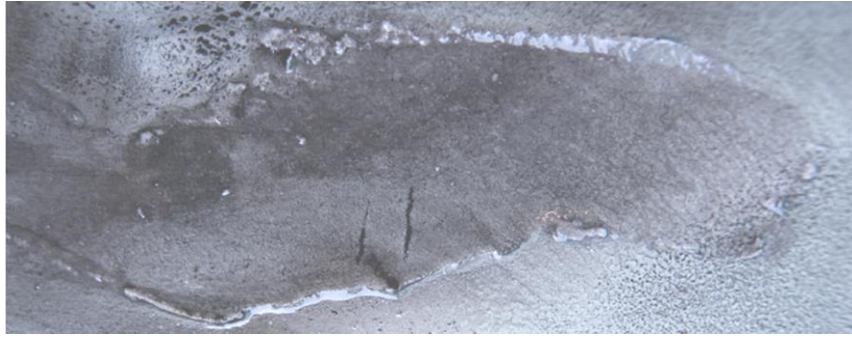
- Damage BG3 from Pipe 1:
 - NDT (Figure 13): crack in the tooth print (impact point);
 - Polished section (Figure 14): a crack, with sharp and complementary edges at the tip;

Figure 13: Crack in the print of damage BG3 from Pipe 1.

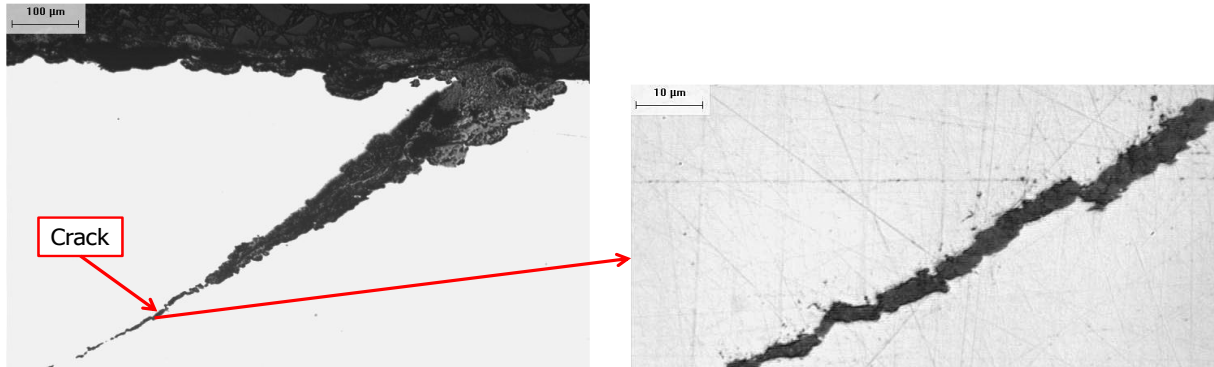
Figure 14: Cracks in the print of damage BG3 from Pipe 1.

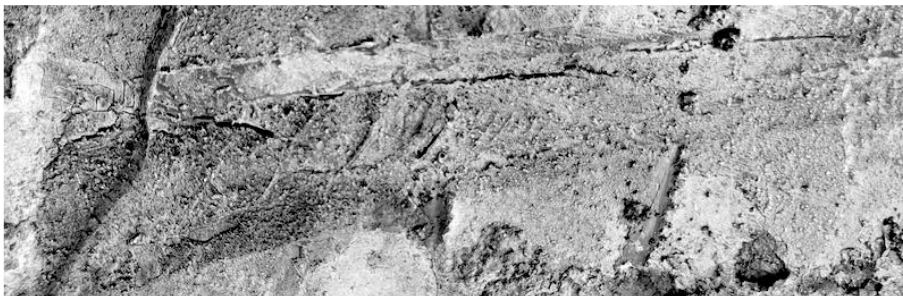
- Damage BG1 from Pipe 5:
 - NDT (Figure 15): cracks at end of gouge;
 - Microstructure (Figure 16): two branched cracks, with sharp and complementary edges. Both cracks start from pipe hardened material;

Figure 15: Crack in the gouge of damage BG1 from Pipe 5.

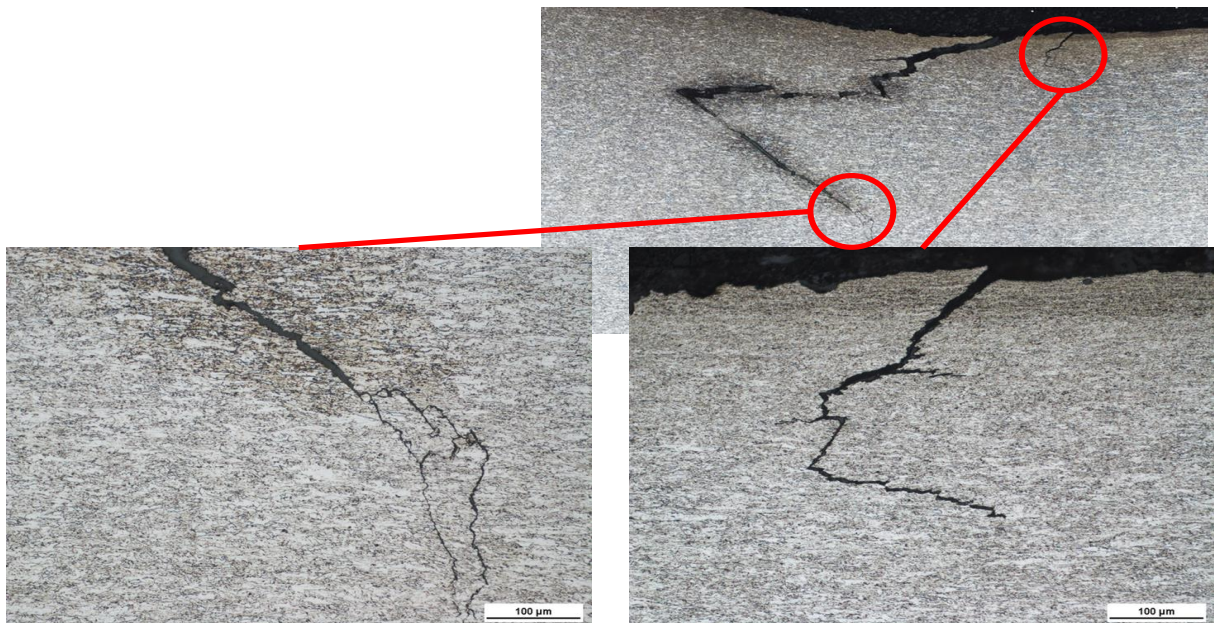
Figure 16: Cracks in the gouge of damage BG1 from Pipe 5.

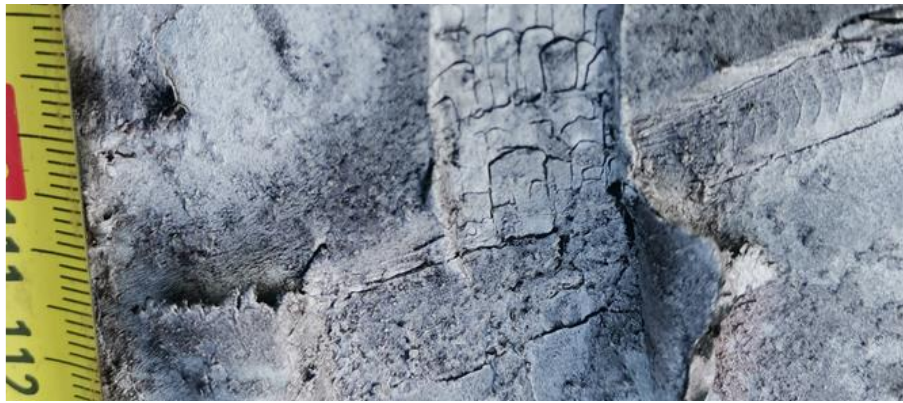
- Damage BG2 from Pipe 5:
 - NDT (Figure 17): cracks at end of gouge;

Figure 17: Cracks at end of gouge of damage BG2 from Pipe 5.

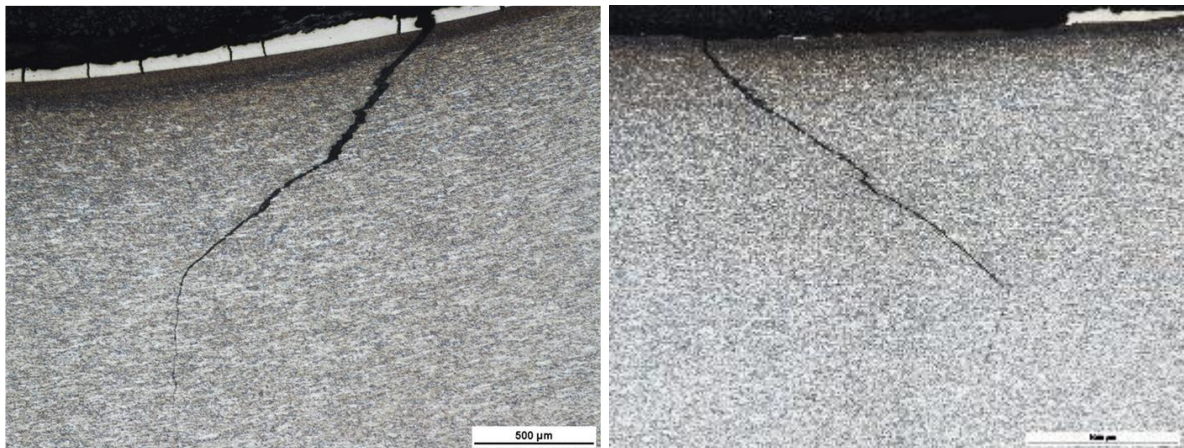
- Microstructure (Figure 18): the left crack is about 1,75 mm deep, while the right one is about 2,25 mm deep. Both have sharp and complementary edges;
- Damage BG4 from Pipe 5:
 - NDT (Figure 19): cracks at end of gouge;
 - Microstructure (Figure 20): cracks with sharp and complementary edges. Tooth material, pipe altered material and pipe base material.

Figure 18: Cracks and pipe altered material at end of gouge of damage BG2 from Pipe 5.

As a consequence, the cracks in Figure 18 extend from pipe surface with high hardness to about 2,0 mm depth, where hardness is lower and there is no evidence of microstructural alteration of pipe material. Such extension of the cracks in the pipe base material may be explained considering local embrittlement at the crack tip due to hydrogen developed by cathodic over protection at -1450 mV.

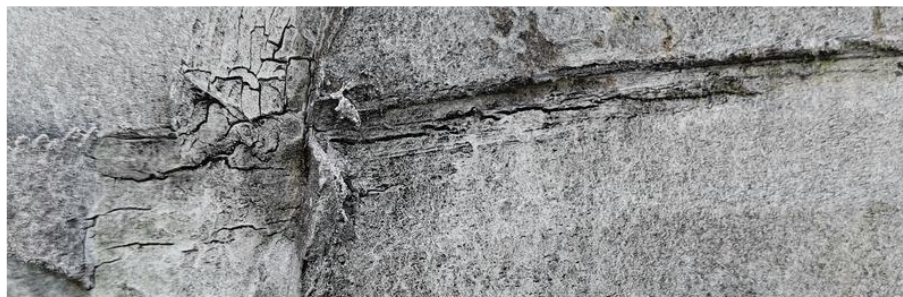
Figure 19: Cracks at end of gouge of damage BG4 from Pipe 5.

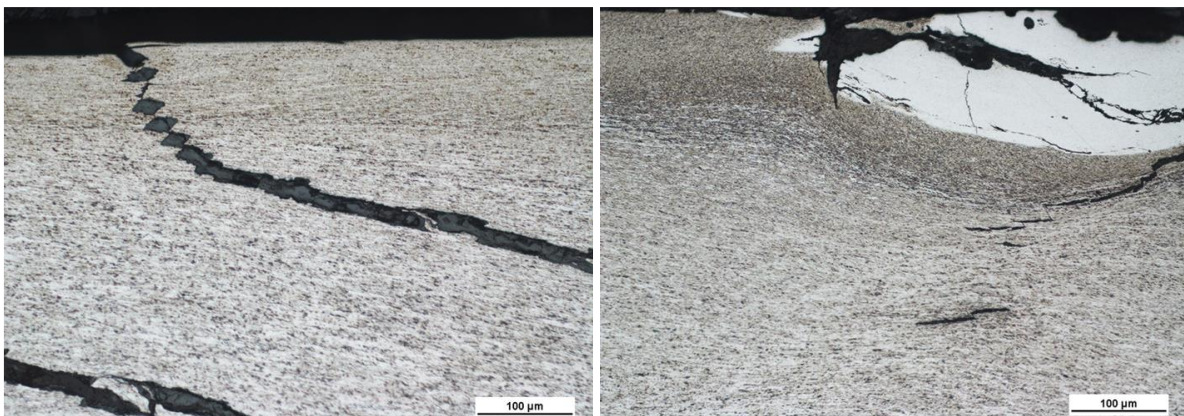
Figure 20: Cracks, pipe altered material and tooth material in the gouge of damage BG4 from Pipe 5.

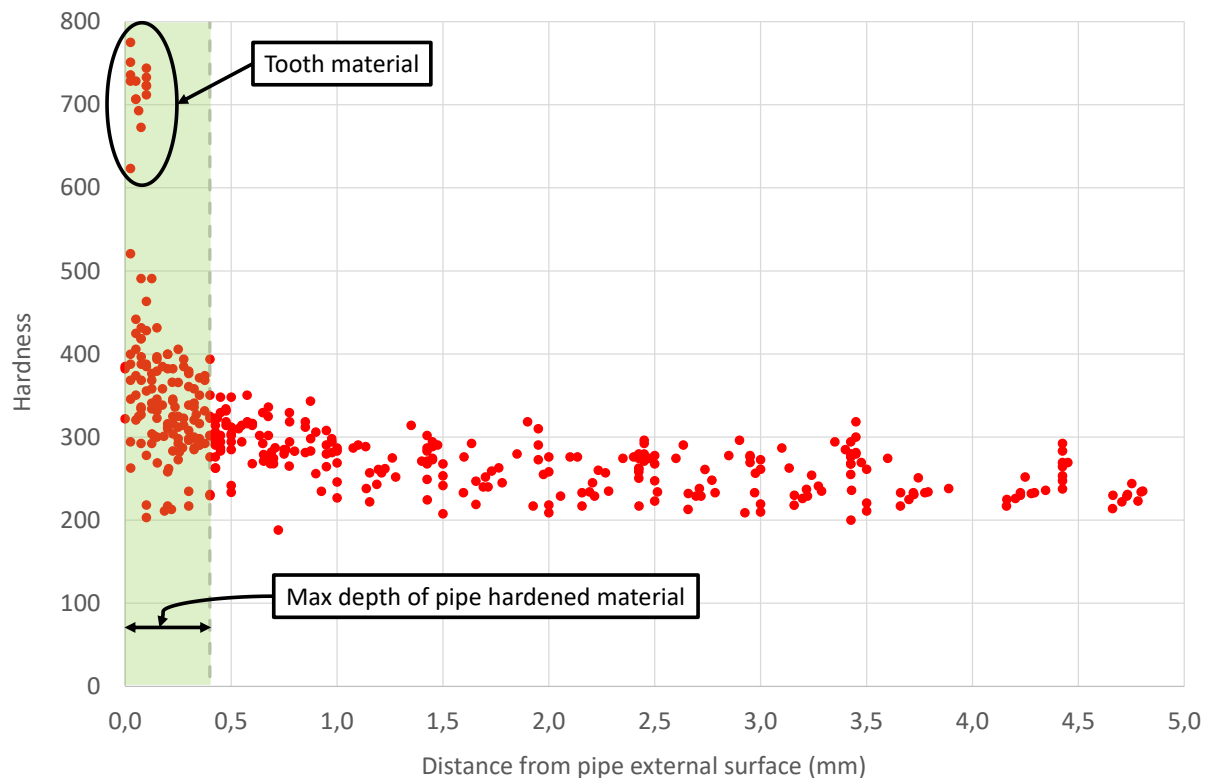
Hardness measurements were performed for all damages that underwent microstructural analysis (Figure 21). Measurements have been performed both close to cracks and far from cracks, including tooth material and pipe hardened material. It is found that hardness of tooth material is quite higher, above 600 HV, than the pipe material. At the same time, the pipe hardened material extends to about 0,4 mm depth from external surface showing values up to 500 HV, higher than 300 HV average beyond 0,5 mm depth and 250 HV beyond 1,0 mm depth.

Figure 21: Hardness measurements.
