## 23rd Joint Technical Meeting

# EFFECTS OF CATHODIC OVER PROTECTION ON RESIDUAL STRENGTH OF DAMAGED PIPES

8 June 2022

G. Malatesta\*, P. Roovers

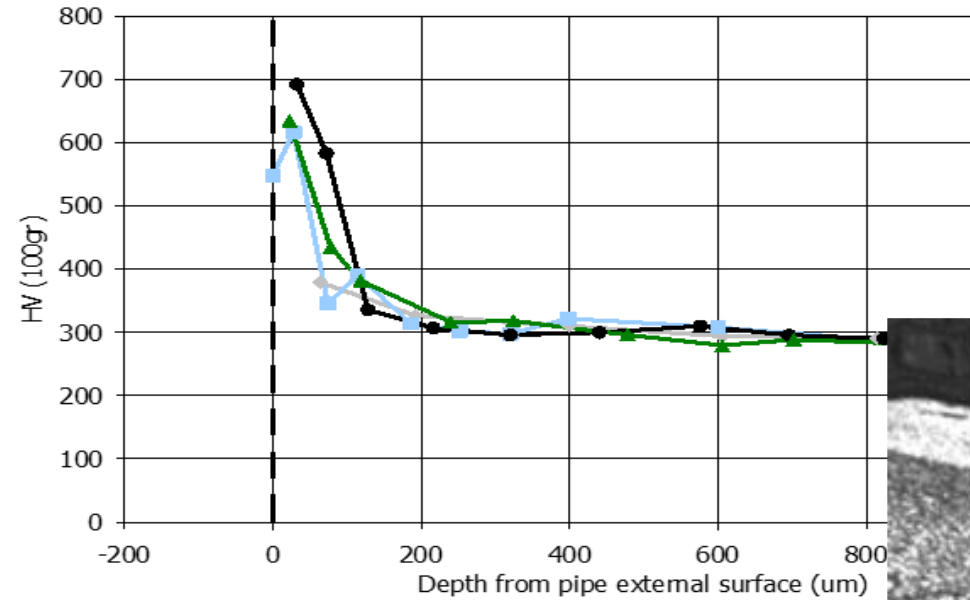
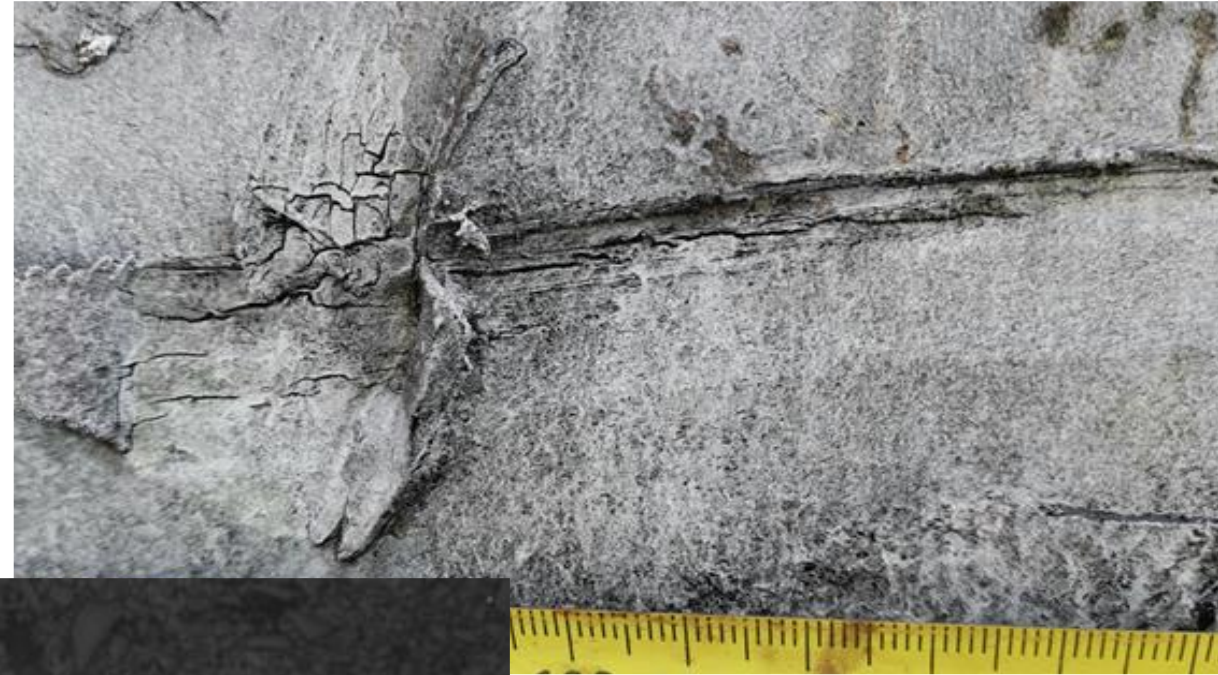
Higher hardness material locally

Cracks in the damage

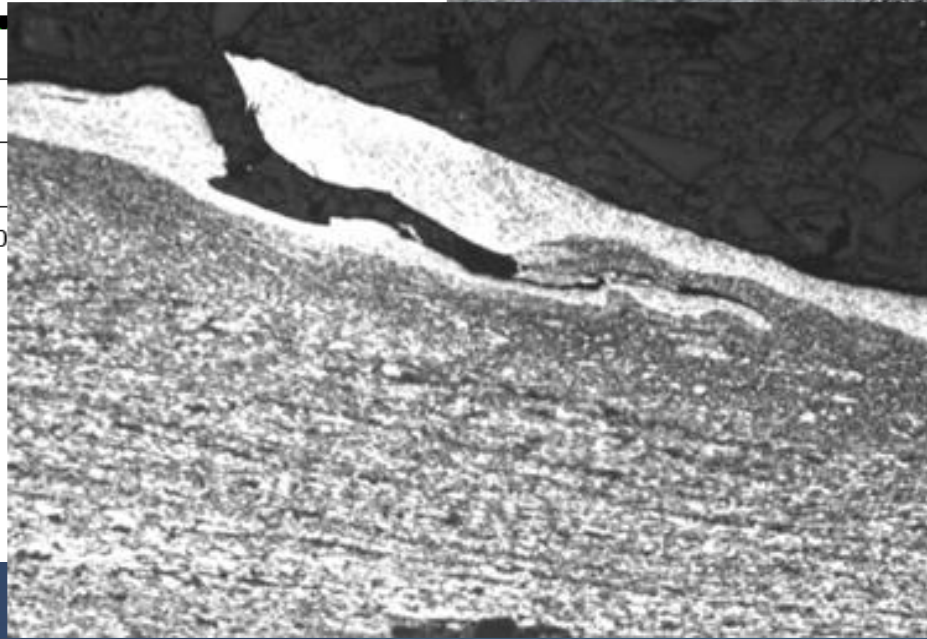
Transformed microstructure in the damaged area

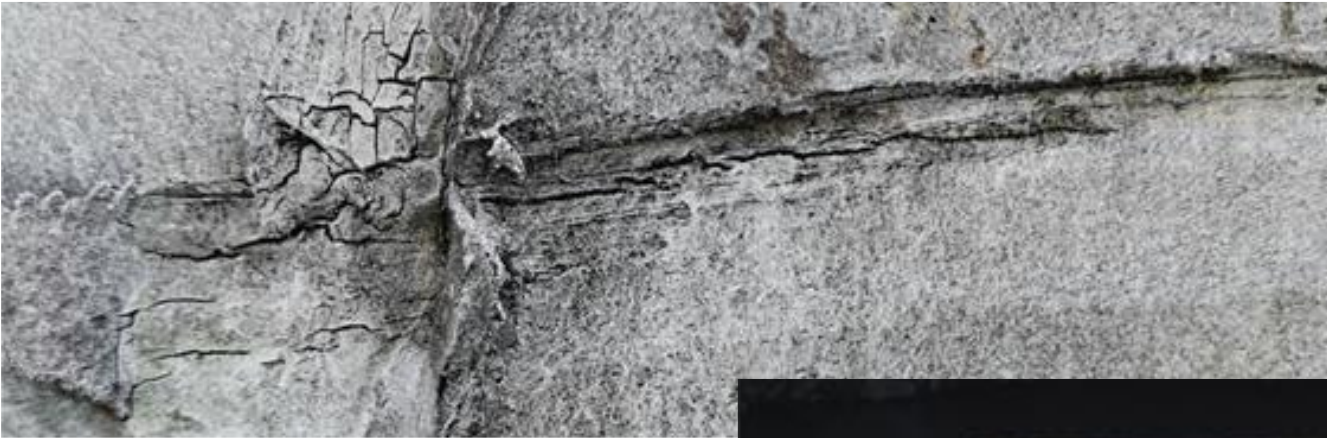
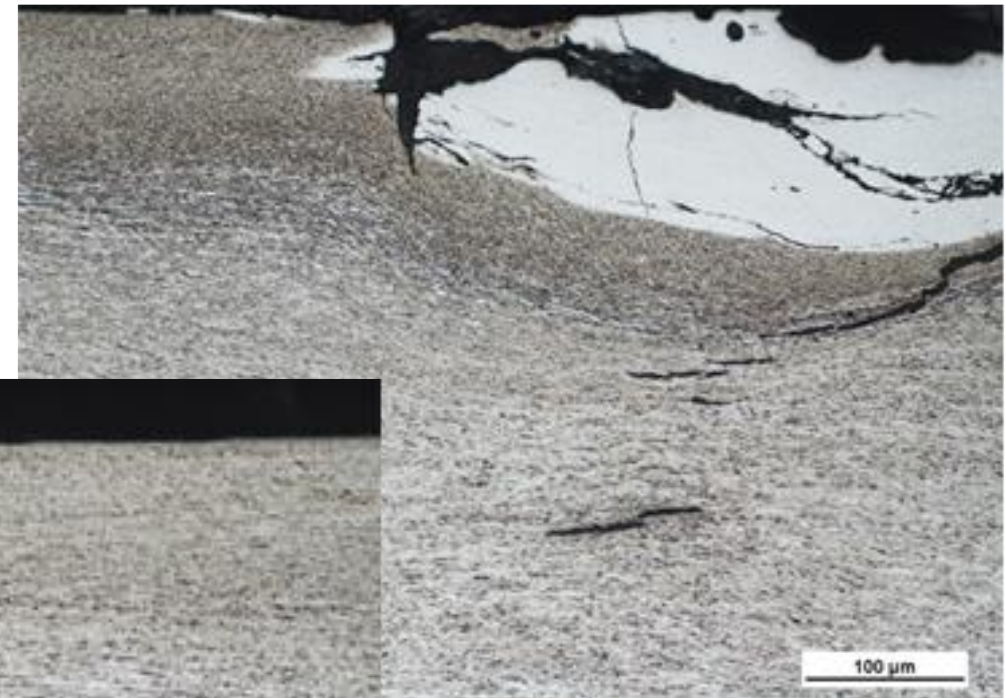
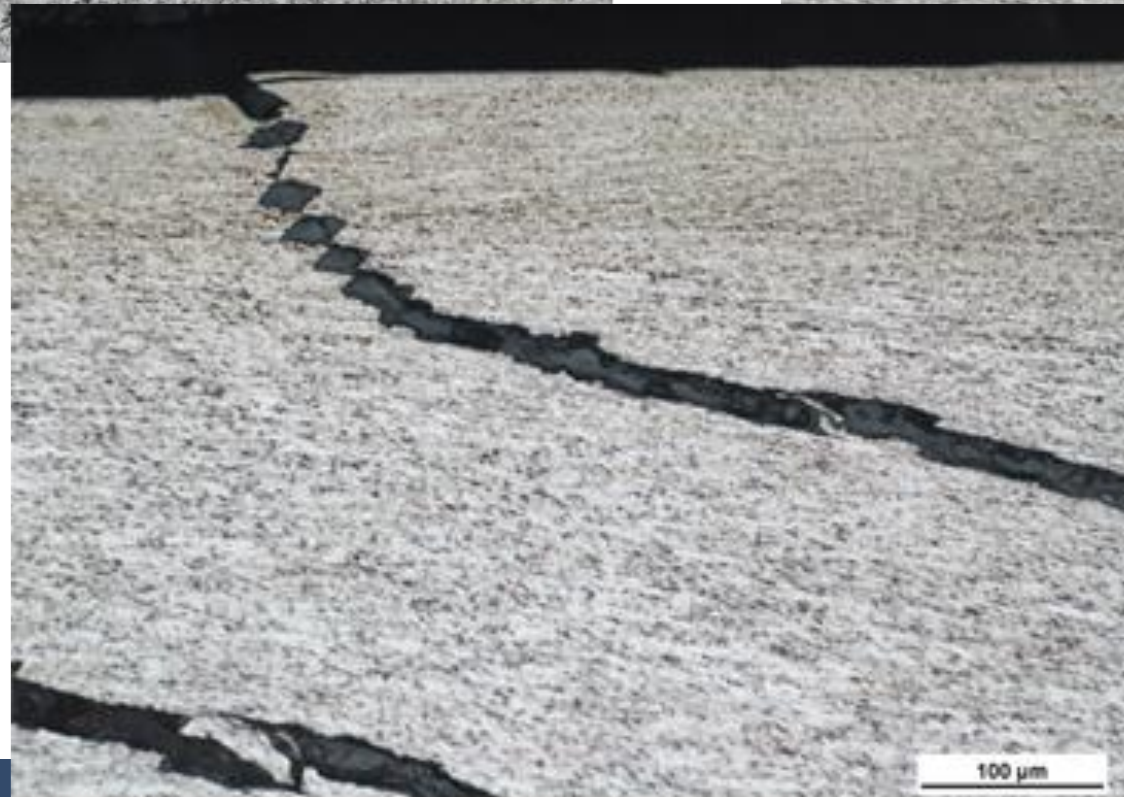
Pipe 5, damage BG4

Cracks found before full scale test grew, and new cracks were observed in damage BG4.

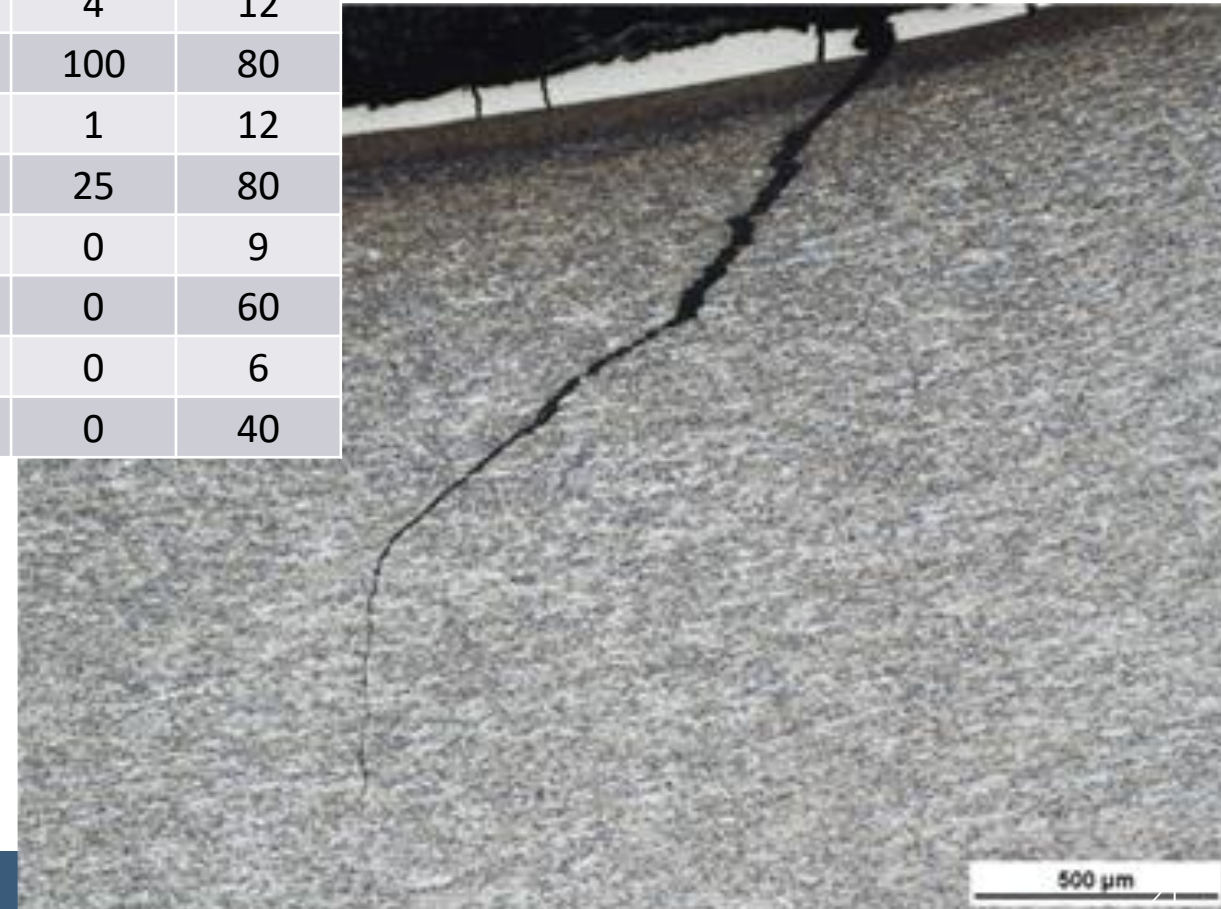
40% of damages showed cracks attributable to cathodic over protection (-1450 mV), while at -850 mV and -1150 mV there was no evidence of such effect.

Comparing the cracks depth from external surface, it is found that the depth of the cracks ranges from about 50 µm to about 2,25 mm. Then, the highest estimated crack growth rate is approximately 0,31 µm/cycle.

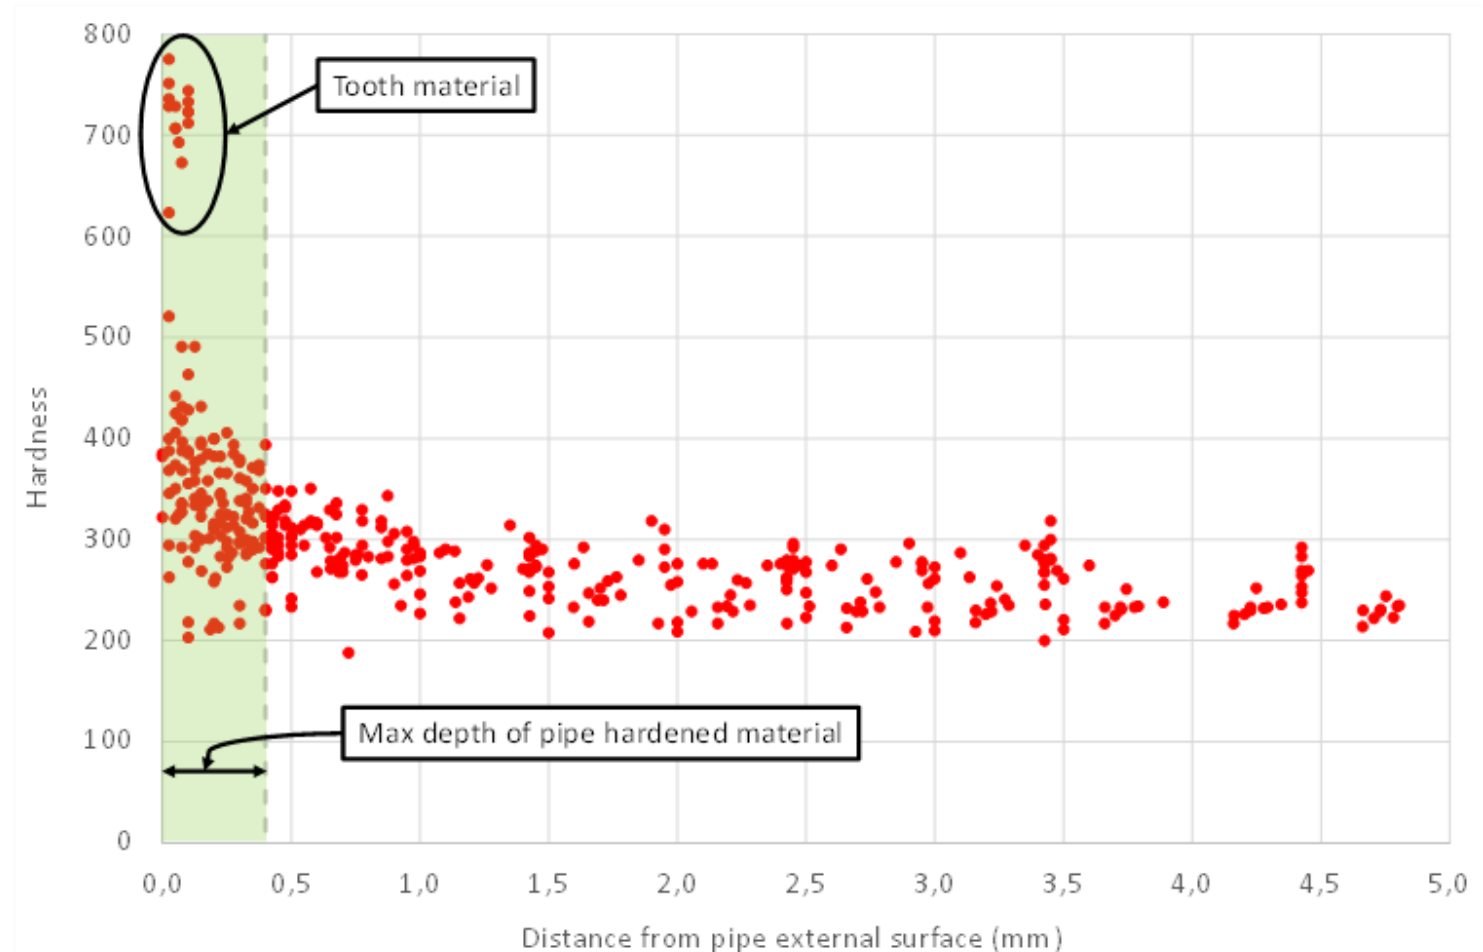
It is found that hardness of tooth material is quite higher, above 600 HV, than the pipe material. At the same time, the pipe hardened material extends to about 0,4 mm depth from external surface showing values up to 500 HV, higher than 300 HV average beyond 0,5 mm depth and 250 HV beyond 1,0 mm depth.

As a consequence, the deep crack from pipe surface with high hardness to about 2,25 mm depth, extended down to material where hardness is lower and there is no evidence of microstructural alteration.

- Hence, in case of evidence of third party damage, the hardened material should be removed to prevent crack growth or initiation;
- Cracks grow or initiate especially at cathodic over protection potentials ( $-1450 \text{ mV vs Cu/CuSO}_4$ ), while at lower potentials (up to  $-1150 \text{ vs Cu/CuSO}_4$ ) there is no evidence of growth or initiation.
