REX2024
PRCI Research Exchange

Reduction of Landslide Impact on Pipelines using Geobuffer *Field Installation*

Ali Fathi, PhD PEng, Integrity Specialist, Enbridge
San Diego, California
February 27, 2024

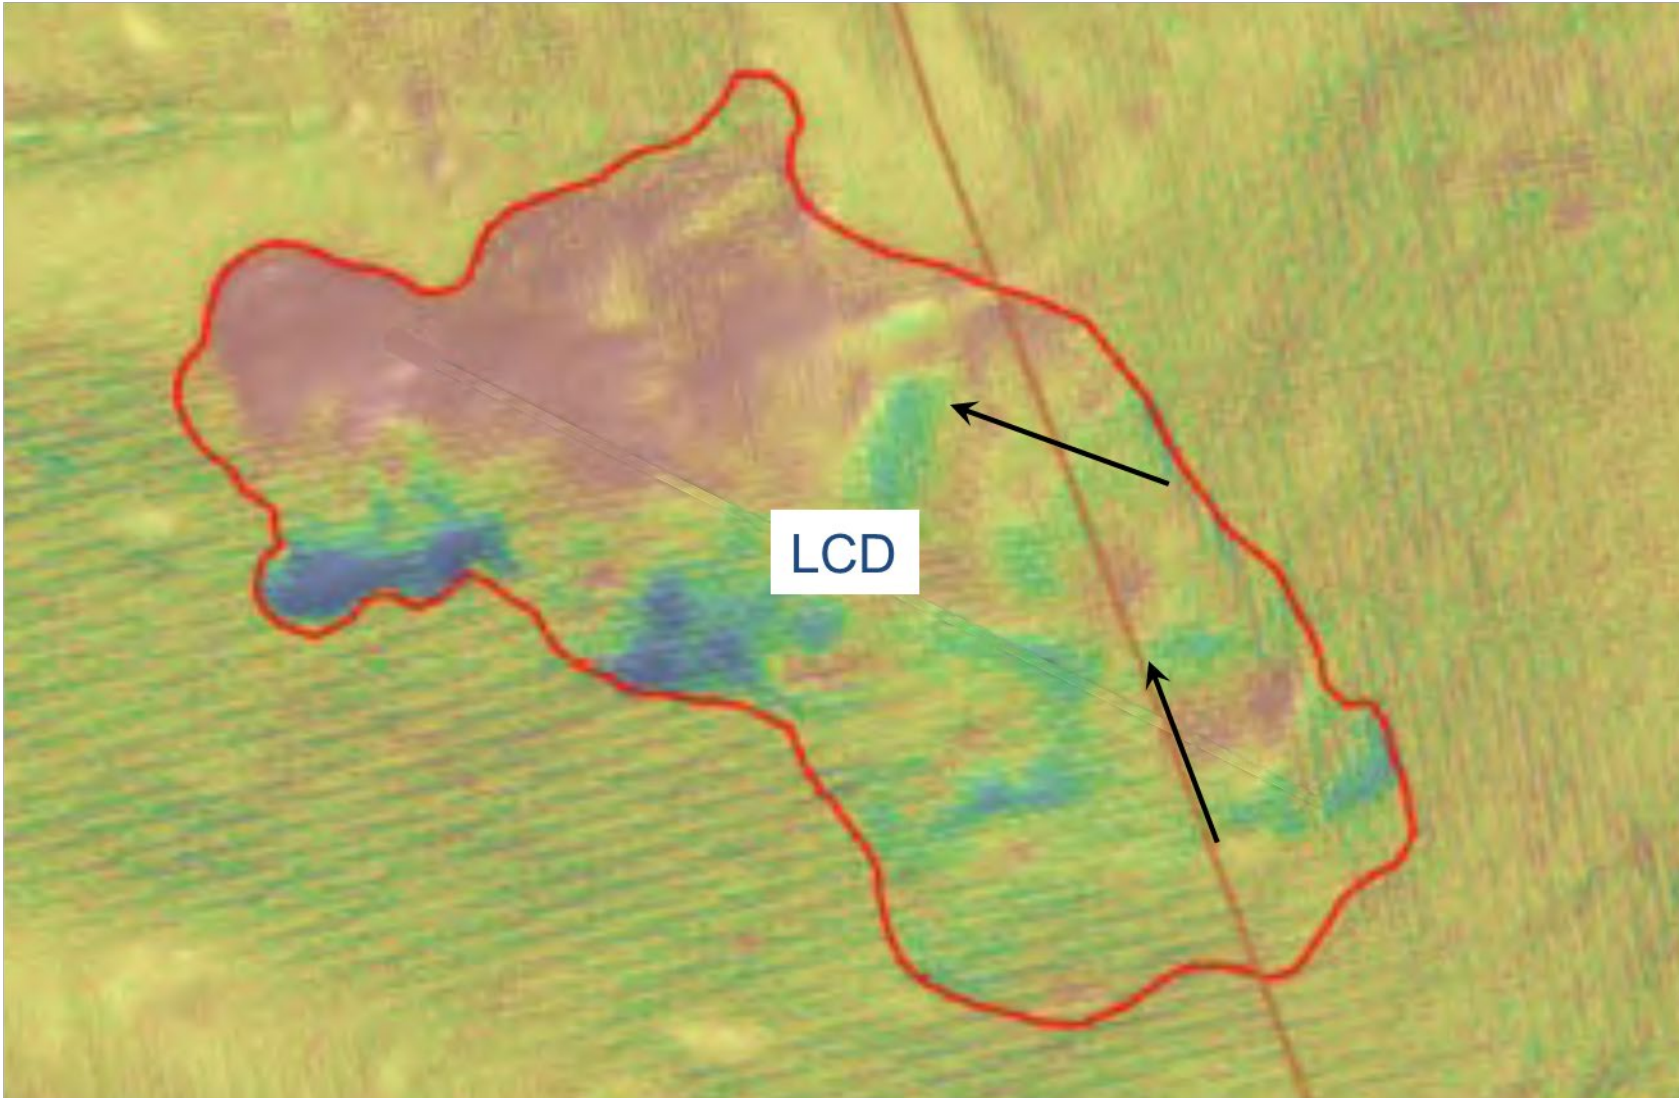
LiDAR Change Detection 2016- 2020

- Landslide identified in 2021 during LiDAR review
- Around 140 feet of intersection with pipeline
- Axial (upper slope) to oblique (mid-slope) direction of movement

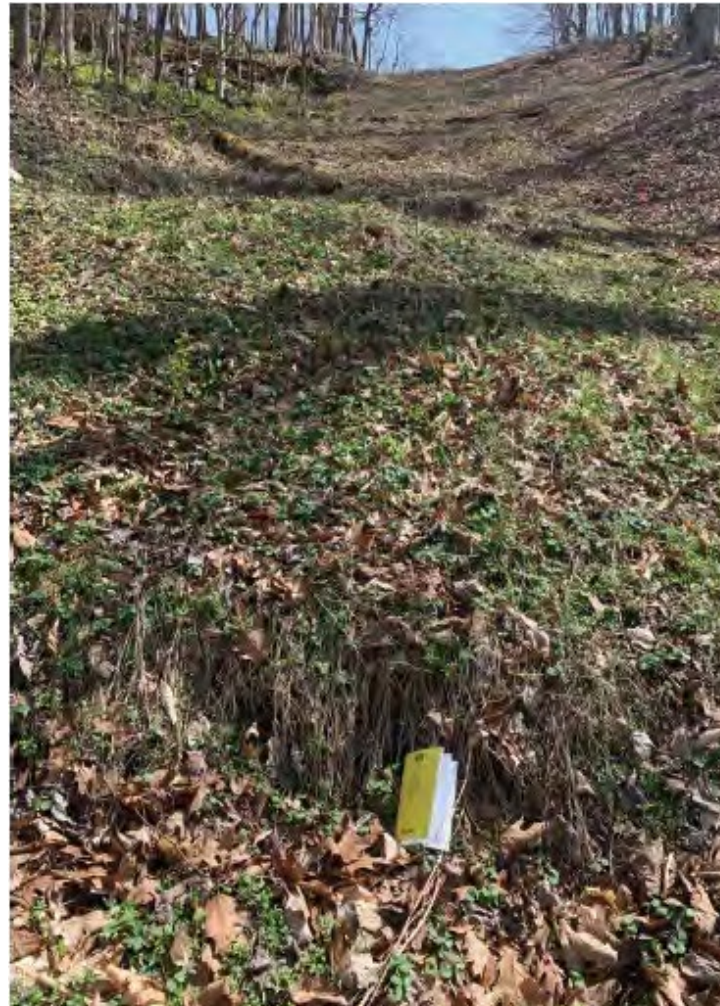
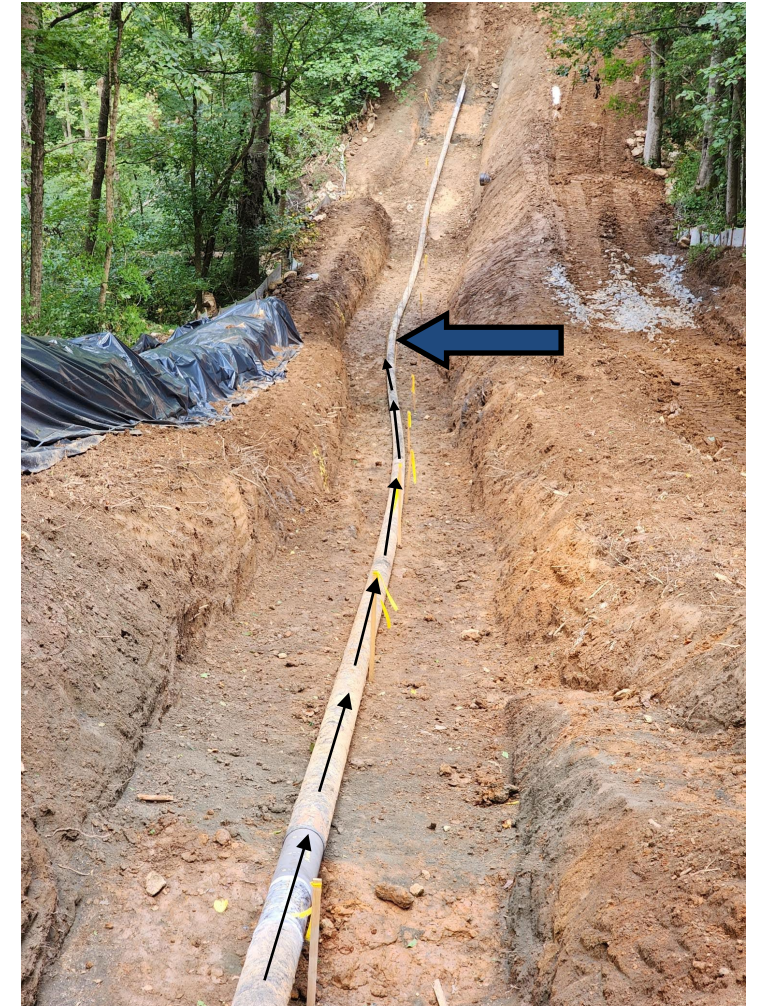
Site/Pipe Condition

- **Field assessment observed** evidence of recent landslide movement
- **From above ground survey** of 1ft OOS over 95 feet
- DOC of 2.4 to 4.1 feet within landslide
- In ROW, heads-scarp 1-to 2-foot high, internal scarps of 3.0 f high

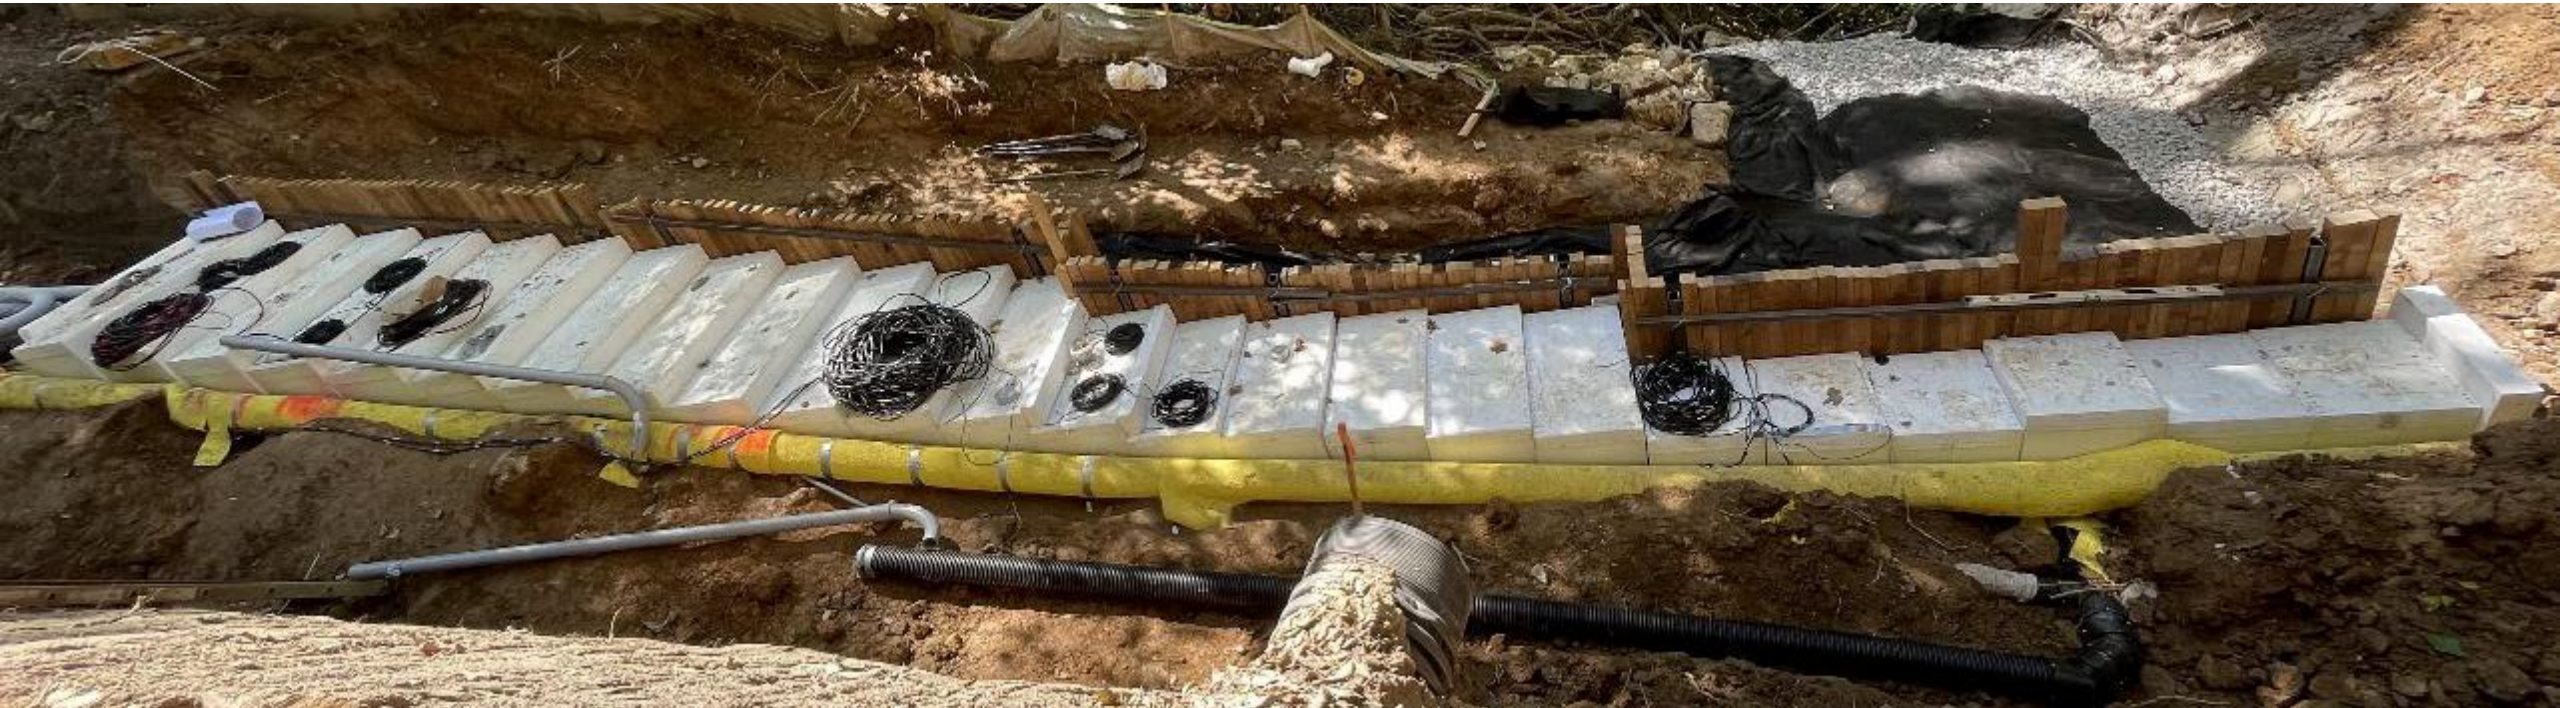
Installation of NW Leg

NW Leg
Installed first

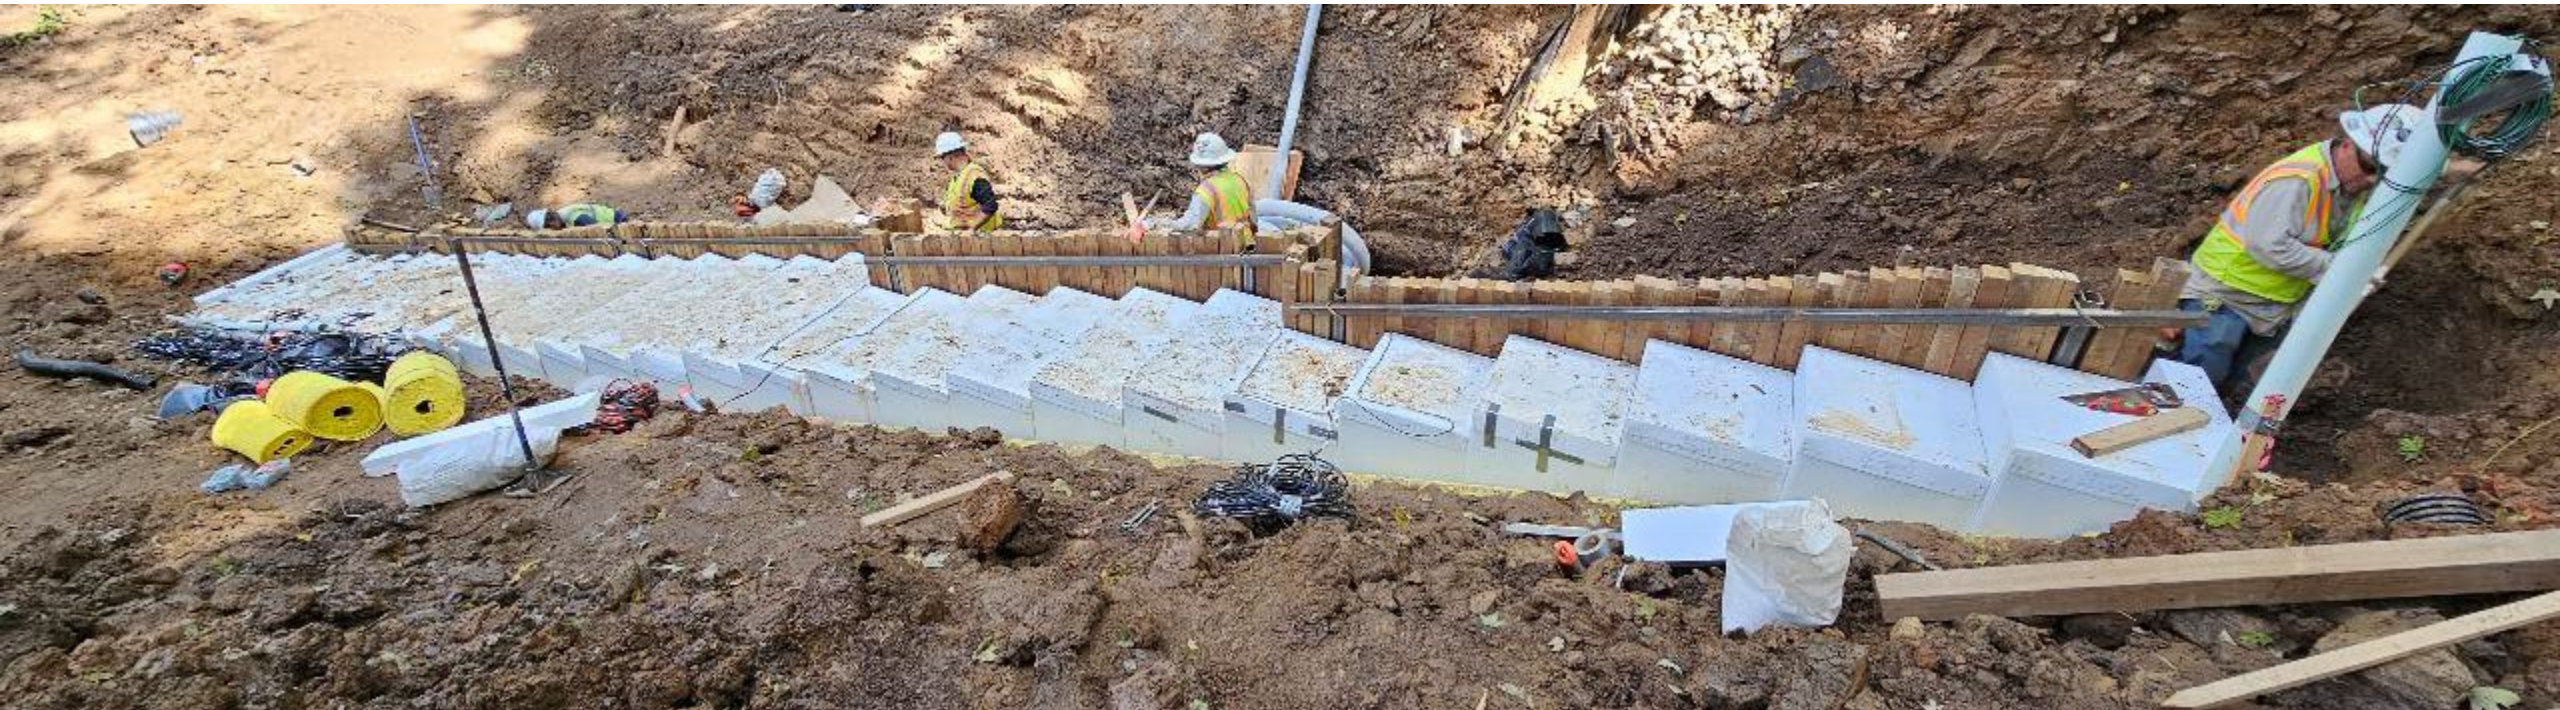
Installation of SE Leg

SE Leg
Installed second
