# Composite Repair of Transmission Pipelines Workshop

**2020 PRCI Research Exchange**

Presented by Dr. Chris Alexander, PE | ADV Integrity, Inc.

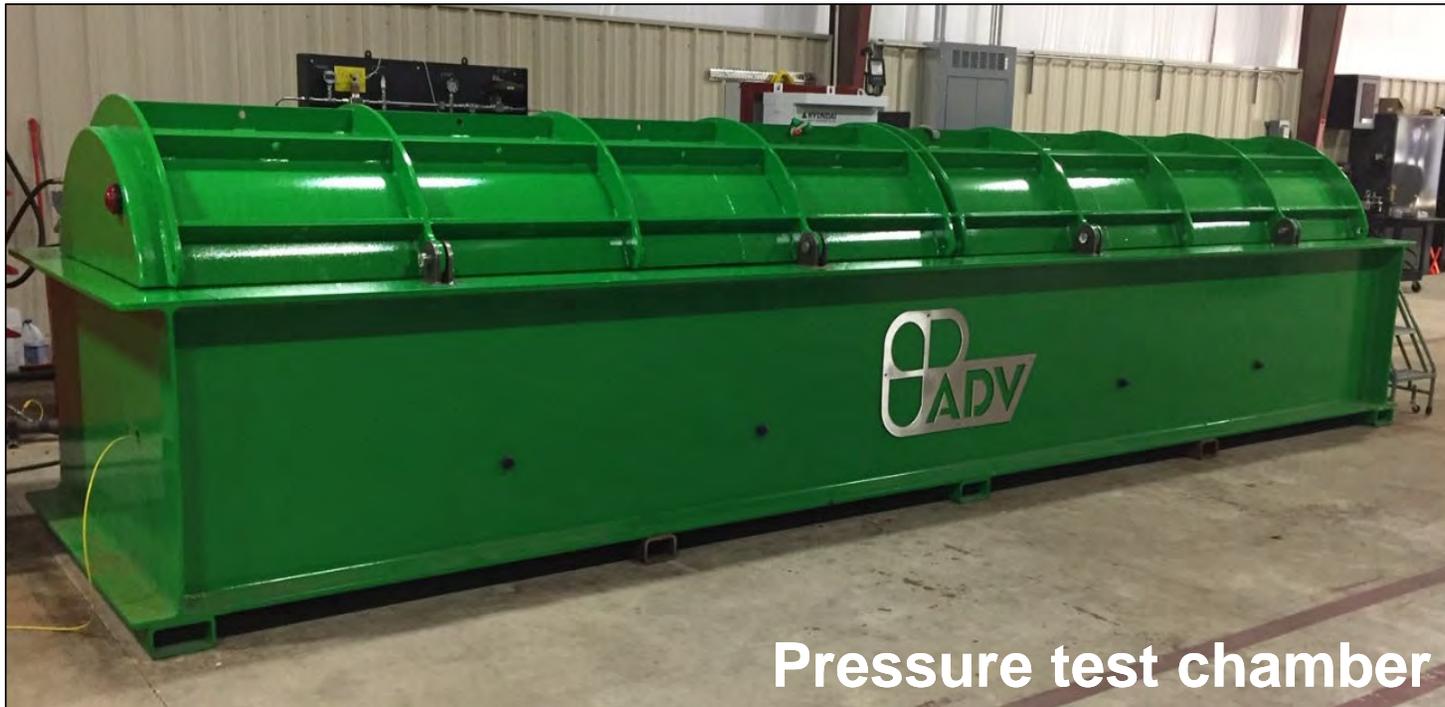
Pressure test chamber

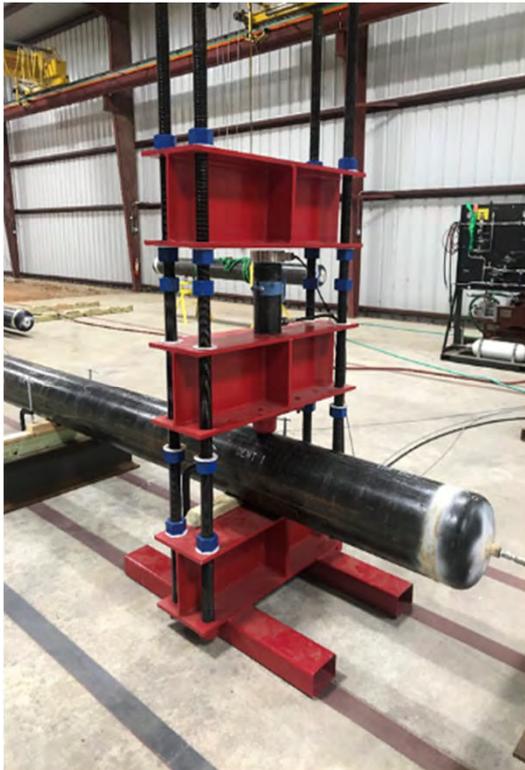
Dent installation test rig

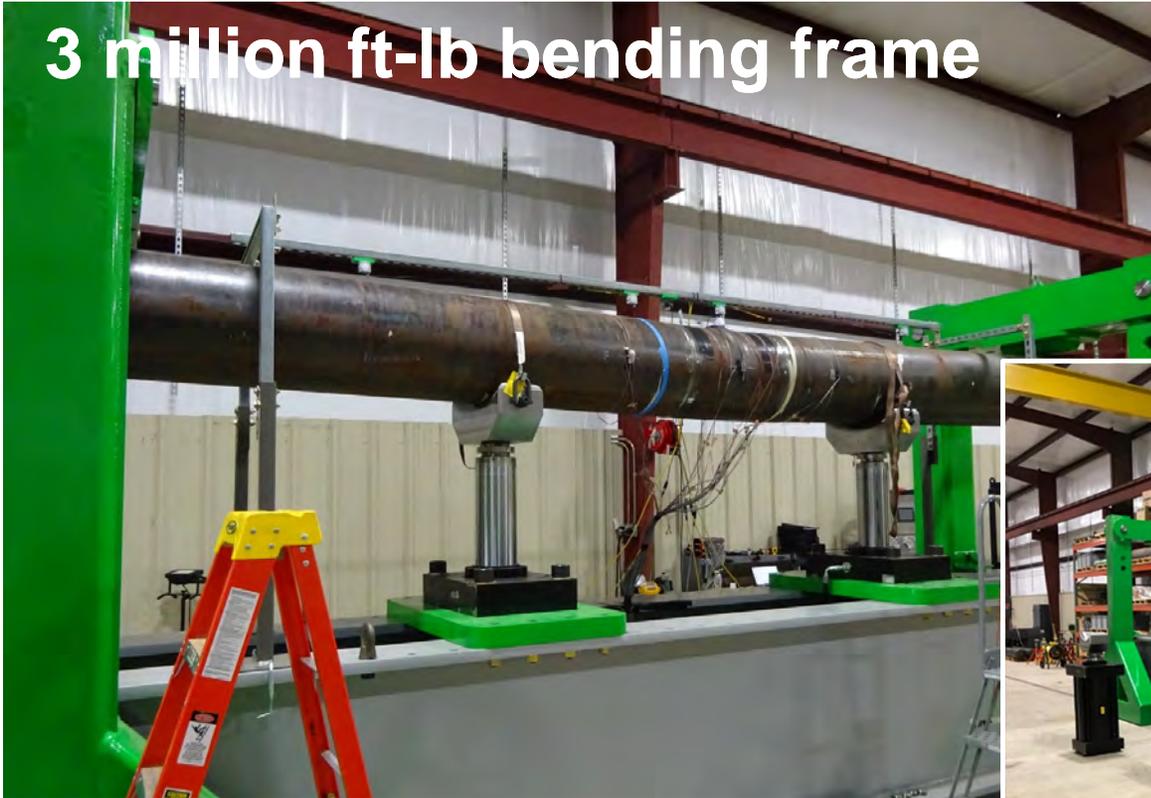
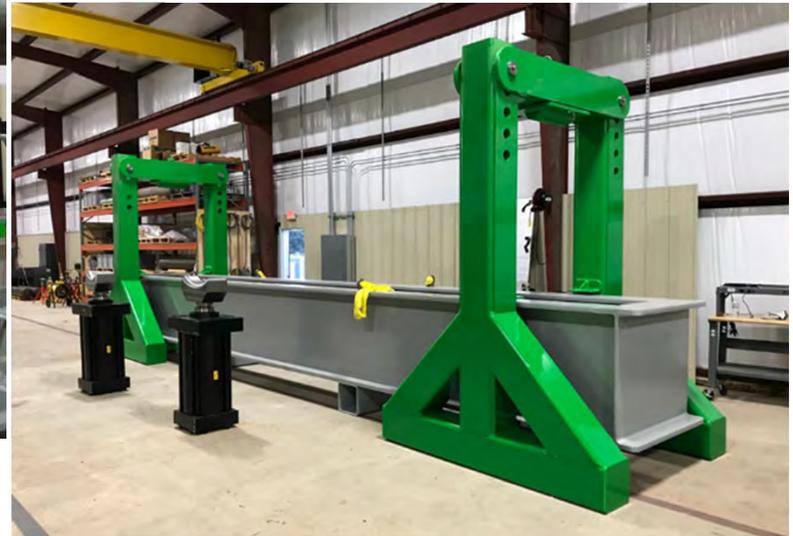
3 million ft-lb bending frame

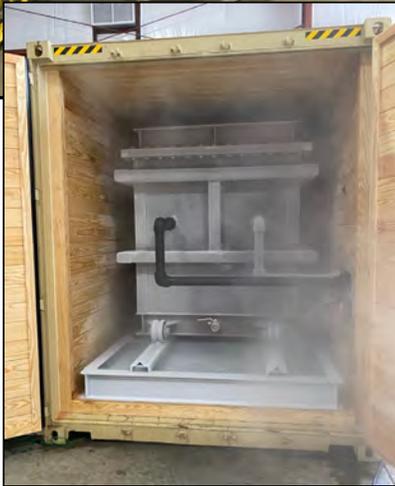
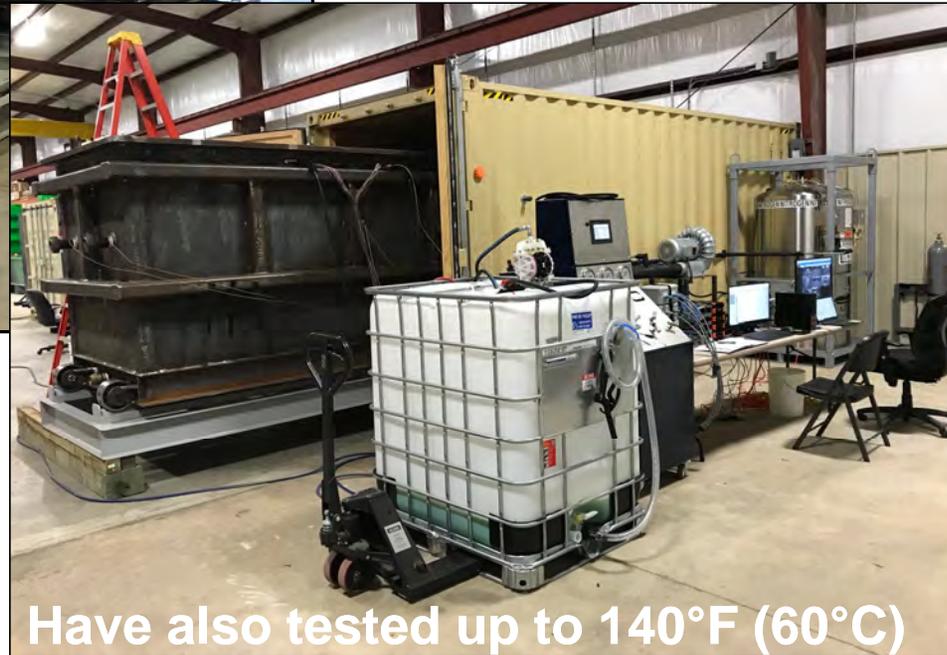
## Cold Temperature Burst Box (-51°F / -46°C)

Have also tested up to 140°F (60°C)

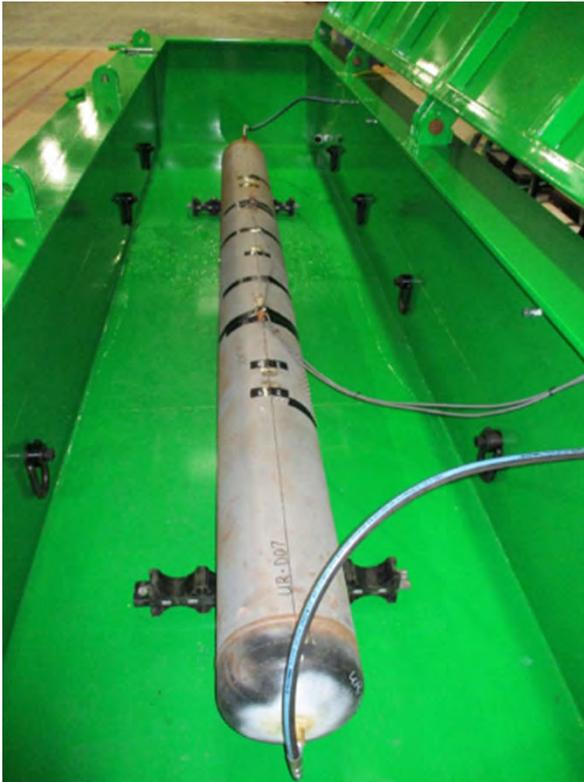
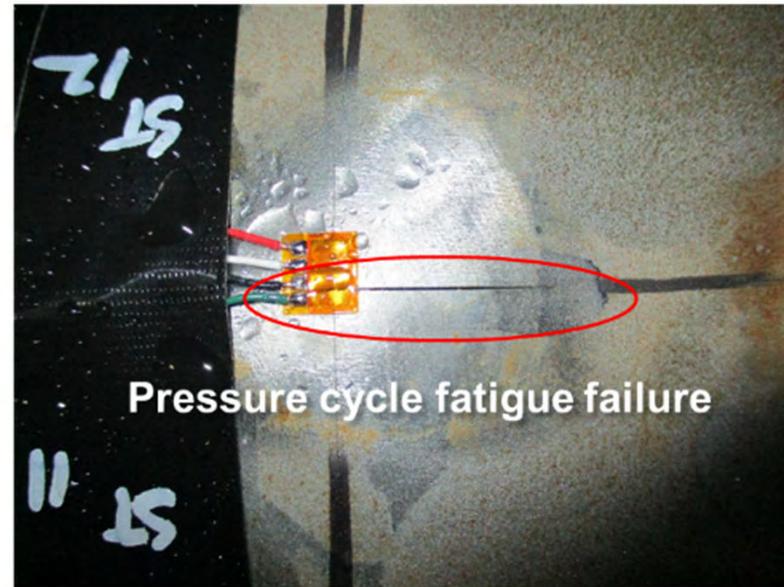
## Pressure cycle fatigue testing dents

In the test lab, dents can be simulated to achieve any geometry and also include interactions with seam welds, girth welds, and corrosion (to name a few).

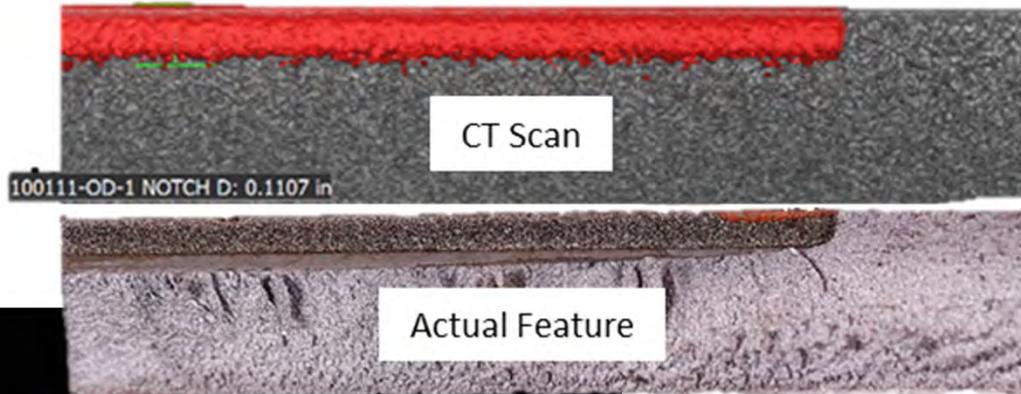
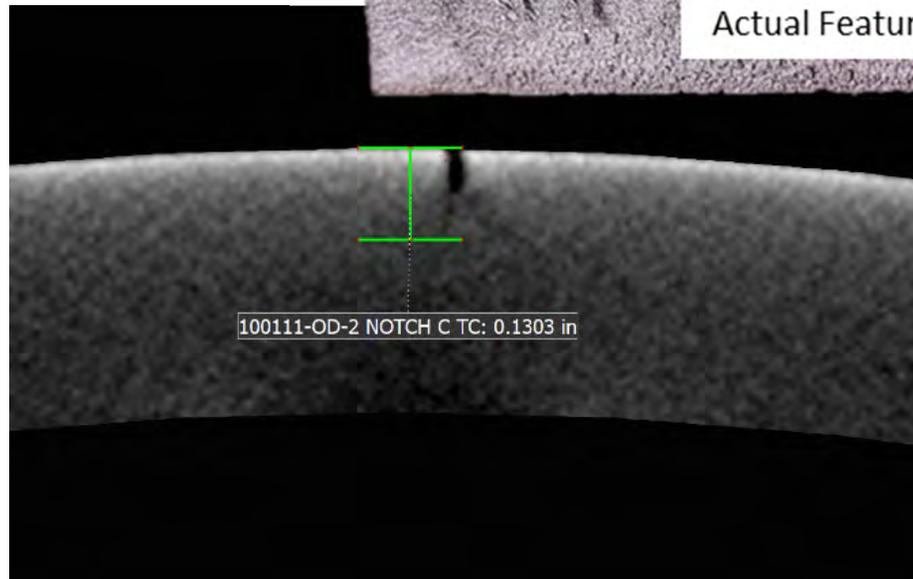
Inspection Technology

Computed tomography (CT) results inspection results of crack-like features in 12-inch NPS pipe material.

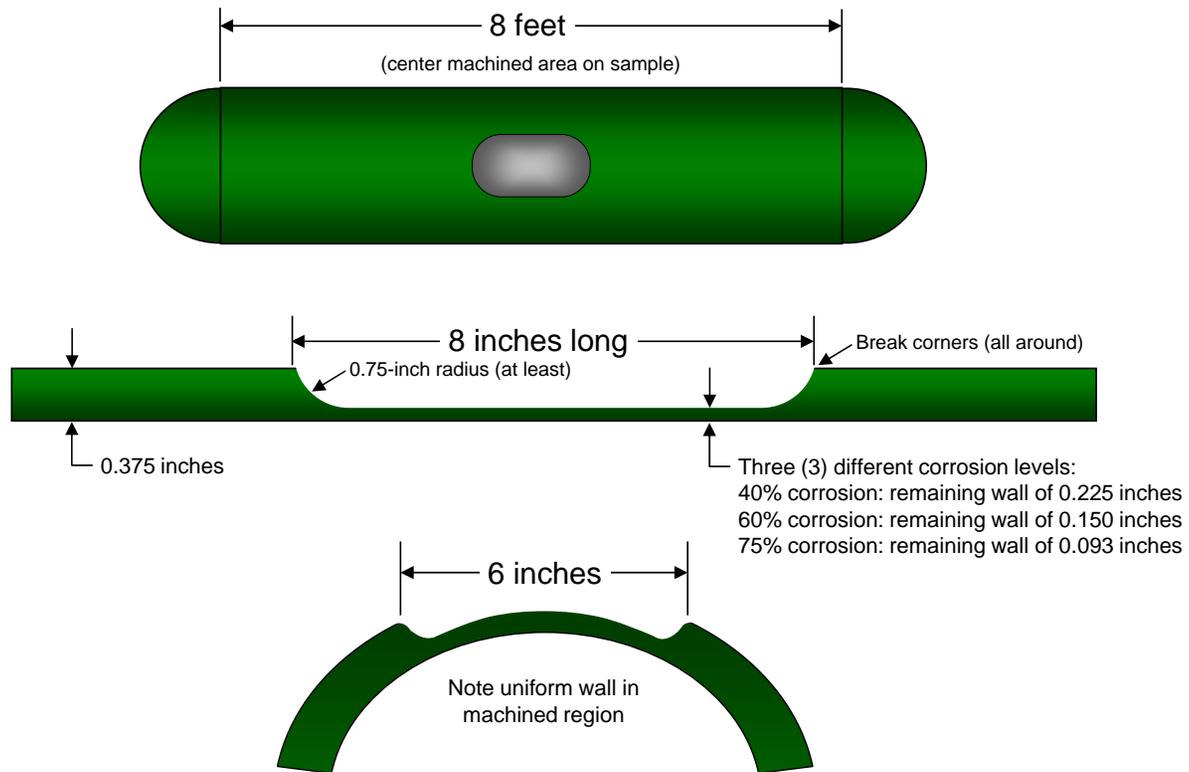
12.75-inch x 0.375-inch, Grade X42 pipe (8-foot long)

**Details on machining**  
(machined area is 8 inches long by 6 inches wide)

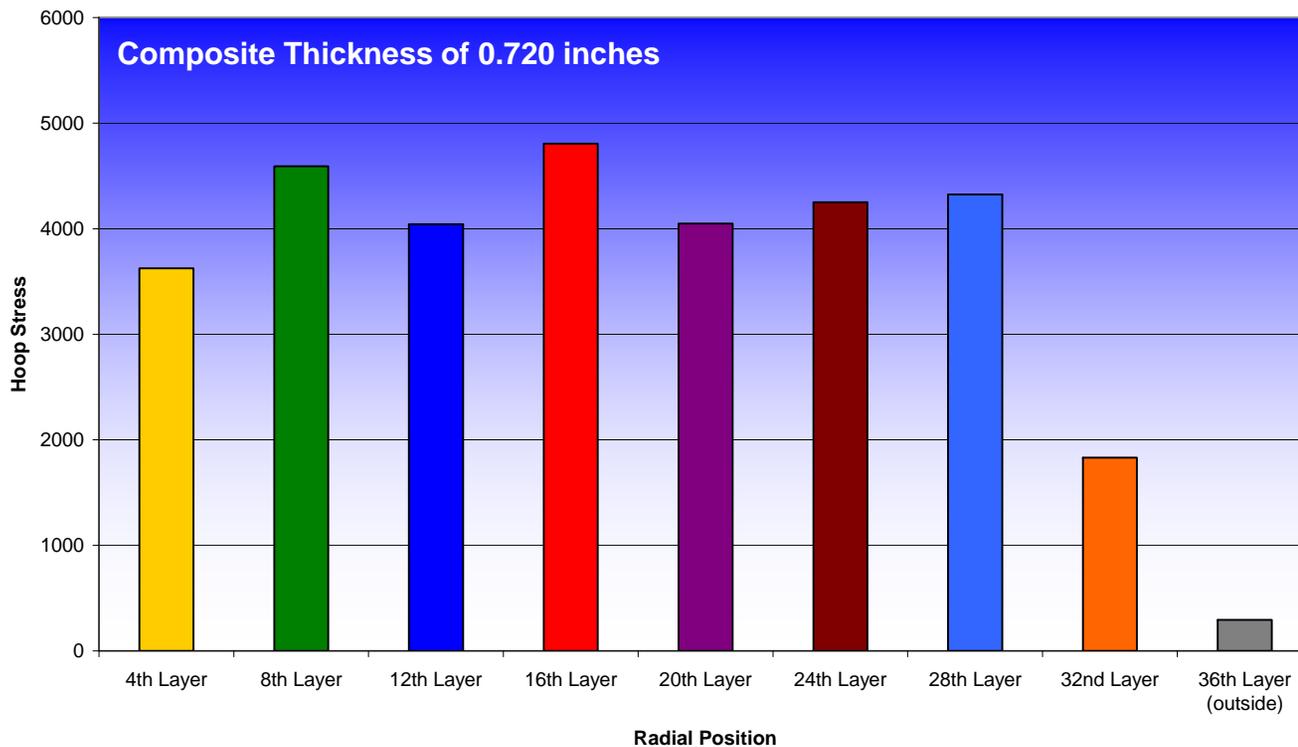
Hoop Stress at 72% SMYS as a Function of Radial Position

Key for Long-term Performance

Safety Factor of 10.8 on short-term tensile strength

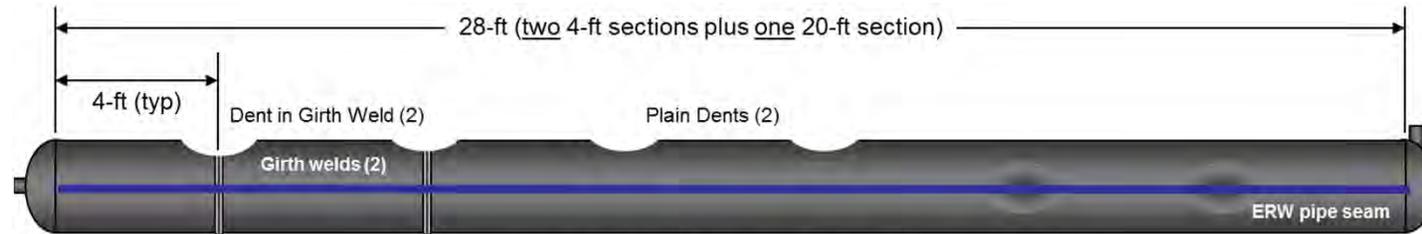
Samples fabricated using 12.75-inch x 0.188-inch, Grade X42 pipe material

Side View of Pipe Sample (6 defects total)

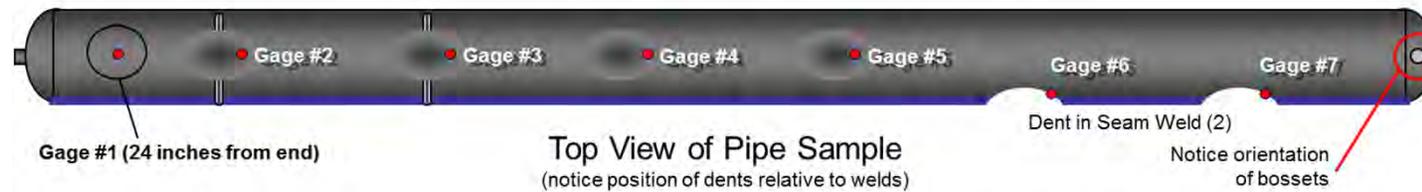
Top View of Pipe Sample  
(notice position of dents relative to welds)

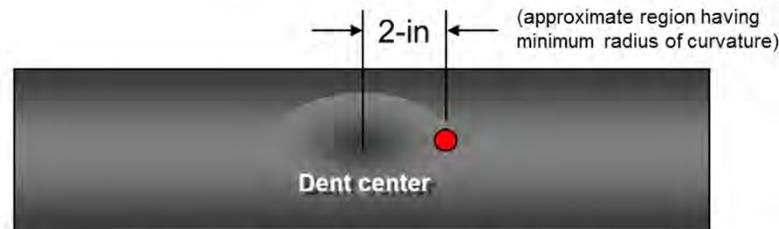
Close-up View of Dented Region

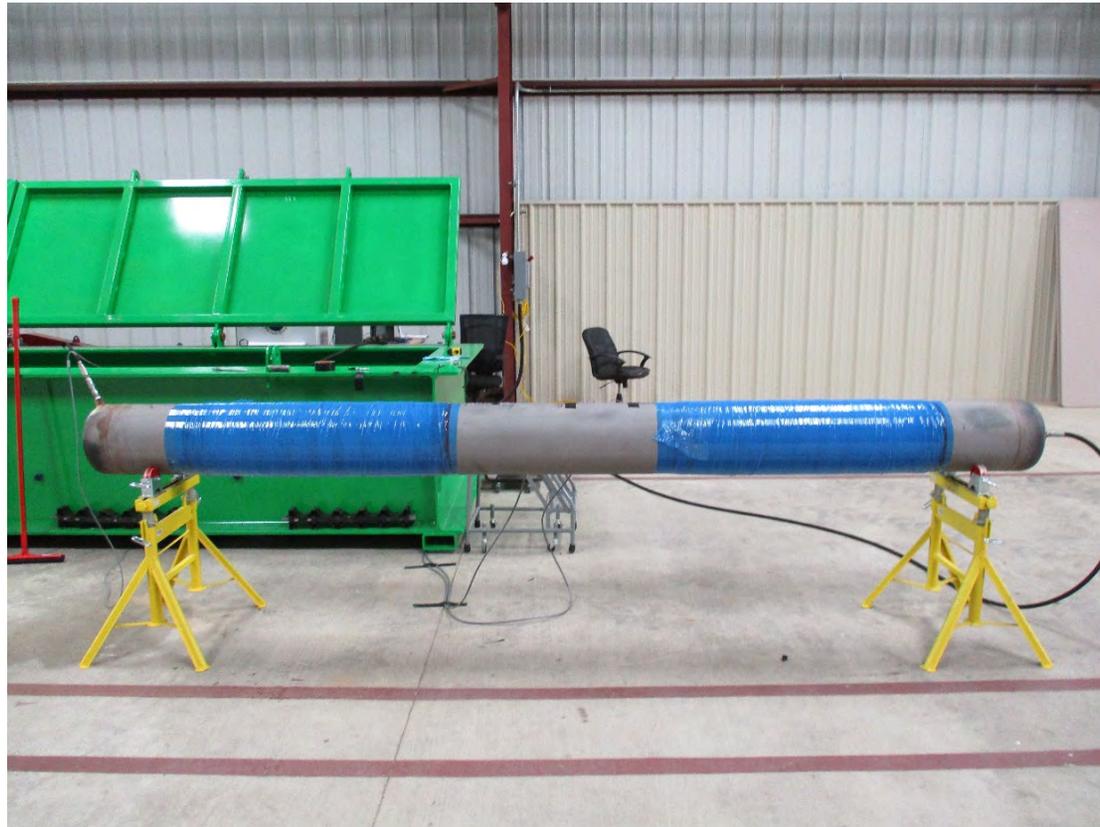
NRI-D02-64|Dent 2 leaked after 30,814 cycles

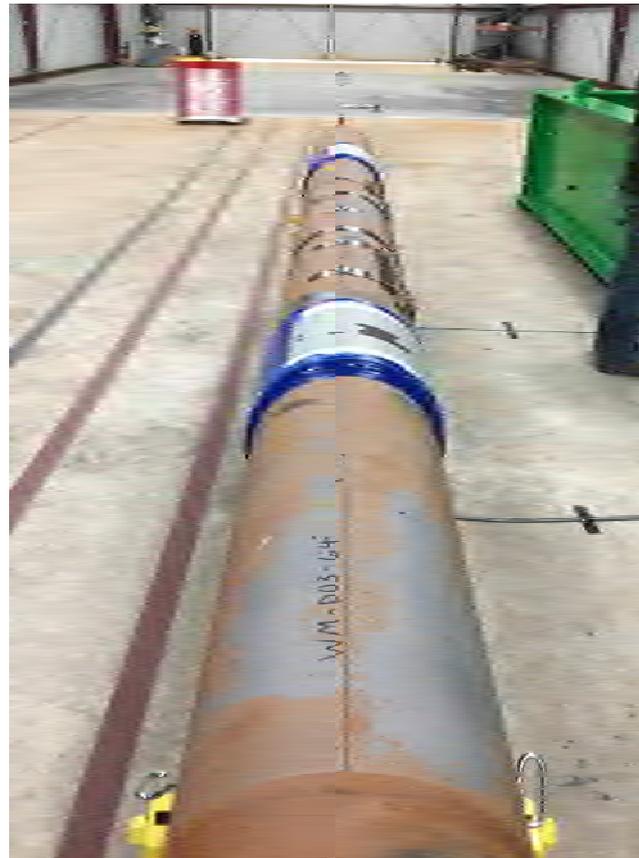
WM-D03-64|Dent 2 Leaked after 24,721 cycles

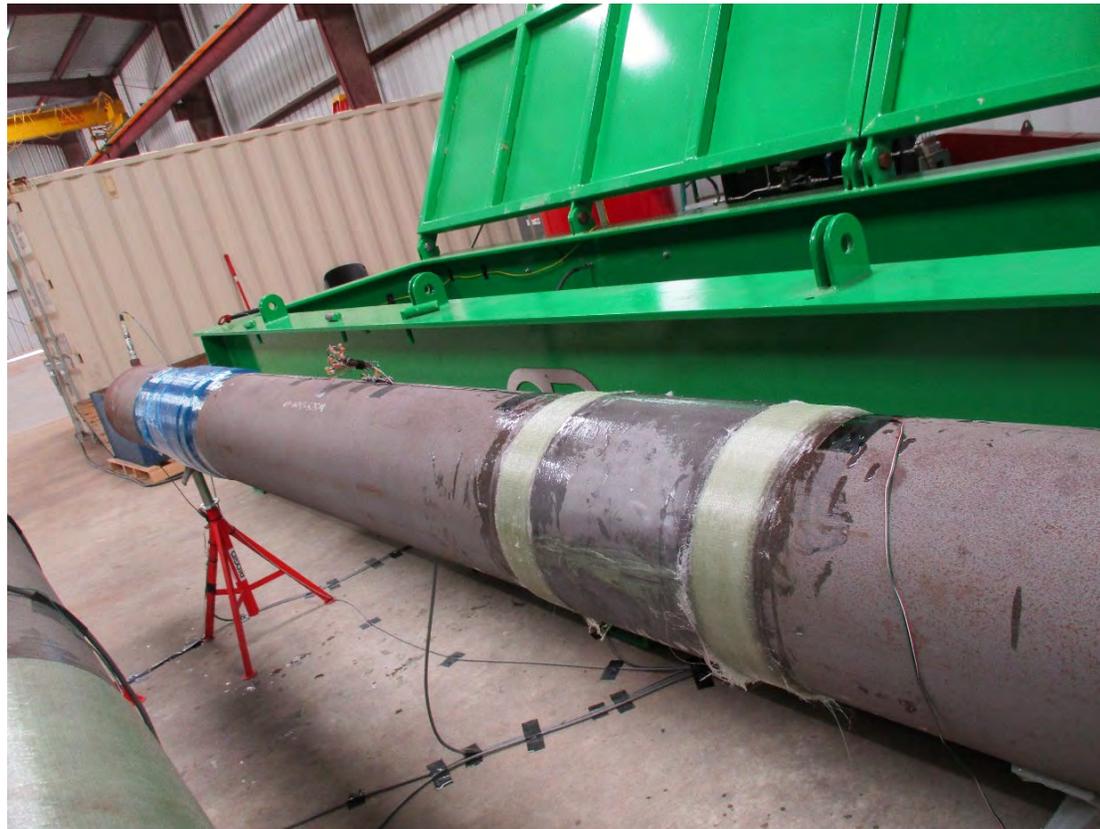
WSCS-D04-64|Dent 1 leaked after 59,927 cycles

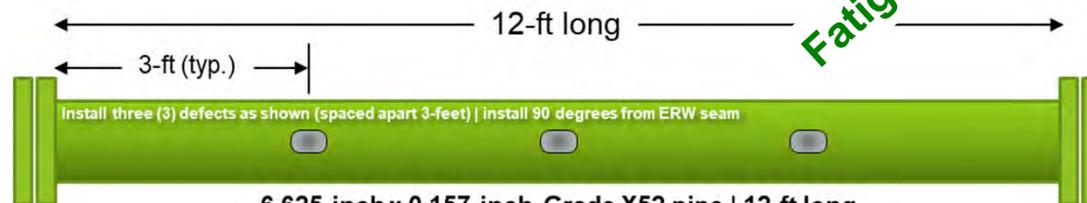
6.625-inch x 0.157-inch, Grade X52 pipe | 12-ft long

**Burst Sample**

**Fatigue Sample**
