Pipeline Research Council International, Inc.

Hard Spots NDE- Validation and Verification

Blade Energy Partners

NDE 4-11 : Phase II (Aug 2018) – Focus of this Presentation

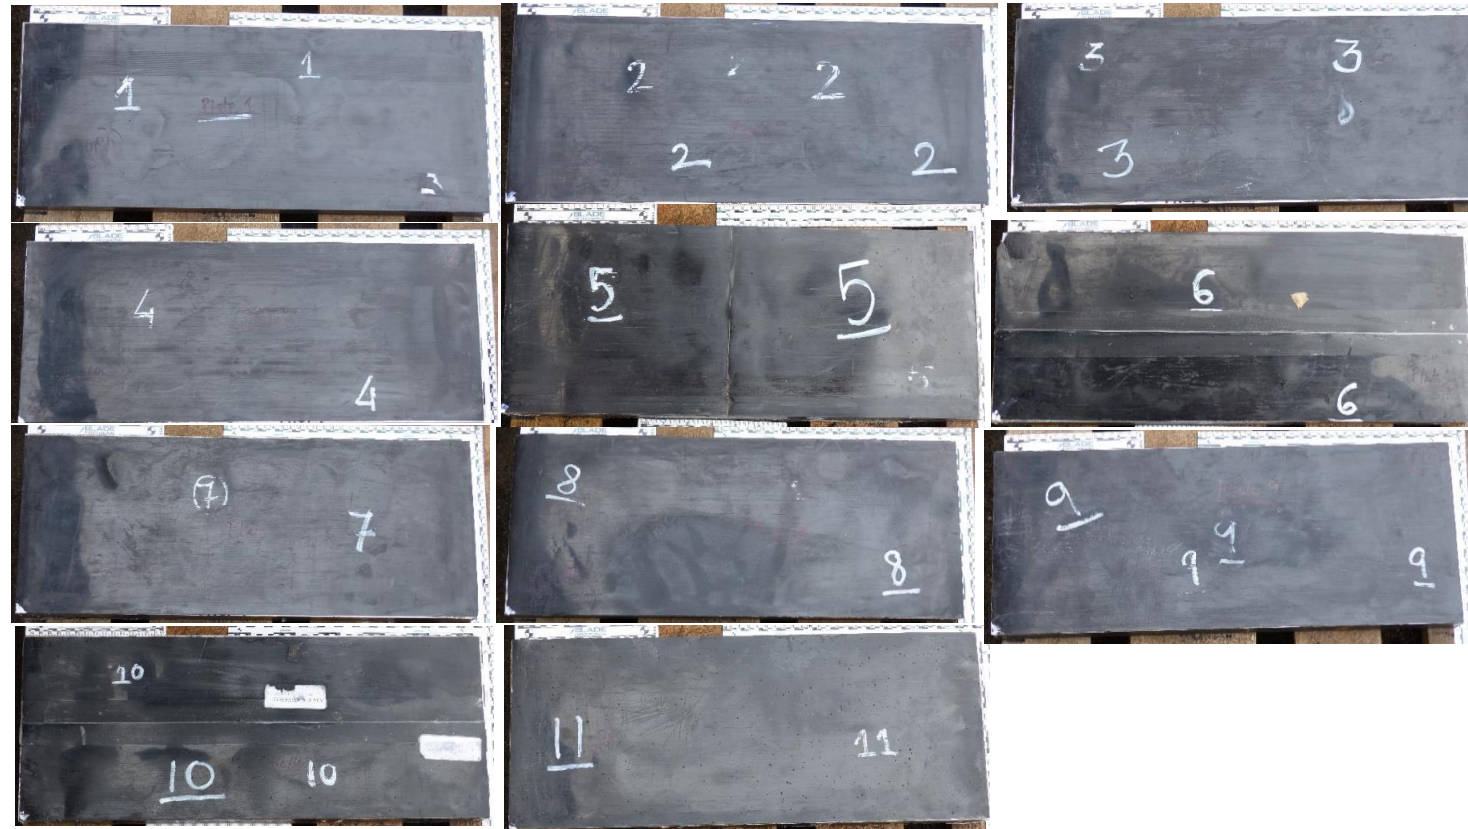
Defect Concealment

Plates surfaces were glued with 1mm thick black opaque ABS sheets

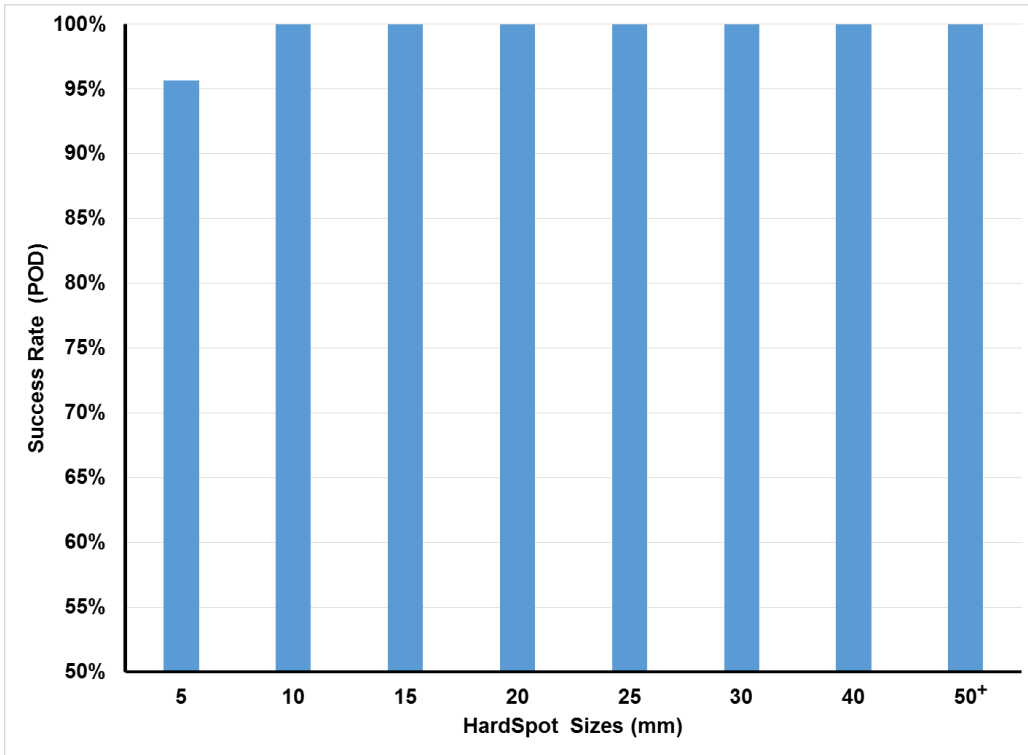
Probability of Detection (POD)

Observations	Success	Binomial Probability	Binomial Confidence	C-P Lower	C-P Upper
5<=x<=10	23	22	88%	95%	81%	100%
10<x<=15	19	19	85%	95%	85%	100%
15<x<=30	29	29	90%	95%	90%	100%
30<x<=50	24	24	88%	95%	88%	100%
50<x<=75	26	26	89%	95%	89%	100%
Total	121	120	98%	95%	96%	100%

Provider "A" can detect 5+ mm hard spots with a certainty of 80% and with 95% confidence

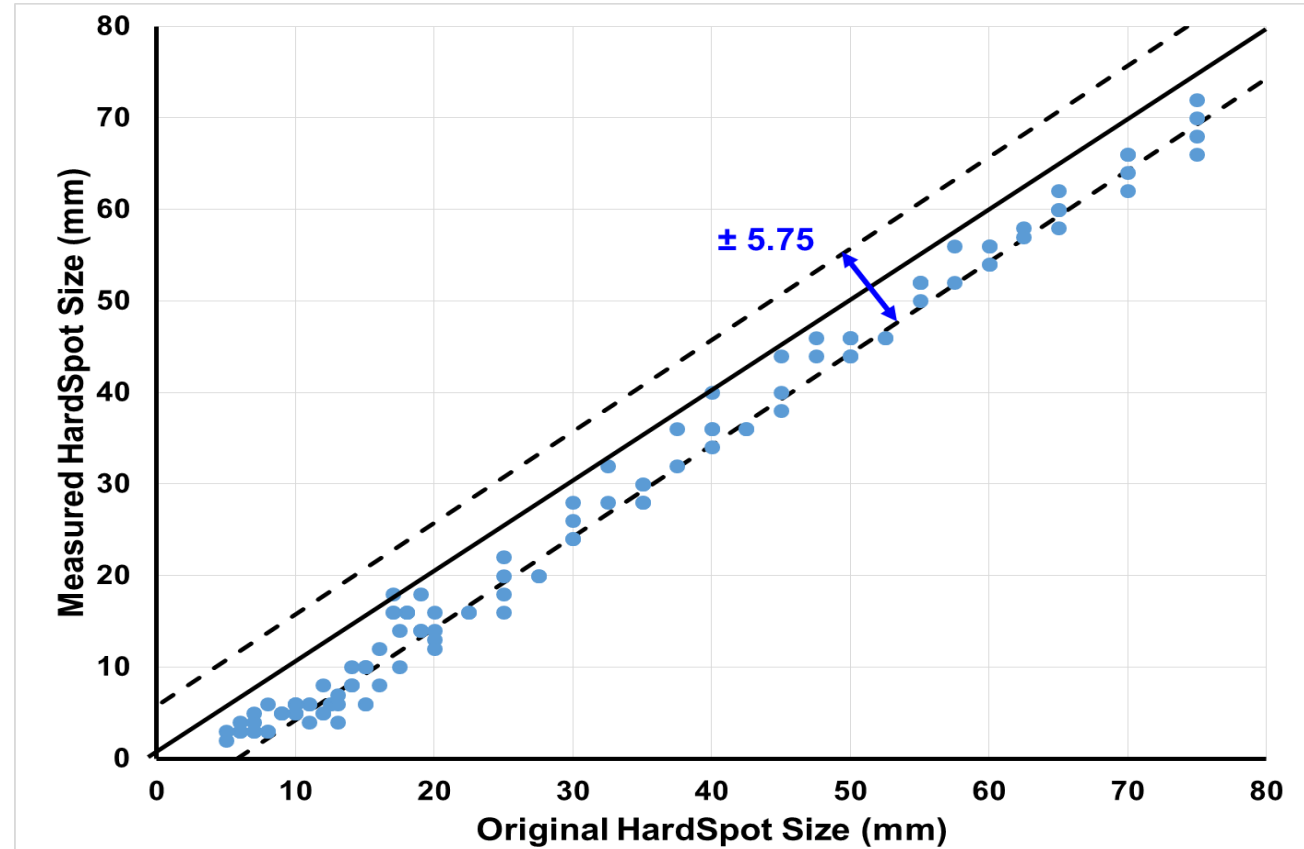
Sizing Accuracy – Unity Plot

- Original versus Measured Hard spot size

Size (mm)	Mean size (mm)	Detected size (mm)	Mean Size Error (mm)	Std. Dev	Tolerance (mm)
5<=x<=10	7.9	4.4	3.7	1.0	4.13
10<x<=15	13.2	6.9	6.3	1.5	6.99
15<x<=20	18.2	14.3	4.0	2.5	5.29
20<x<=25	24.2	18.0	6.2	1.8	8.01
25<x<=30	29.2	23.7	5.5	2.0	7.46
30<x<=40	36.7	32.5	4.2	2.2	5.58
40<x<=50	47.1	42.5	4.6	1.9	5.76
50<x<=75	63.3	58.3	5.0	1.7	5.70
Total	30.7	26.1	4.8	2.0	5.75

Mean Tolerance 5.75 mm

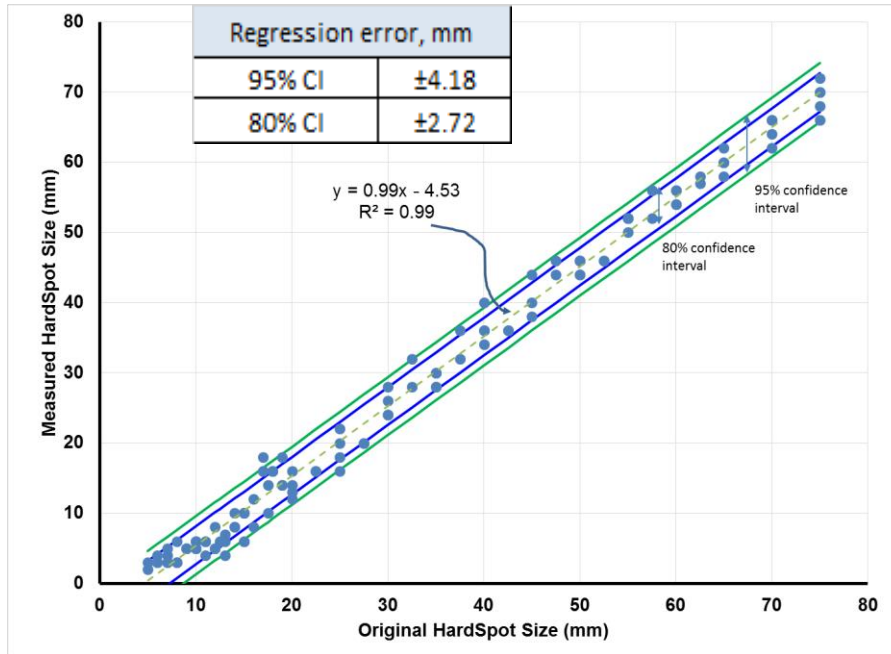
Along the longitudinal orientation

- 1.) Can be used to estimate the size using the regression fit
- 2.) Deviation in the detected and original size at 95% confidence interval is ± 4.18 mm

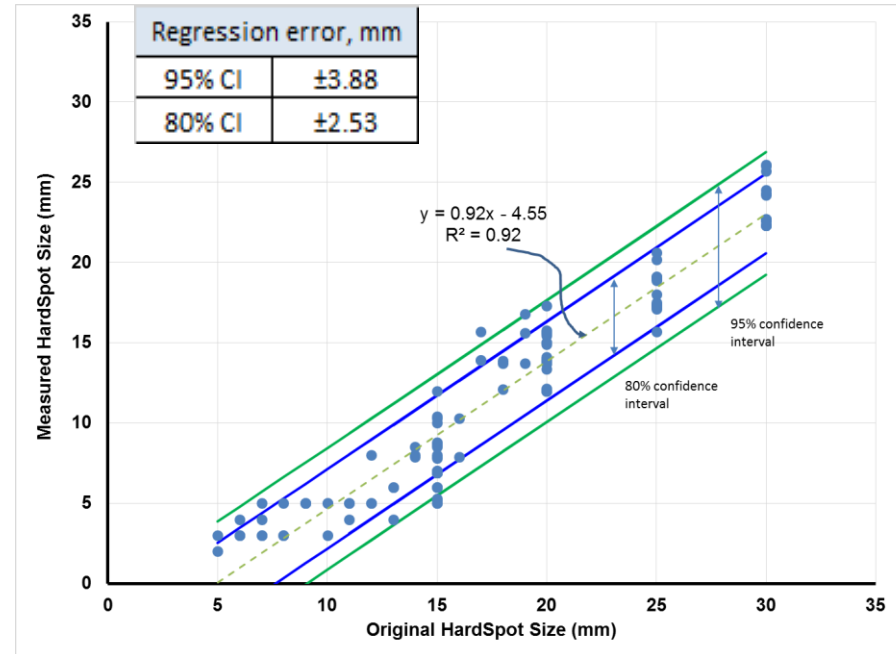
Along the width orientation
