EPRG-PRCI-APGA
23rd Joint Technical Meeting
Edinburgh, Scotland
6-10 June 2022

PERFORMANCE OF ILI TECHNOLOGIES FOR DENTS WITH INTERACTING FEATURES

PAPER NUMBER: 19

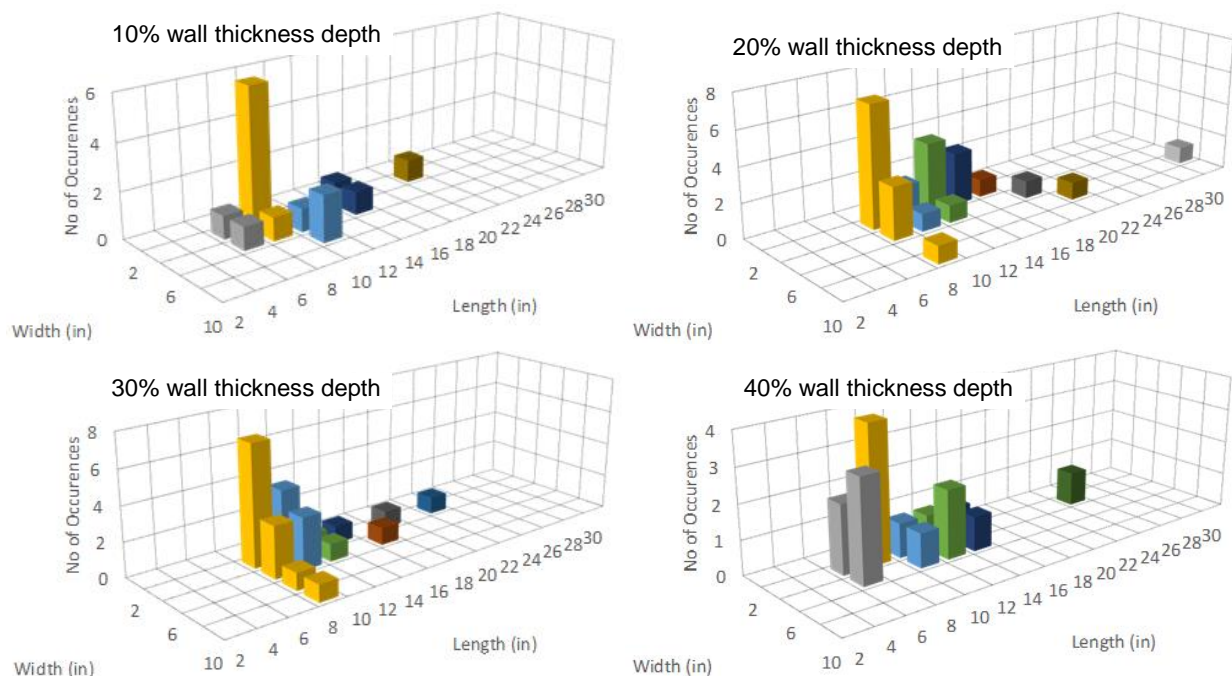
Figure 1: Sample Corrosion Feature and Size Statistics

aspect ratios such that they represent the corrosion feature definitions (e.g., pitting, grooving, general corrosion) defined in API 1163. Figure 1 illustrates a sample of the pipe outside diameter (OD) surface with corrosion features and provides statistics of the range of features considered in the project. The trial specimens included corrosion features within dent features and those outside of dents so that the performance of the ILI tool in detecting identifying and sizing corrosion and corrosion coincident with dents could be compared.

a) Sample corrosion features after cyclic loading to form fatigue cracks near the dent center

b) Corrosion feature size statistics

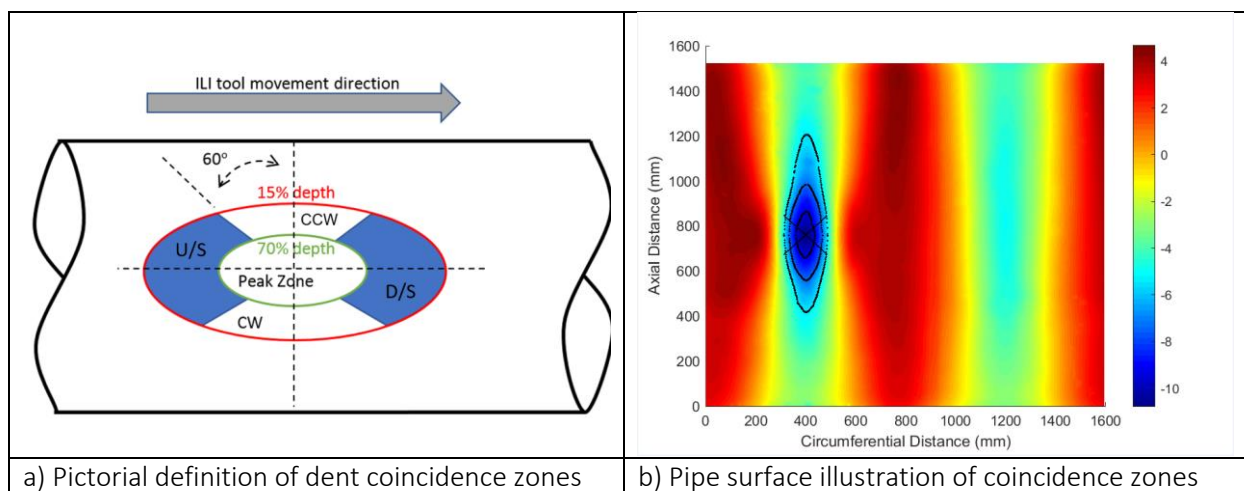
Figure 6: Dent Coincident Feature Locations

The collected data was used to evaluate the performance of ILI systems by comparing the ILI system reported data with the project Truth data. It is noted that statistics reported in this project may be based on relatively small data sets and thus may not be representative of the performance of the ILI system over a larger population of features that may be used by the ILI Service Provider to develop their performance specification. In addition, the performance of the ILI systems was evaluated with respect to coincident feature combinations and the effects of speed that may not be explicitly considered in the ILI system specification. For this investigation, the coincidence of features with the dent were identified based on their location within the five zones defined in Figure 6. Based on these definitions of the coincidence zones, the coincident feature location was identified by the following characteristics:

- ID and OD,
- U/S shoulder,
- D/S shoulder,
- Sides of the dent (clock position),
- Center of dent, and
- Plain pipe (outside of the dent feature).

Both statistical summaries of performance (average and standard deviation of difference between the Truth (reference) data and ILI system measurements) and unity plots were developed. This description will focus on the unity plots considering corrosion features that are coincident or not coincident with dent features in Figure 15. The graphs include reference lines for perfect agreement, ± 10 percent and ± 20 percent wall thickness, as well as ± 0.5 inches (12.7 mm) and ± 1.0 inches (25.4 mm) in feature size (i.e., length or width). The feature size performance may have been affected by not applying feature interaction or boxing rules as illustrated by the underestimation of the feature length in the unity plots. These unity plots, for this specific ILI tool, illustrate that while the performance of the ILI system in reporting corrosion feature depth tested is affected by the presence of the dent, there is only a limited reduction in performance. As shown in Table 4, for a specific ILI system, the POD for all metal loss (ML) features drops on average 1% when the corrosion feature is coincident with a dent. The POD is lowest for features in the dent peak zone, as defined in Figure 6a.

Figure 18 illustrates the effect of corrosion feature location within the dent for a specific ILI system on probability of detection. This result indicates that while performance is good, the ILI system has the most difficulty in detecting and sizing features at the peak of the dent. The dent coincidence zones from Figure 6a are repeated in this figure for reference.

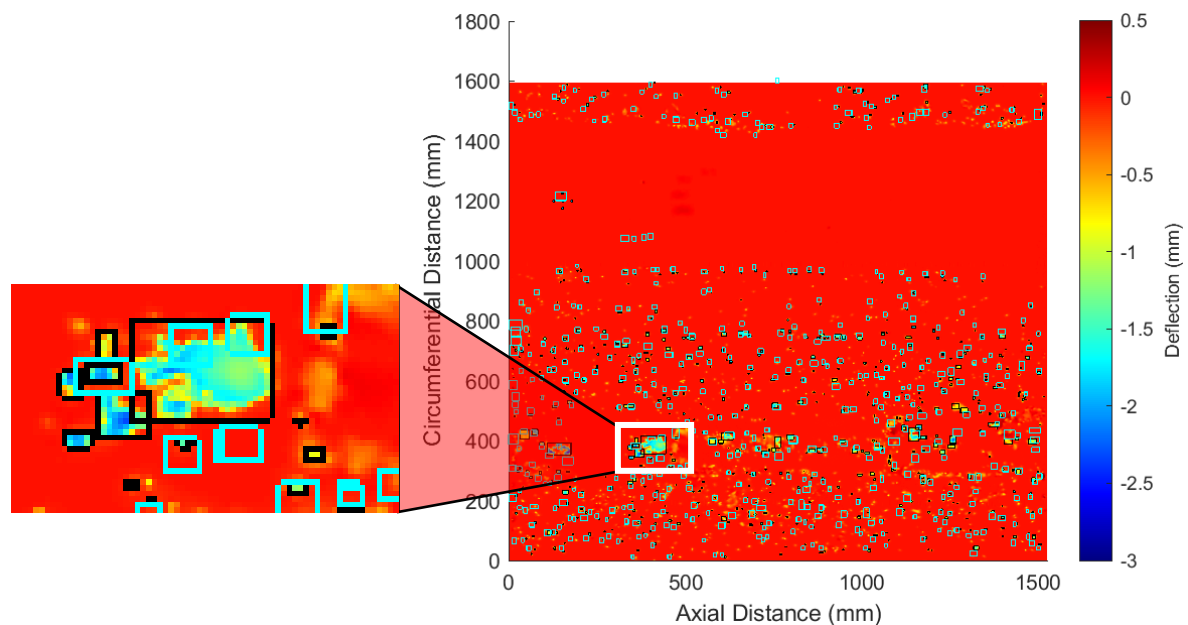
The corrosion features were sub-characterized using the corrosion feature type definitions (e.g., pitting, grooving, general corrosion) in API 1163. Corrosion features with depths of less than 10 percent of the pipe wall thickness were not considered in the ILI system performance evaluation reporting process. In comparing the ILI system reported corrosion features with the Truth data, no metal loss interaction or clustering criteria were applied to the Truth data and the two data sets were aligned by aligning the five-hole reference marker (Figure 3) in the two data sets. Individual features were matched by minimizing the distance between the features in the two data sets as shown in a sample laser scan (Truth data black box outline) and ILI system reported (features in the blue box outline) in Figure 7. The laser scan Truth data shown with black outline boxes may intersect with multiple ILI reported features as shown in the magnified area of Figure 7. In this instance all of the intersecting ILI reported features will contribute positively to the probability of detection (POD) but will diminish the probability of identification (POI) because the feature may represent the wrong metal loss class.

Figure 7: Sample Truth Data (Laser Scan Black Outline Box) to ILI System Reported (Blue Box) Features

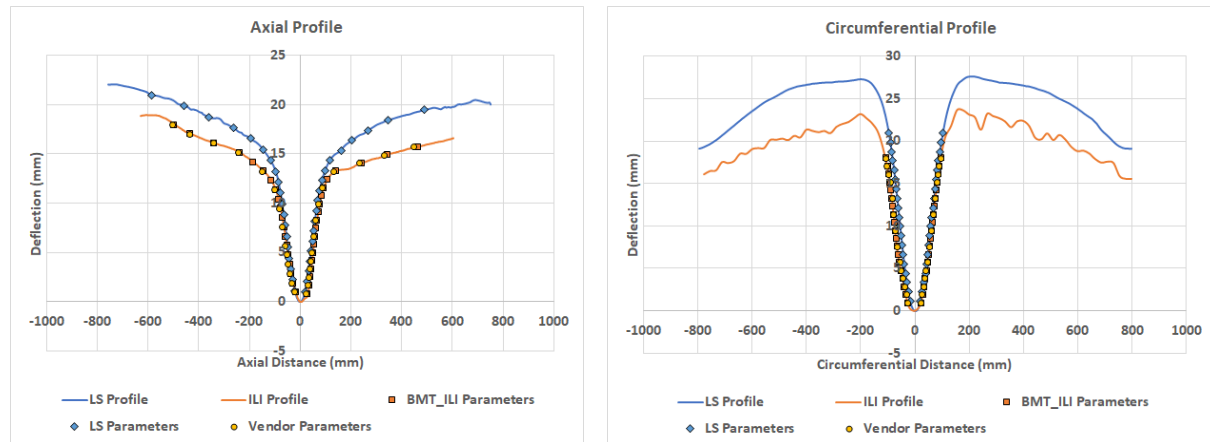
The performance in characterizing dent features was completed by comparing the API RP 1183 characteristic lengths and areas derived from ILI caliper tools to those derived from laser surface scan data. Figure 8 illustrates the API RP 1183 characteristic lengths derived from an axial profile of a dent taken at the clock position such that the profile traverses the deepest point of the dent. Figure 8 also includes a sample illustration of the overlay of the ILI, surface scan and the points used to characteristic lengths for the API RP 1183 dent shape definition process. The illustrations in this figure demonstrate that the U/S and D/S dent depths can be different if the dent is not symmetric because the U/S and D/S dent shapes are different.

a) Illustration of the dent axial profile characteristic length definition

b) Sample comparison of ILI and Truth data

Figure 8: Dent Profile Shape Characteristic Length Definition and Truth Data to ILI System Comparison

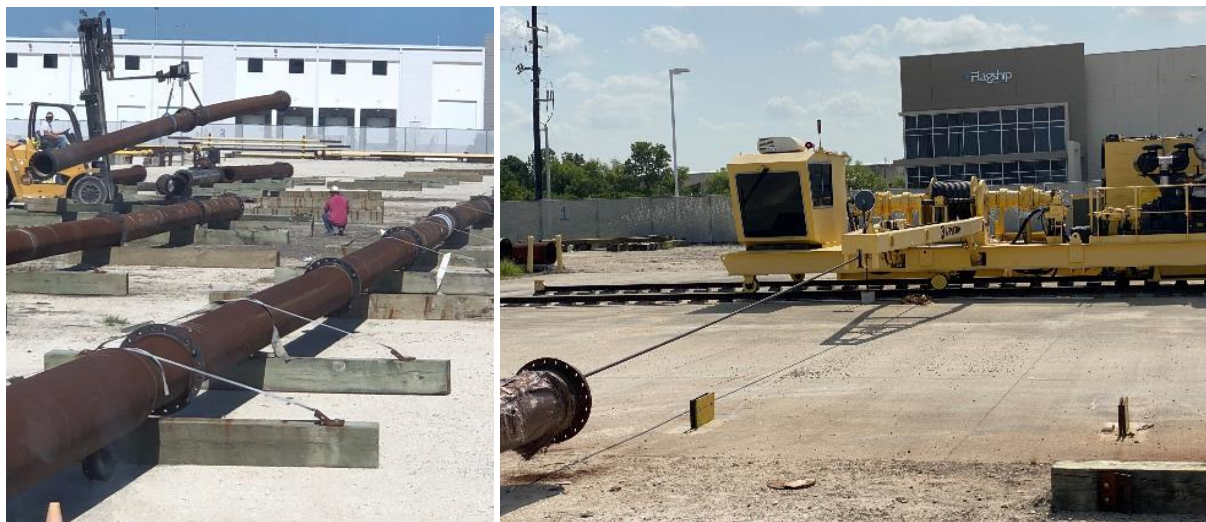
Figure 9 illustrates the ILI performance trial winch and pull string assembly for the program. The pull strings were roughly 152 m (500 feet) long and contained more than 65 dent features with and without corrosion, cracks and gouges). The test setup also included pipe samples with just corrosion features that were used as a reference samples for the performance evaluation.

Figure 9: ILI Trial Setup and Pull Through Winch

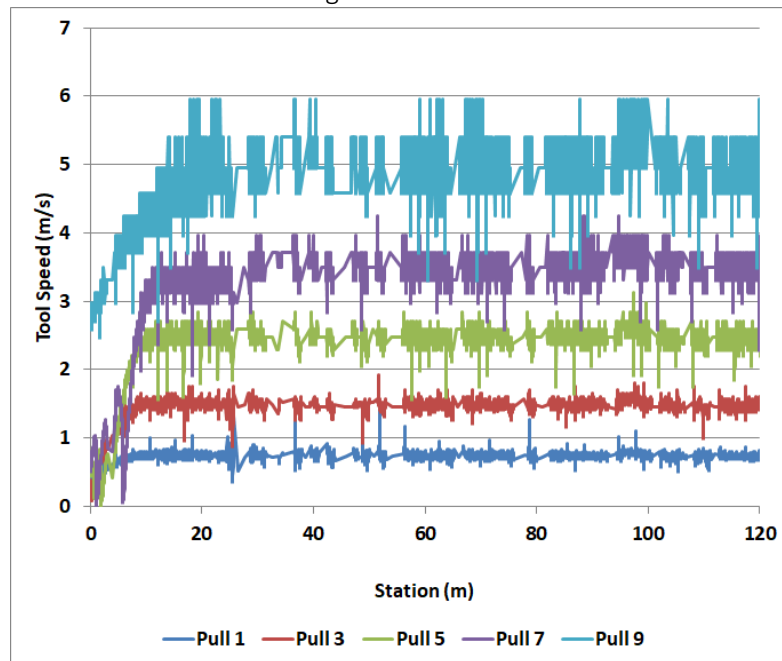
Both trial day data testing conditions and processed data were collected as outlined in the previous section. The trials were completed as blind trials, in that the ILI Service Providers were only informed of the types of features that would be present in the trial strings prior to testing. During the trials, the ILI system data, trial conditions, attendees and any issues related to the trial were recorded for future reference. For example, the pull speed was recorded based on the winch wire speed to demonstrate

the uniformity of the pull speed as shown in Figure 10. This data was compared with tool speed data provided by the ILI service Provider and no significant difference was observed.

Figure 10: Reported ILI Trial Pull Speeds

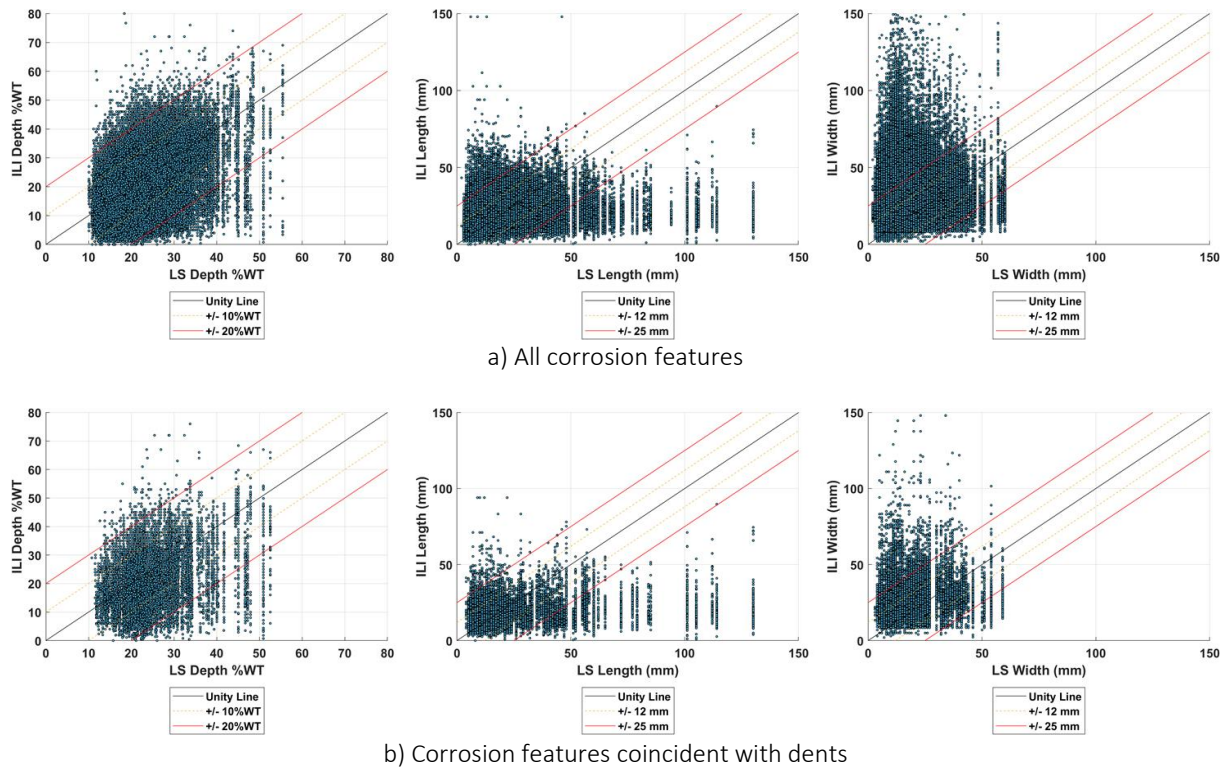
The performance of MFL based ILI systems in characterizing corrosion features, considering six ILI systems, is presented in Figure 16. These observations represent approximately 194,000 corrosion feature measurements from the ILI performance trials. These unity plots are comparable to those presented in Figure 15. The performance of the group of ILI systems is similar to that of the individual ILI system with a slightly higher standard deviation (spread) of the observations. This additional spread is due in part to the differences in measurement bias and reporting characteristics of each tool. The measurements include a small bias for underestimating feature depth and due to the clustering rules not being applied and ILI system performance long features are underestimated and feature widths are over estimated.

Figure 16: Corrosion Metal Loss Feature Unity Plots For Six ILI Systems

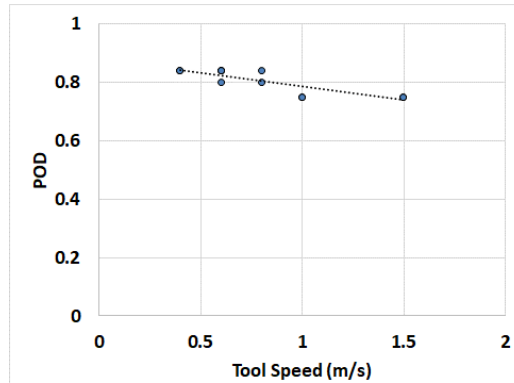
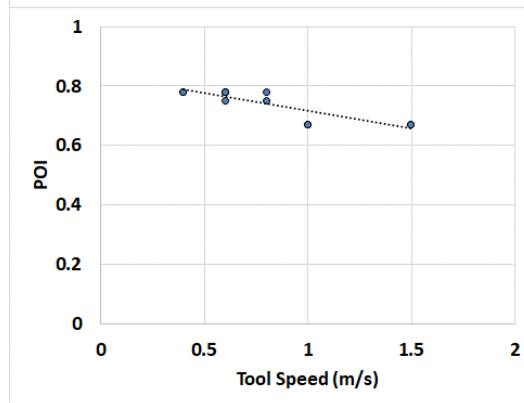
The performance of the ILI system in detecting and identifying the cracks is shown in Figure 20 considering the probability of detection and probability of identification. The crack included in this performance trial result are in plain dents and in dents with coincident corrosion. The probability of identification involved correctly identifying the crack initiation surface and the orientation of the crack (i.e., angle of the crack with respect to the pipe axis). These results illustrate that there is a small effect

of tool speed and the POD and POI are on the order of 80 percent. There were a significant number of false positives in the ILI system reported crack data.

a) Crack probability of detection

b) Crack probability of identification

Figure 20: Ultrasonic Inspection System Performance for Cracks

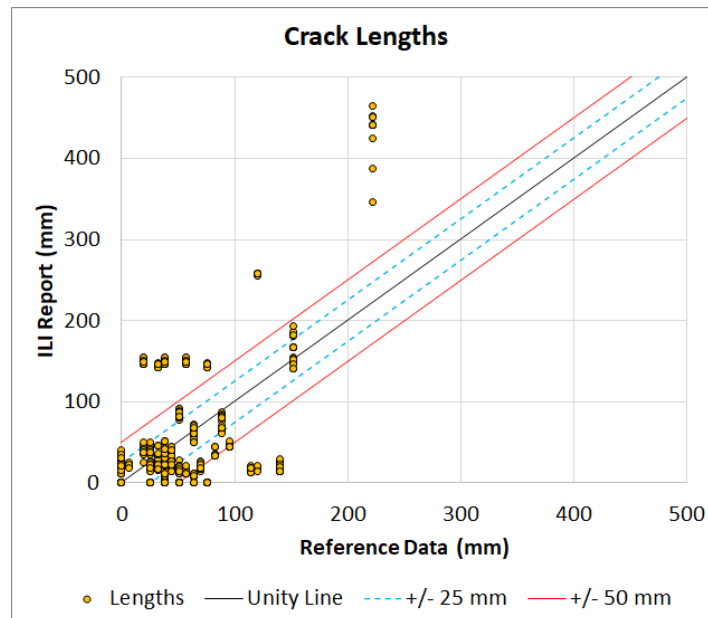
The performance of the ultrasonic tool in sizing the crack features is shown in Figure 21. These results illustrate good performance in reporting crack lengths in plain dents and dents with corrosion. There is a bias that overestimates the crack length; however, most cracks are sized within ± 2 inches (50 mm).

Figure 21: Ultrasonic Inspection System Crack Sizing Performance
