# APPRAISAL OF THE MICROGROOVING PHENOMENON OCCURRING IN A SOUR ENVIRONMENT ON 4PB SPECIMENS

#### **ABSTRACT**

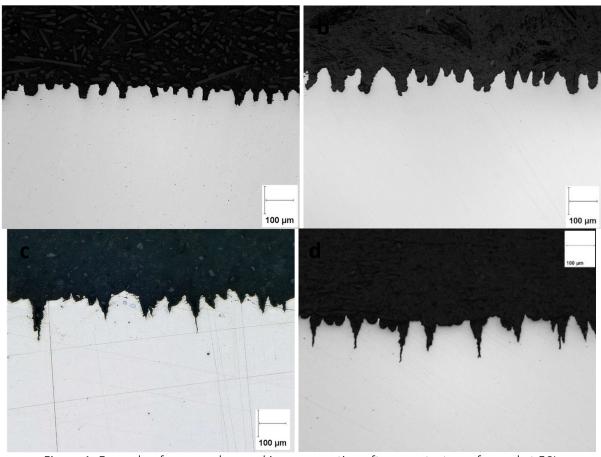
However, after cross-sectional observations of non-broken carbon steel specimens, superficial so-called "grooves" are often observed that can be significantly different in shape and depth depending on the material and test conditions considered. Some examples of such grooves observed after SSC tests performed at the FCI are presented in Figure 1. In some conditions, only grooves with a depth lower than  $100~\mu m$  are observed (Figure 1a and b) while crack initiation at the groove tip can sometimes be highlighted (Figure 1c and d).

Figure 1: Example of groove observed in cross-section after sour tests performed at FCI.

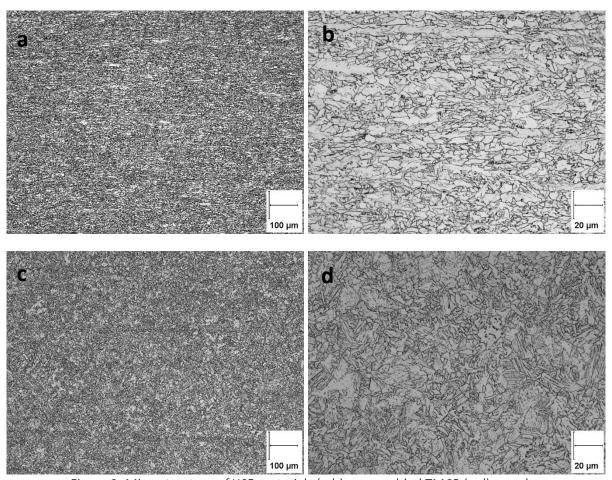
Figure 2 displays the microstructures of both grades observed after Nital etching. These observations were conducted on the specimens sampled for SSC testing and therefore close to the inner surface of supplied pipes.

The TMCP-seamwelded grade has structure that is mostly ferritic with presence of pearlite at grain boundaries while the seamless heat is bainitic. It is noticeable that although both grades have a different microstructure, the mechanical properties are similar.

Figure 2: Microstructure of X65 materials (a-b) seamwelded TMCP (c-d) seamless

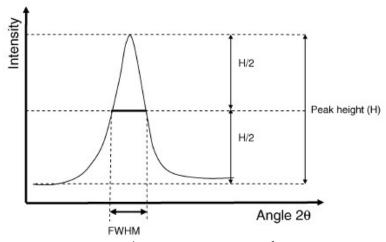
Figure 4: Schematic presentation of FWHM

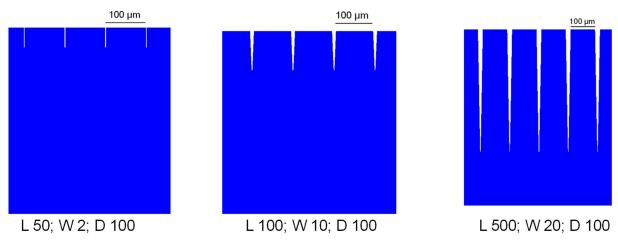
Examples of modelled microgrooves are given in Figure 7. In all cases, rather sharp grooves were obtained that could lead to severe stress concentration factors (theoretically from 16 to 50 [10]) at the groove tip when considered individually. However, interaction of the stress fields between grooves should contribute to decrease the apparent stress concentration factor.

Figure 7: Examples of microgrooves in the numerical model (L=length in  $\mu$ m, W=width in  $\mu$ m and D=distance between 2 grooves in  $\mu$ m).

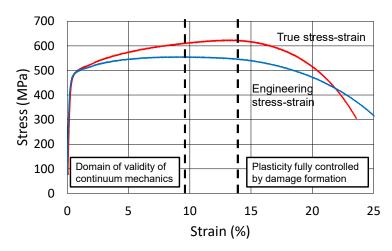
Figure 8: Uniaxial tensile curve for X65 steel in engineering stress-strain and true stress-strain.

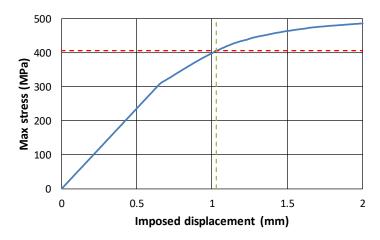
To evaluate the required displacement that should be applied on the loading point to reach 90%AYS on the surface, a numerical calculation without microgrooves in the gauge section was performed. The maximum stress on the outer surface was evaluated as a function of the imposed displacement. As shown in Figure 10, a displacement of 1.03 mm was necessary to reach the required stress. The same displacement was imposed in the case of geometries with microgrooves.

Figure 10: Calculation of the maximum stress as a function of imposed displacement on the load point.

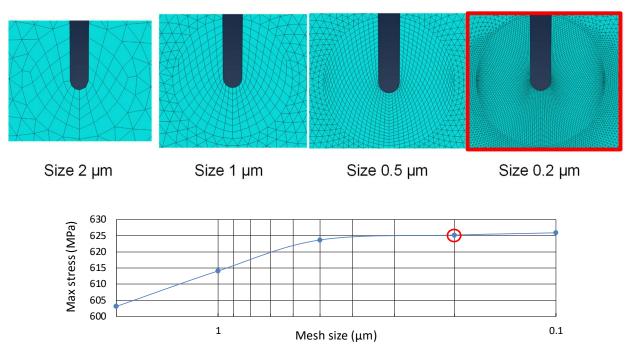
To evaluate the required size of the mesh close to the microgroove tip that would limit the calculation errors, simulations were performed for different mesh sizes. As presented in Figure 12, the mesh should be refined down to 0.2  $\mu$ m to limit the error below 1 MPa. Such a dimension was selected for all the calculations performed in this study.

Figure 12: Examples of refined mesh close to the groove tip and evaluation of the maximum stress for the same boundary conditions.

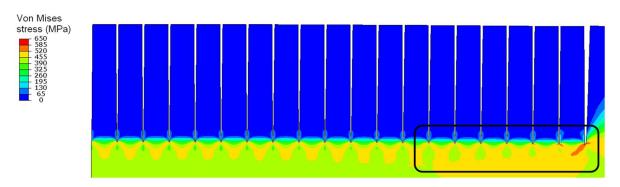
The objective of the study was to evaluate the stress relaxation effect linked to the interaction of several grooves at the surface of 4PB specimens. For the same boundary conditions, calculations were done with 10, 15 and 20 grooves (L=500 $\mu$ m, W=10  $\mu$ m and D=100 $\mu$ m) close to the symmetry axis, representing 19 to 39 grooves. As shown in Figure 13 and Figure 14, the stress field was different the closer to the last groove, far from the center of the specimen, that clearly showed over-stresses. Out of the 7 last grooves, the stress distribution at the tip of the grooves was rather similar.

Considering the maximum stress at the location of the 4th groove from the center, a slight deviation of 3 MPa was observed in the case of the modelling with 10 grooves (628.4 MPa) compared to the 2 other cases (625.2 MPa). Thus, at least 15 grooves should be modelled to avoid edge effects.

Figure 13: Stress distribution calculated with 20 grooves.

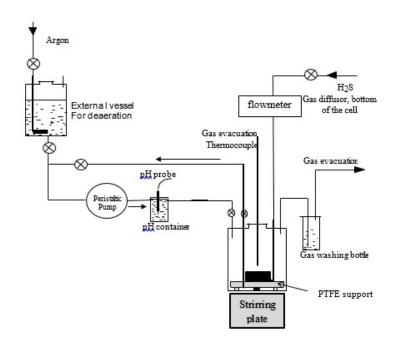
A schematic presentation of the test vessel is given in Figure 15

Figure 15: Schematic presentation of the test vessel for 4PB tests

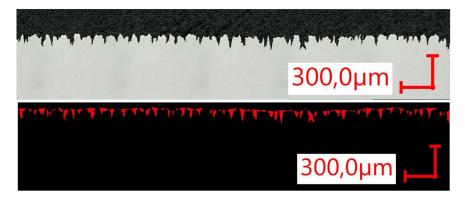
The evaluation of the groove distribution was performed using numerical microscopy (Keyence tradename) and an example of measurement is presented in Figure 16. The surface scales present on the specimens after exposures were dissolved using hydrochloric acid inhibited with hexamethylenetetramine as per ASTM G1. Then, from a metallographic cross-section, the grooves are first assigned colors from which their dimensions (depth (d) and width (w)) were automatically determined by image analysis. The groove depth and shape factor (the ratio d/w) of each groove was then estimated. Grooves with a high shape factor are sharp and thus could possibly be cracks while those with a low shape factor are smooth. The groove depths are measured with respect to a base line at the top of the grooves (the surface). The position of the baseline is not corrected for corrosion considering that the average corrosion rate and associated impact on the baseline are the same for all materials.

Figure 16: Example of groove dimension measurement by image analysis

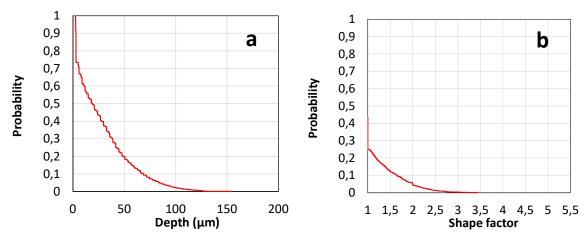
than their width) leading to possible high stress concentration at groove tip. In the example presented, 20% of the measured depths were greater than 50  $\mu$ m and the maximum depth measured was 160  $\mu$ m. Also, 5% of the grooves had a shape factor higher than 2.

Figure 17: Example of probability versus depth of the different grooves measured through cross-sectional observations. Measurements using image analysis. 2610 measurements.

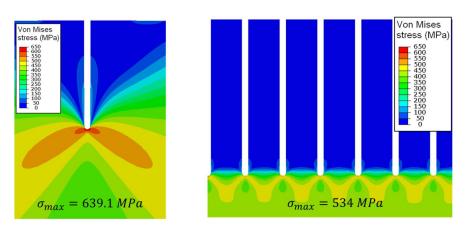
The stress and strain fields were evaluated for the cases presented previously in Table 3 i.e. 27 different calculations. Moreover, reference cases were modelled with a single groove in the gauge section of the 4PB sample. An example in the case of 50  $\mu$ m deep, 2  $\mu$ m wide and a distribution of 10  $\mu$ m is shown in Figure 18. The maximum stress concentration at the tip of the single groove reached 639.1 MPa (out of the domain of validity of the model – ductile damage can be expected), whereas the max. stress remained at 534 MPa with a close-packed groove distribution. Thus, a strong stress relaxation was obtained due to the interaction of the stress fields around the grooves.

Figure 18: Numerical calculation of the stress distribution for (left) one single groove and (right) several grooves on the 4PB sample. L=50μm, W=2μm, D=10 μm.

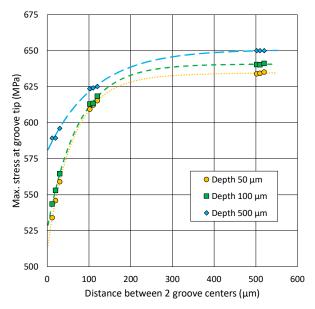
In the range of distance from 10  $\mu m$  to 150  $\mu m$ , it could be observed that for groove depth of 50 and 100  $\mu m$  the maximum stresses were in the same range, the distance being the main controlling factor. For deeper groove, i.e. 500  $\mu m$ , the maximum stress was clearly higher in the range of investigated distances. Each set of 3 points closely packed corresponded to the 3 different widths used in the calculation. Thus, it could be observed that the width of the groove, in the range of 2 to 20  $\mu m$ , did not significantly influence the results. Indeed, considering the theoretical calculations of the stress concentration at the tip of a notch, the most important parameters are the depth of the notch and the radius at the notch tip.

Figure 19: Evolution of the maximum stress at the tip of the grooves as a function of the groove distance and depth.

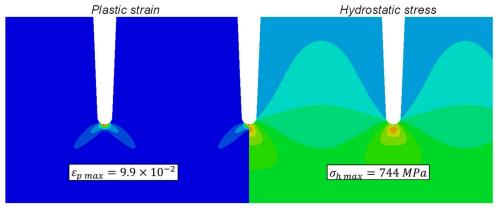
A clear stress relaxation could be observed when several grooves were distributed over the surface of the 4PB samples. But, to assess the risk of hydrogen assisted cracking at the tip of the grooves, other mechanical factors should be investigated: the plastic deformation and the hydrostatic stress. The plastic deformation, strongly linked to dislocations, can increase the local amount of trapping sites and consequently the local concentration of hydrogen. Moreover, plastic deformation may play a role on the corrosion mechanism of the steel, which could favor the local anodic dissolution. Hydrostatic stress can be a driving force for the diffusion of hydrogen, also increasing the local amount of hydrogen at the front of the notch, as illustrated in Figure 20.

Figure 20: Numerical calculation of (left) plastic strain (right) hydrostatic stress. L=100 $\mu$ m, W=10 $\mu$ m.

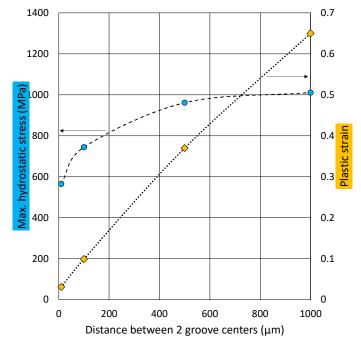
Consequently, favorable conditions for hydrogen cracking could be reached at the tip of the sharp V-shape grooves. But, as shown in Figure 21, a rather tight groove distribution can strongly decrease these parameters. For distances typically observed on specimens tested in corrosive solution with H2S, in the range of 50 to 100  $\mu$ m, the hydrostatic stress was in the range of 600 to 800 MPa, whereas for an isolating groove, it would be over 1000 MPa. The plastic strain also was limited, below 10%, when it reached 65% for the single groove (out of the domain of validity of the model – ductile damage should occur). Thus, a tight distribution of the grooves can also reduce the risks of hydrogen assisted cracking from the tip of the groove.

Figure 21: Evolution of the strain and hydrostatic stress at the tip of the grooves as a function of the distance for a groove depth of 100  $\mu$ m.

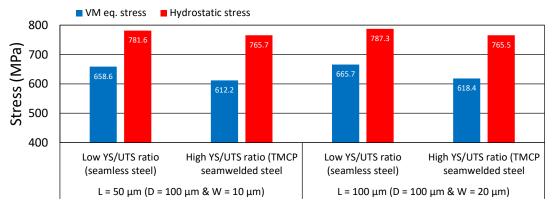
wide, respectively) were considered. The maximum stress at the tip of the grooves, the maximum plastic strain and hydrostatic stresses were evaluated in each case. The results are compared in Figure 22 and Figure 23.

For a defined geometry, the decrease of the YS/UTS ratio (corresponding to an increase of the hardening rate) led to higher equivalent stress and hydrostatic stress around the groove tip. However, a slight decrease of the local plastic strain could be observed. Considering a mechanism of enhanced corrosion rate by local stress or SSC cracking phenomenon, the local mechanical conditions would be more critical for a steel showing lower YS/UTS ratio. However, the sensitivity of the steel in terms of critical local stress/strain for SSC crack initiation must be considered to evaluate the real risk of cracking. Indeed, the microstructure and the mechanical properties are strongly linked, so that a higher YS/UTS ratio could be related to a more sensitive microstructure, or the presence of local residual stresses at the scale of the grains which would affect the stress distribution. Such aspects were not covered by the modelling work.

Figure 22: Maximum von Mises (VM) equivalent stress and hydrostatic stress at the tip of a groove of 50  $\mu$ m and 100  $\mu$ m deep, with a distribution of 100  $\mu$ m and a width of 10 and 20  $\mu$ m, respectively.

From a pure mechanical aspect, the mechanical properties of the steel can also impact the stress concentration at the groove tip. Indeed, for higher hardening rate (lower YS/UTS ratio) the local stress and hydrostatic stress are increased, and the plastic strain slightly decreased. For a mechanism of corrosion enhanced by local stress or even corrosion enhanced by local hydrogen content, that is increased with the level of hydrostatic stress, a low YS/UTS ratio could make groove growth easier in the direction of the maximum stress, this is to say from the groove tip, keeping the V-shape of the groove. On the contrary, decreasing the stress concentration could favored U-shape grooves for which the stress distribution would be drastically modified.

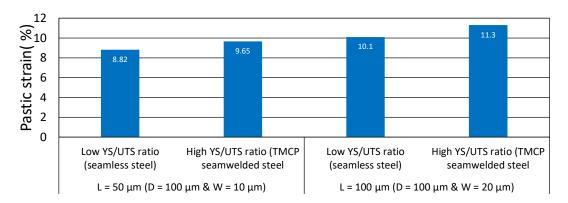
Figure 23: Maximum plastic strain at the tip of a groove of 50  $\mu$ m and 100  $\mu$ m deep, with a distribution of 100  $\mu$ m and a width of 10 and 20  $\mu$ m, respectively.

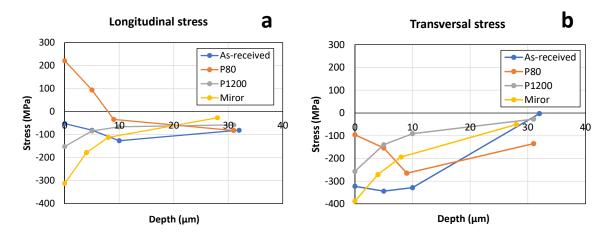
The results of the residual stress profiles measurement are displayed in Figure 25 and Figure 26. The first figure gathers the evolution of the residual stress measured at each depth considered and the second the evolution of the FWHM giving a relative overview of the level of cold-work (the higher the FWHM, the higher the cold-work). Obviously, the residual stresses are located within the first 10  $\mu$ m and almost negligible in the deeper in the bulk of the materials. Considering the expected corrosion rate in the test environment selected for the SSC tests (1 to 2 mm/year), this layer is supposed to be fully corroded within the early first days of exposure.

Figure 25: Effect of surface preparation on the residual stress profiles measured on the "seamless" steel grade. (a): measurement in the longitudinal direction – (b): measurement in the transversal direction.

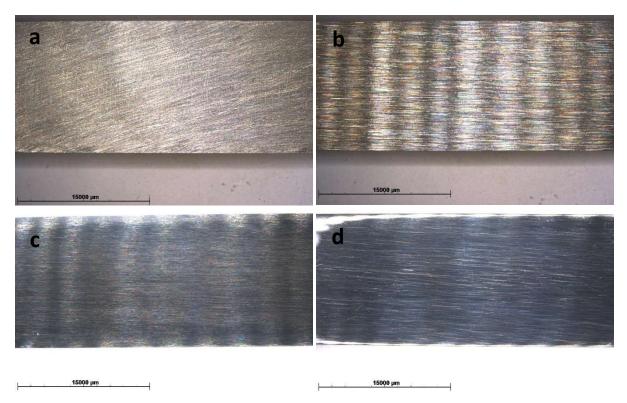
The polishing was performed in the longitudinal direction to be orthogonal to the principal applied stress. Some residual polishing scratches are visible on the "mirror" surface finish, but they are not visible under naked eyes. These residual scratches are better visible under the binocular due to the surface illumination. The NACE TM0177 standard specifies a minimum average roughness (Ra) lower that 0.8  $\mu$ m and all surface finish but the "P80" would therefore acceptable. Some other guidelines like EFC16 are rather specifying a minimum level of roughness of 0.2  $\mu$ m that can only be achieved through refined polishing. The standard surface state used at FCI for sour qualification tests is P1200.

Figure 27 : Macro-observations of the initial surface after the different level of polishing considered. (a): as-machined – (b): P80 – (c): P1200 – (d): Mirror finish.

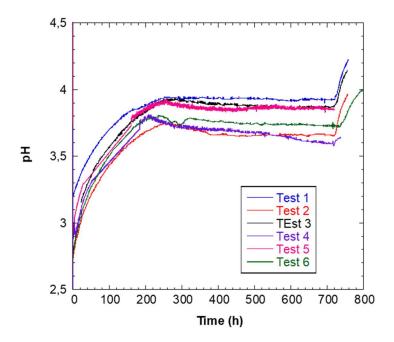
No failure nor crack initiation was observed after any test conditions considered, neither through macrographic observations, nor MPI. The evolution of the pH during the different tests performed to complete the program are presented in Figure 28. The standard evolution expected for a "free-pH" test is observed in each case. Indeed, the initial pH is acidic, mainly slightly below pH=3 and tends to increase during the exposure due to the alkalization of the solution through the corrosion process. The pH tends to reach a plateau after about one week of exposure that is always lower than pH=4. The pH value of the plateau varies from one test to another with an interval of about 0.3 pH unit. We also observed a decrease of pH in one test (as-received conditions in purple). This evolution is linked to a drift of the pH

probe and has no physical meaning. The final raise in pH after 700 hours of exposure occurred when the desaturation of the solution started.

Figure 28: pH evolution during exposures.

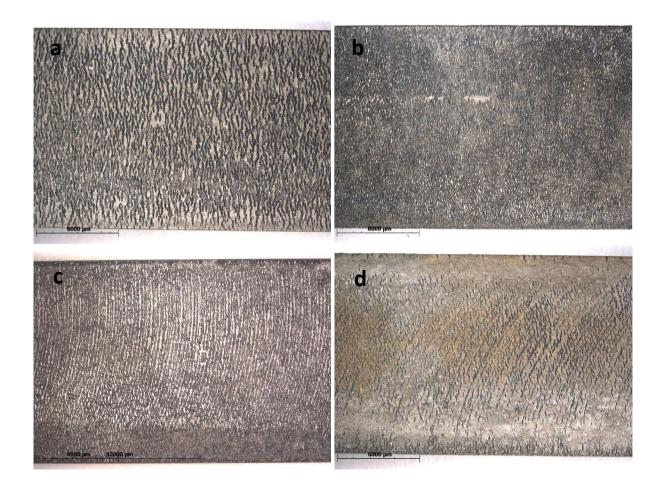
From a qualitative point of view different macrographic states were visible after experiment as depicted in Figure 29. In a large number of cases (27 specimens out of 36 tested), the scratches inherited from the preparation route using milling appears after testing (Figure 29c-d) while not visible after the surface preparation by polishing (Figure 27). It seems that the grooves are preferentially initiating on the former milling scratches suggesting an inherit of the machining route. Note however that in such case, grooves are also initiating on the rest of the exposed surface out of the former milling scratches. The occurrence of this phenomena is not correlated with the nature of the grade or test conditions considered. In the other cases (9/36), the grooves are homogeneously distributed on the stressed surface (Figure 29a-b). The phenomenon occurs also when started from a surface polished to a mirror finish (Figure 29c)

Figure 29: Typical surface of the 4PB specimens after SSC test and descaling. (a) : Seamless grade 72%AYS /P1200 - (b):seamless grade 90%AYS/P1200 - (c): TMCP - 90%AYS/Mirror finish - (d):TMCP - 80%AYS /P1200.

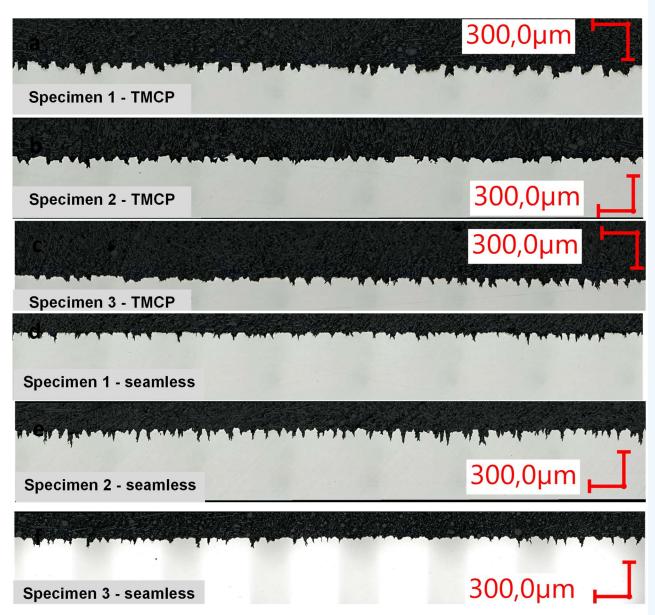
Figure 30 displays the cross-sectional observations of all specimens tested under 90%AYS with the initial surface preparation "P1200". From a qualitative standpoint, the shape of the grooves forming on the specimens is clearly different for the two different grades. On the TMCP seamwelded material, the grooves have a U-shape while it is rather V-shape pattern on the seamless grade. It is also clear from the cross-section that the groove shapes and distributions seem quite homogeneous on the TMCP grade while not for the seamless. For this latter grade, it seems that the 3 specimens tested simultaneously are displaying grooves with different shapes.

Figure 30: Metallographic cross-section of the specimens tested under 90%AYS with an initial surface finish P1200. (a-c): grade TMCP / (e-g): grade seamless.

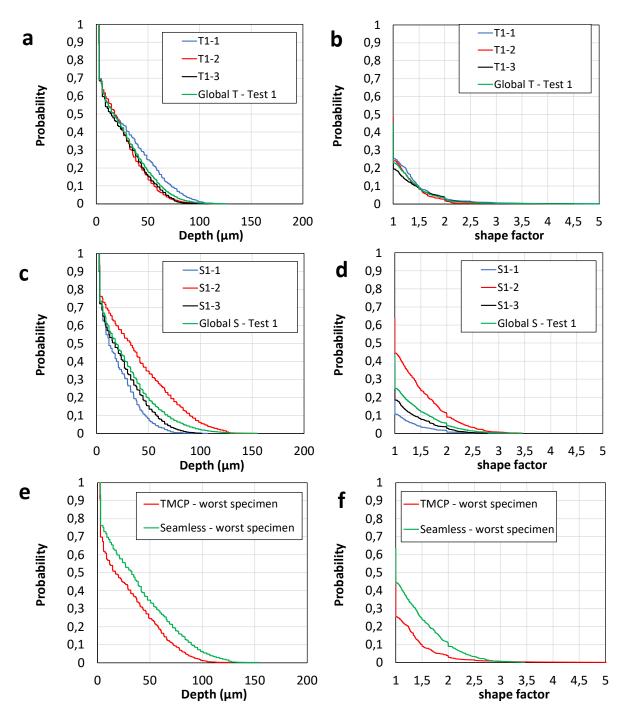
Figure 31 shows the corresponding groove distributions which confirm the homogeneity of the grooving on the TMCP-seamwelded material with all the probability plots superimposed. On the contrary, scattering is observed between the 3 specimens sampled in the seamless pipe.

Figure 31: Groove depth and shape factor distribution of the different specimens tested under 90%AYS and an initial surface state P1200. (a-b): TMCP seamwelded (individual measurement and average) / (c-d): Seamless grade / (e-f): comparison of the worst specimen of both grades.

The difference between both materials can only be highlighted in the distribution plot when the worst specimens are compared (Figure 31e-f). When the average measurements of the 3 specimens of each material are compared, the curves are perfectly superimposed (Figure 32).

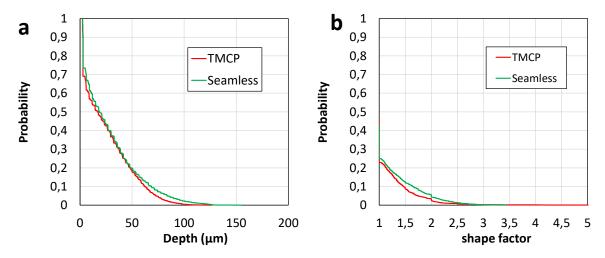
Figure 32: Groove depth and shape factor distribution of the different specimens tested under 90%AYS. Comparison of the average values considering all measurements in 3 specimens per grade (2600 to 2800 measurements per grade).

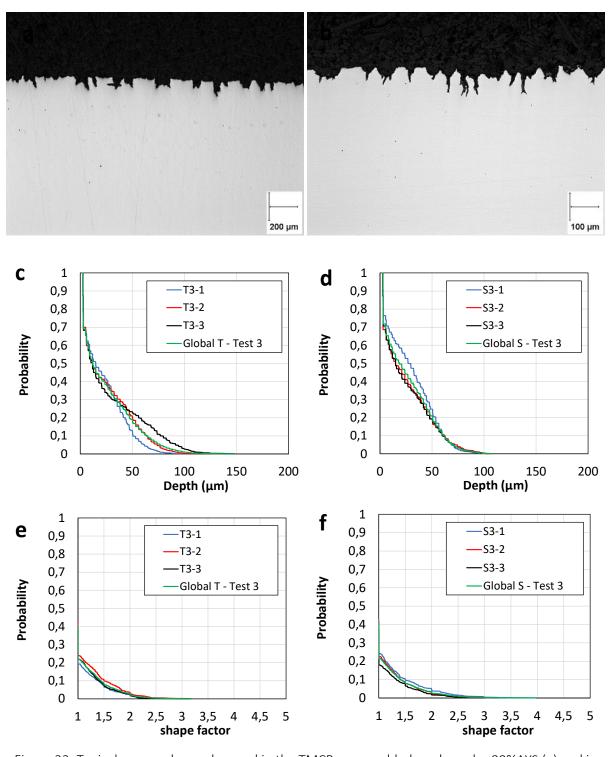
Figure 33 displays the typical groove shapes observed on both grades and the associated distributions measured through image analysis. Under this stress level, both grades highlight U-shape grooves, but it seems that the grooves in the seamless pipe are turning to a V-shape at different locations (Figure 33b). From a statistical point of view, the measurements in the 3 specimens of both grades are homogeneous and there is not significant difference between the average values of both grades (Comparison not shown but the plots corresponding to the average measurements in both grades are perfectly superimpose). The difference between both grades is only the trend to see locally a transition between a U-shape and a V-shape in the microgrooving of the seamless that is not visible in the TMCP.

Figure 33: Typical groove shape observed in the TMCP-seamwelded grade under 80%AYS (a) and in the seamless one (b). Corresponding groove distribution for TMCP (c-e) and seamweld (d-f).

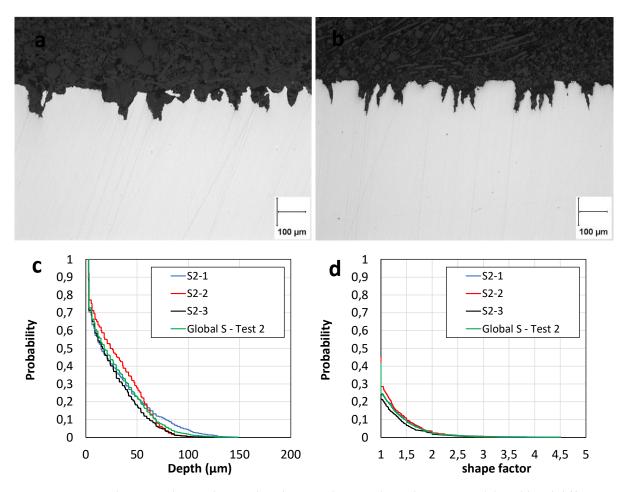
Figure 34: Typical groove shape observed in the seamless grade under 72%AYS (a) and local difference in some area (b). Corresponding statistical distribution of the grooves (c-d).

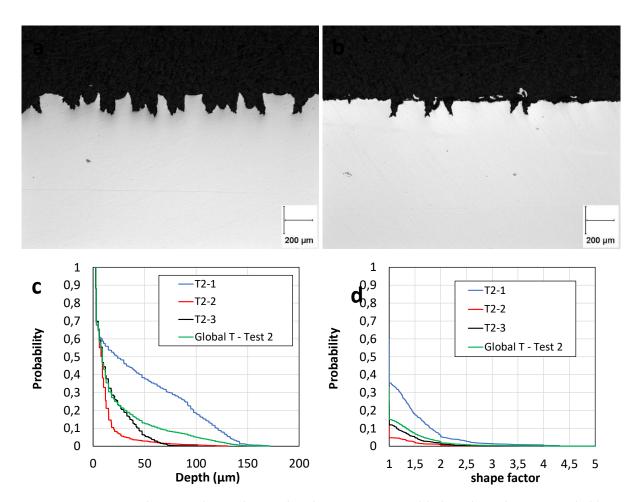
Figure 35: Typical groove shape observed in the TMCP-seamwelded grade under 72%AYS (a-b) showing heterogeneous distribution of the groove along the stressed surface. Corresponding statistical distribution of the grooves (c-d).

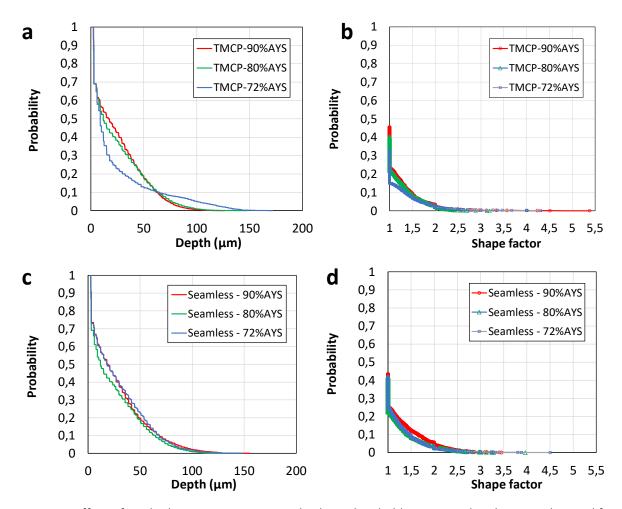
All the results obtained in the investigations of the effect of applied stress on microgrooving are given in Figure 37 and Figure 38. First, there is obviously no significant difference between the average measurements in both grades (Figure 38a-b). Second, some differences are highlighted in the distributions of the TMCP-seamwelded material (Figure 37a-b) but that can be explained by the non-homogeneous distribution of the microgrooves on the specimens loaded at 72%AYS. On the contrary, the distributions are superimposed for the Seamless grade (Figure 37c-d). From these results, it can be concluded that, for an applied stress sufficiently higher than the one triggering the microgrooving process, no effect of the actual load can be observed. The main effect of stress observed in this work is the trend of the Seamless grade to develop V-shape grooves for high applied stress while the TMCP-seamwelded only produce U-shape patterns.

Figure 37: Effect of applied stress on grooving in both grades. (a-b): average distributions obtained for each stress on the TMCP grade. (c-d): average distribution for the seamless grade.

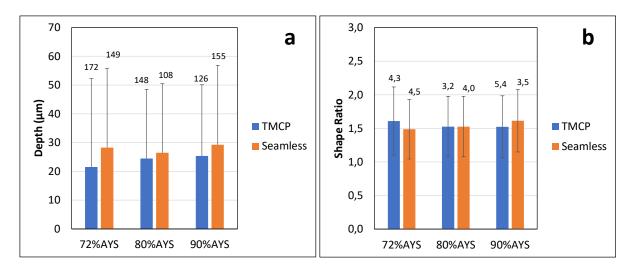
Figure 38: Effect of applied stress on grooving in both grades: average values of (a) the depths and (b) shape factor out of more than 2000 measurements per grade (the number/error bars on each histogram is the max value measured).

Such observation is supported by the average groove depth measurements, presented in Figure 38, with deeper grooves for the seamless steel at all investigated applied loads compared to the TMCP steel, thus probably related to a higher corrosion rate from the tip of the groove for the seamless steel. However, the impact from the microstructure or the texture (preferential crystallographic orientations) cannot be totally excluded.

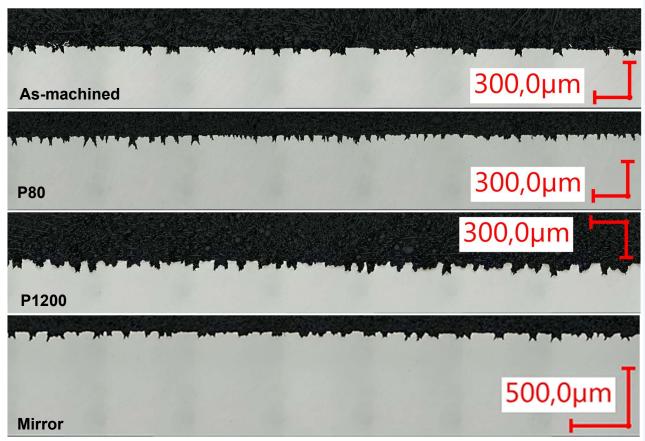
Figure 39: Micrographic observation of the grooves formed on the TMCP-seamwelded specimens after test under 90%AYS and different initial surface finish.

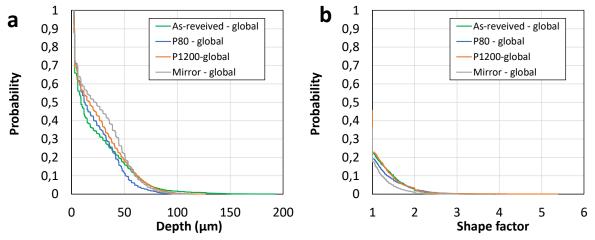
This trend is also confirmed in the analysis of the groove distributions on both grades. The profiles are superimposed for the TMCP material whatever the initial surface considered (Figure 40) while they become shallower and flatter with the seamless material as the initial surface quality is improved. Mainly, with the mirror finish, no groove deeper than 100  $\mu$ m or with a shape factor higher than 4 can be highlighted on the contrary to other surface states (Figure 42).

Figure 40: Groove distribution for the different initial surface state considered, measured in the TMCP specimens. (a): groove depths / (b): shape factor.

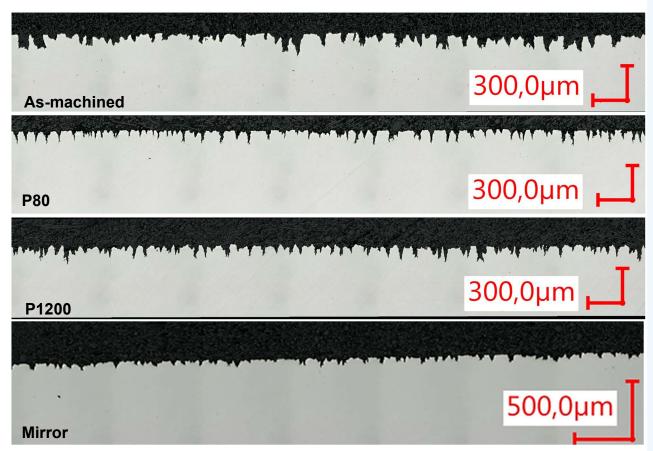
Figure 41: Micrographic observation of the grooves formed on the seamless specimens after test under 90%AYS and different initial surface finish.

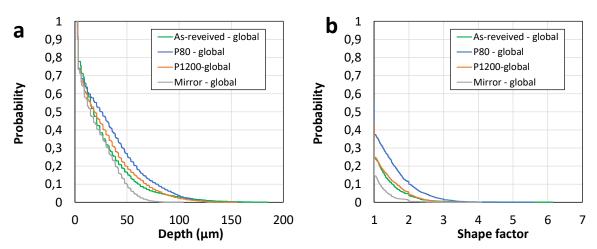
Figure 42: Groove distribution for the different initial surface state considered, measured in the seamless specimens. (a): groove depths / (b): shape factor.

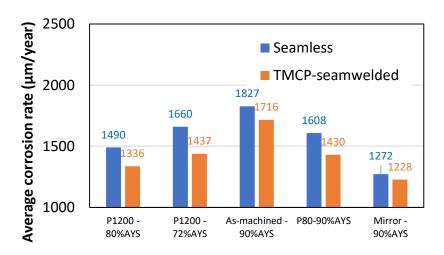
This assumption are also corroborated by the average corrosion rate calculated through weight loss of the 4PB specimens after testing and descaling. As highlighted by the Figure 43, the average corrosion rates measured on the 3 specimens after each test is slightly higher with the seamless grade which is quite well correlated with the deeper grooves observed in this grade. This result suggests again that grooving is a stress-assisted corrosion mechanism.

Figure 43: Average corrosion rates measured through weight loss evaluation of the 4PB specimens after SSC tests
