EPRG-PRCI-APGA

23rd Joint Technical Meeting

PERFORMANCE OF ILI TECHNOLOGIES FOR DENTS WITH INTERACTING FEATURES

PRCI NDE-4-18 Project – Introduction

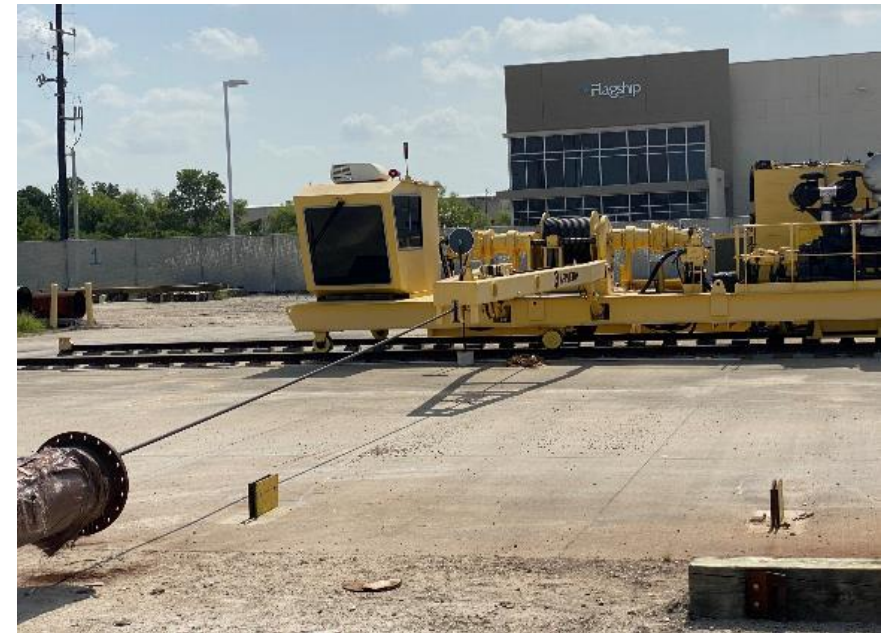
- This is an overview of the PRCI NDE-4-18 project, part of the PRCI MD SRP
 - To support industry drive for integrity management improvement
 - PRCI sponsored these trials to consider ILI performance for mechanical damage (dents) with coincident features (corrosion, gouge, crack)
 - Consider a range of ILI technologies and systems
- The objectives were to
 - Prepare and characterize pipe samples with dents and coincident features
 - Demonstrate performance of ILI technologies wrt feature detection, identification and sizing
 - Provide feedback and reference data to Service Providers for system and specification development

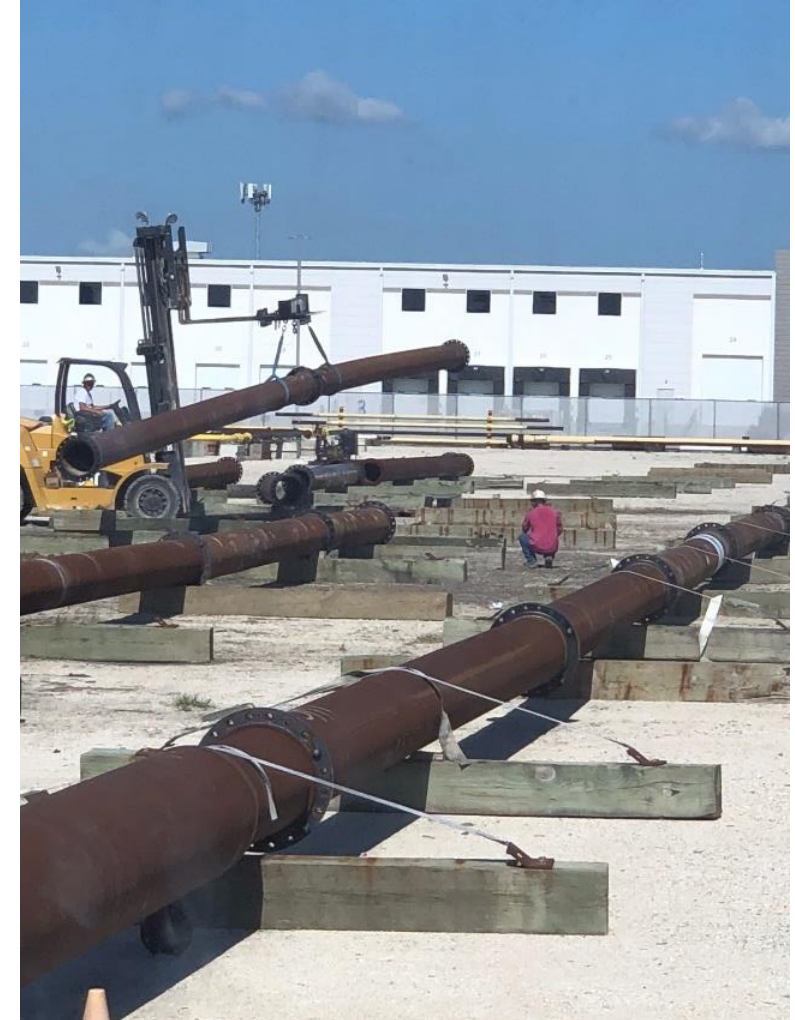
- Trial Samples and Features
 - Focus on 20 inch diameter (ERW / DSAW) pipe
 - 0.25 to 0.5 in wall thickness
 - Features in current trials identified as
 - Dent
 - Corrosion in plain pipe
 - Dent with corrosion
 - Dent with gouge
 - Dent with cracks
 - Dent with corrosion and cracks
 - Approx. 500 ft of pipe with 65 dent features w/wo coincident features

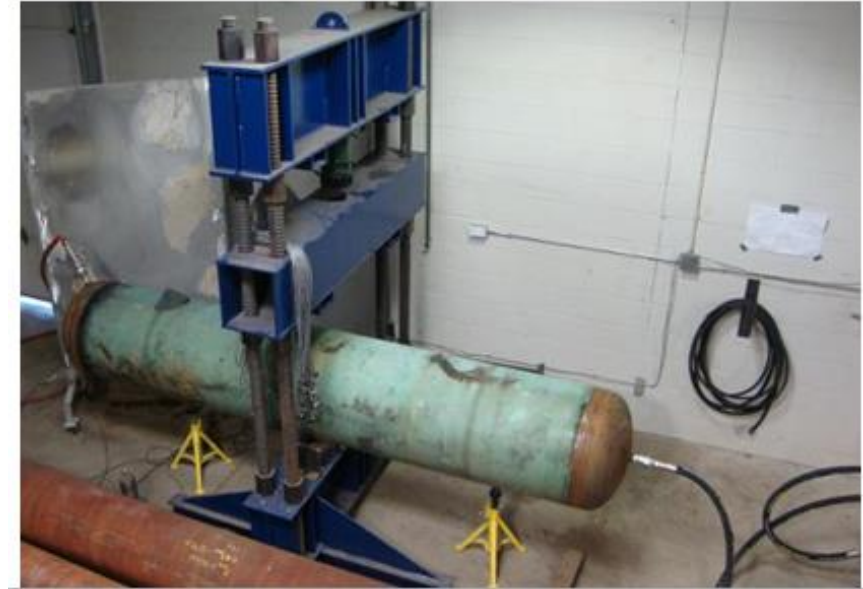
- Sample Feature Production
 - Dent features
 - Formed in lab with a range of indenters
 - Single and multi-peak dent shapes
 - Corrosion features
 - Pipe removed from service
 - Corrosion wall thickness reduction 10% to 40%
 - Cracks
 - Formed in dents by cycling pipe internal pressure
 - Gouges (EPRG provided)
 - Simulated during indentation with backhoe tooth
 - Machined on dent surface

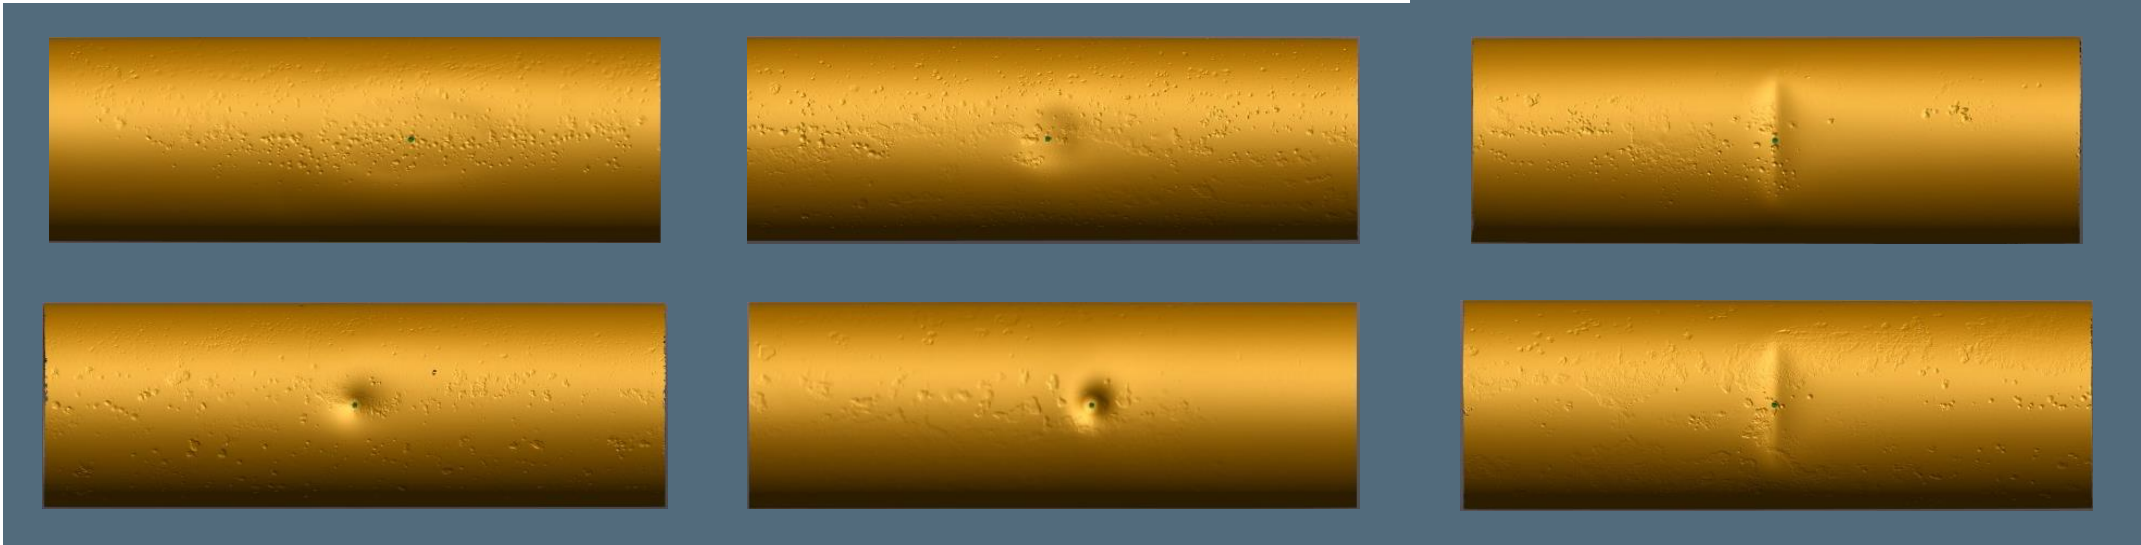
- Sample Characterization
 - Dent and corrosion features
 - Full circumference surface laser scan
 - Defines 3 dimensional shape of dent and corrosion features
 - Scan data confirmed with caliper & pit gauge

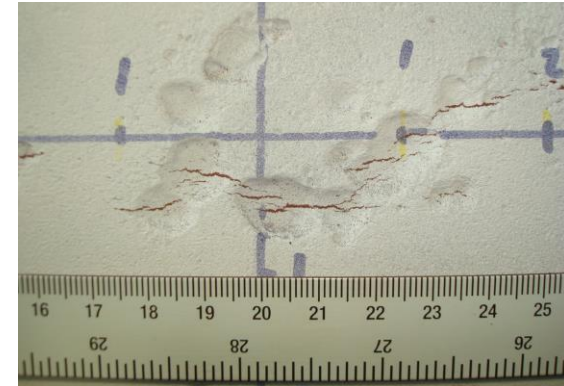
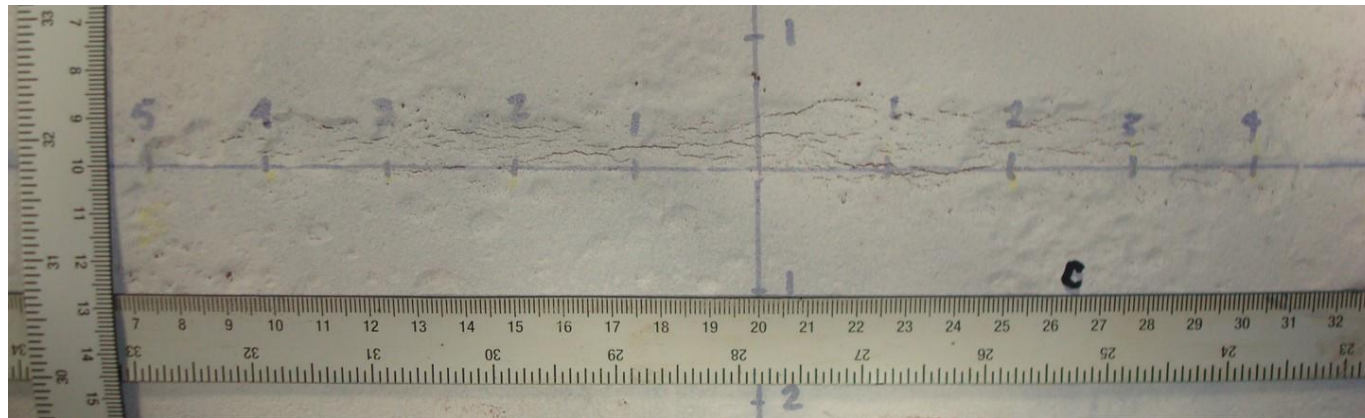
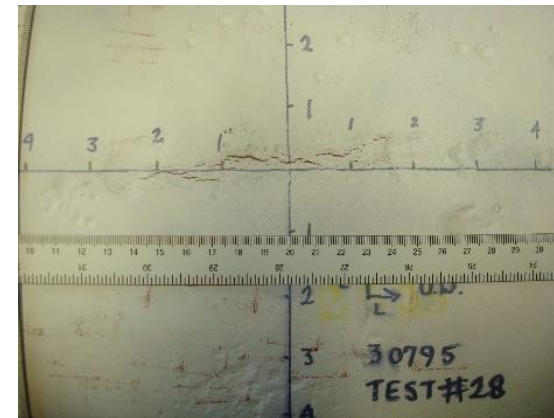
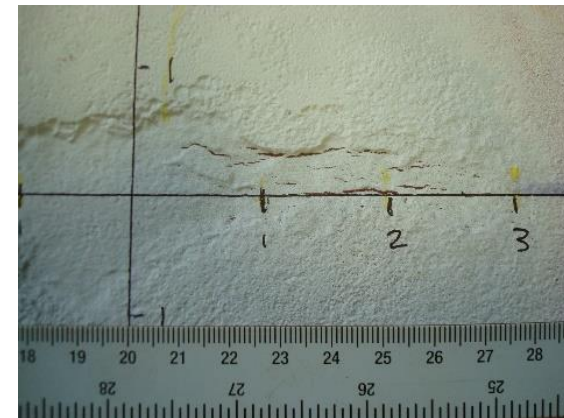
- Sample Characterization
 - Crack features
 - Characterized digitally after magnetic particle inspection (MPI)
 - Defines surface length and position of features
 - Metallurgical sectioning and Computed Tomography (CT) used to augment crack depth and shape for a subset of features

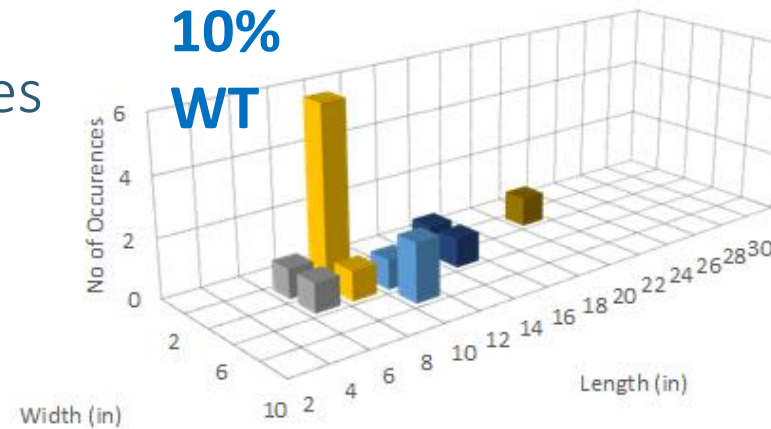
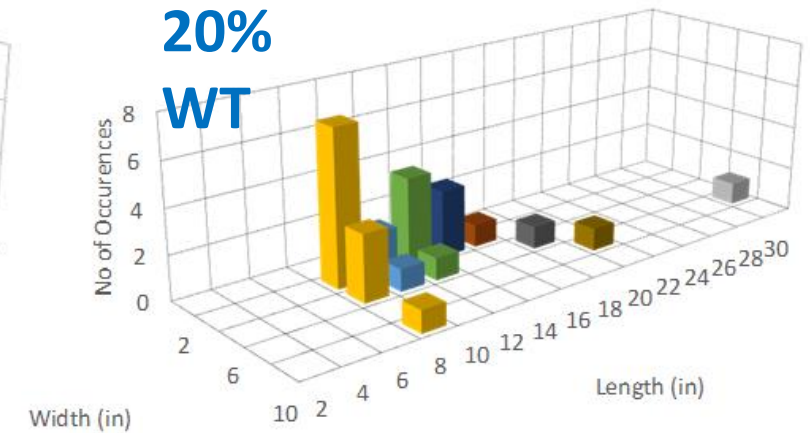
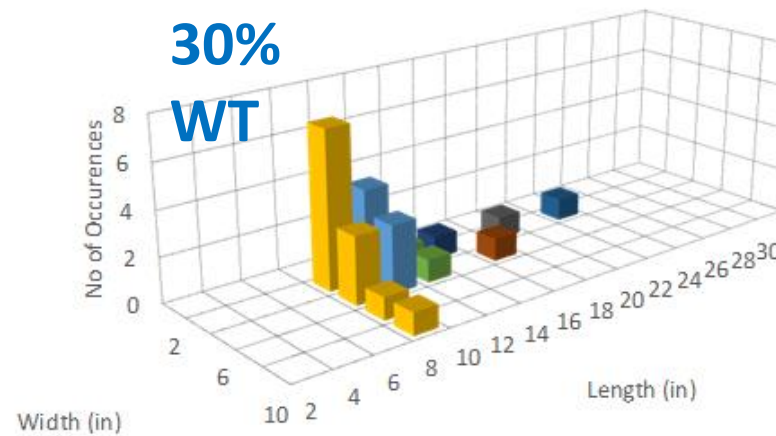
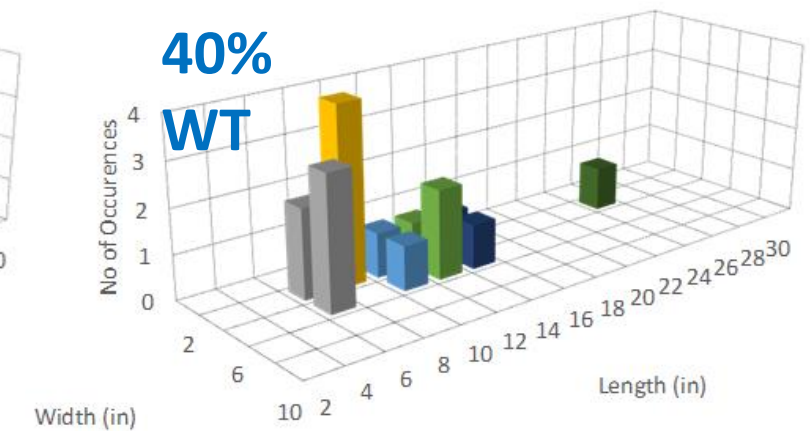
- Range of Corrosion Features

- Considered features of various depth, length and width
- All features identified based on API 1163 classes
 - Pin-hole
 - Pit
 - Axial / Circ. Groove
 - Axial / Circ. Slotting
 - Extended

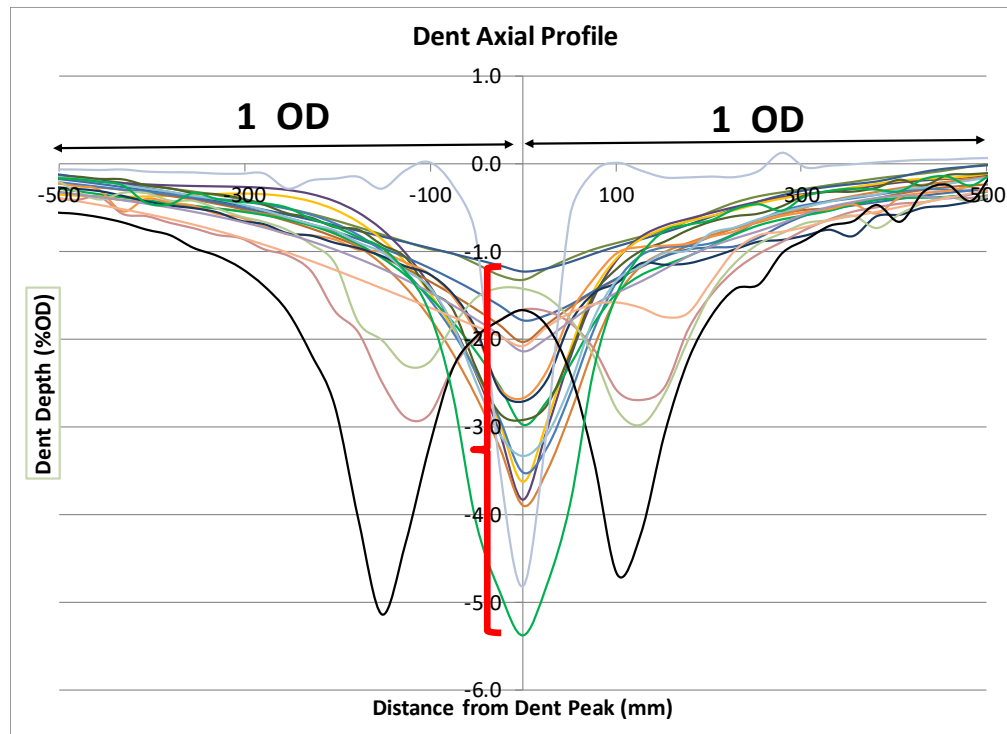
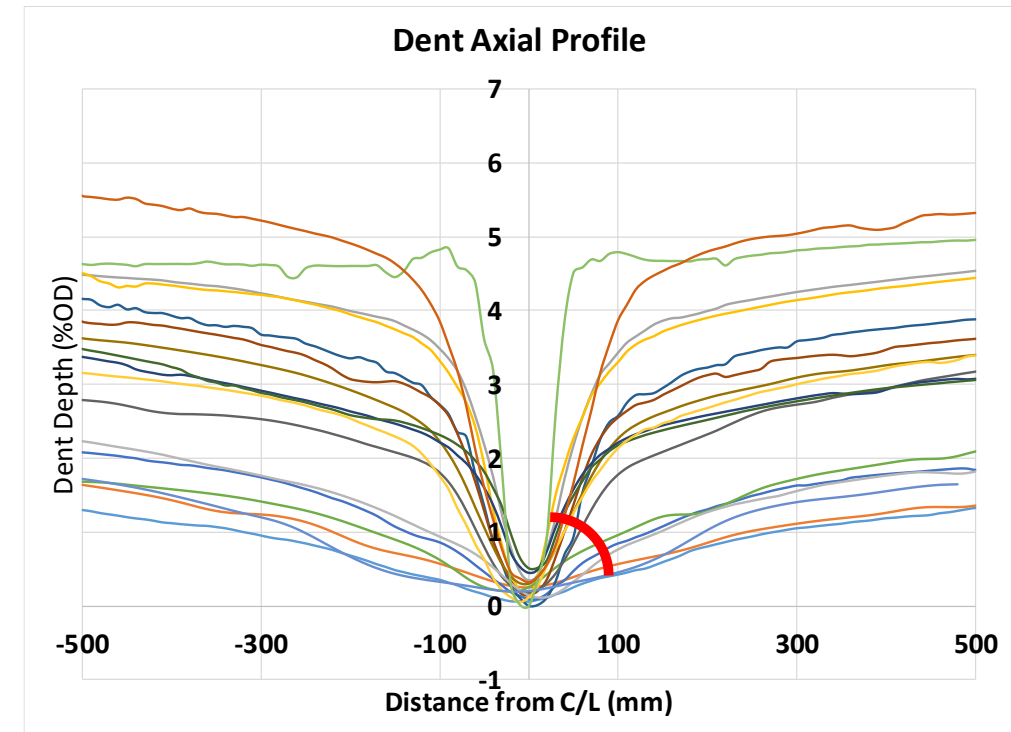
- Range of Dent Feature Shapes
 - Single and multi-peak dents with depths ranging from 1 to 5% of pipe dia.
 - Dents created with various indenters with pipe unpressurized and pressurized

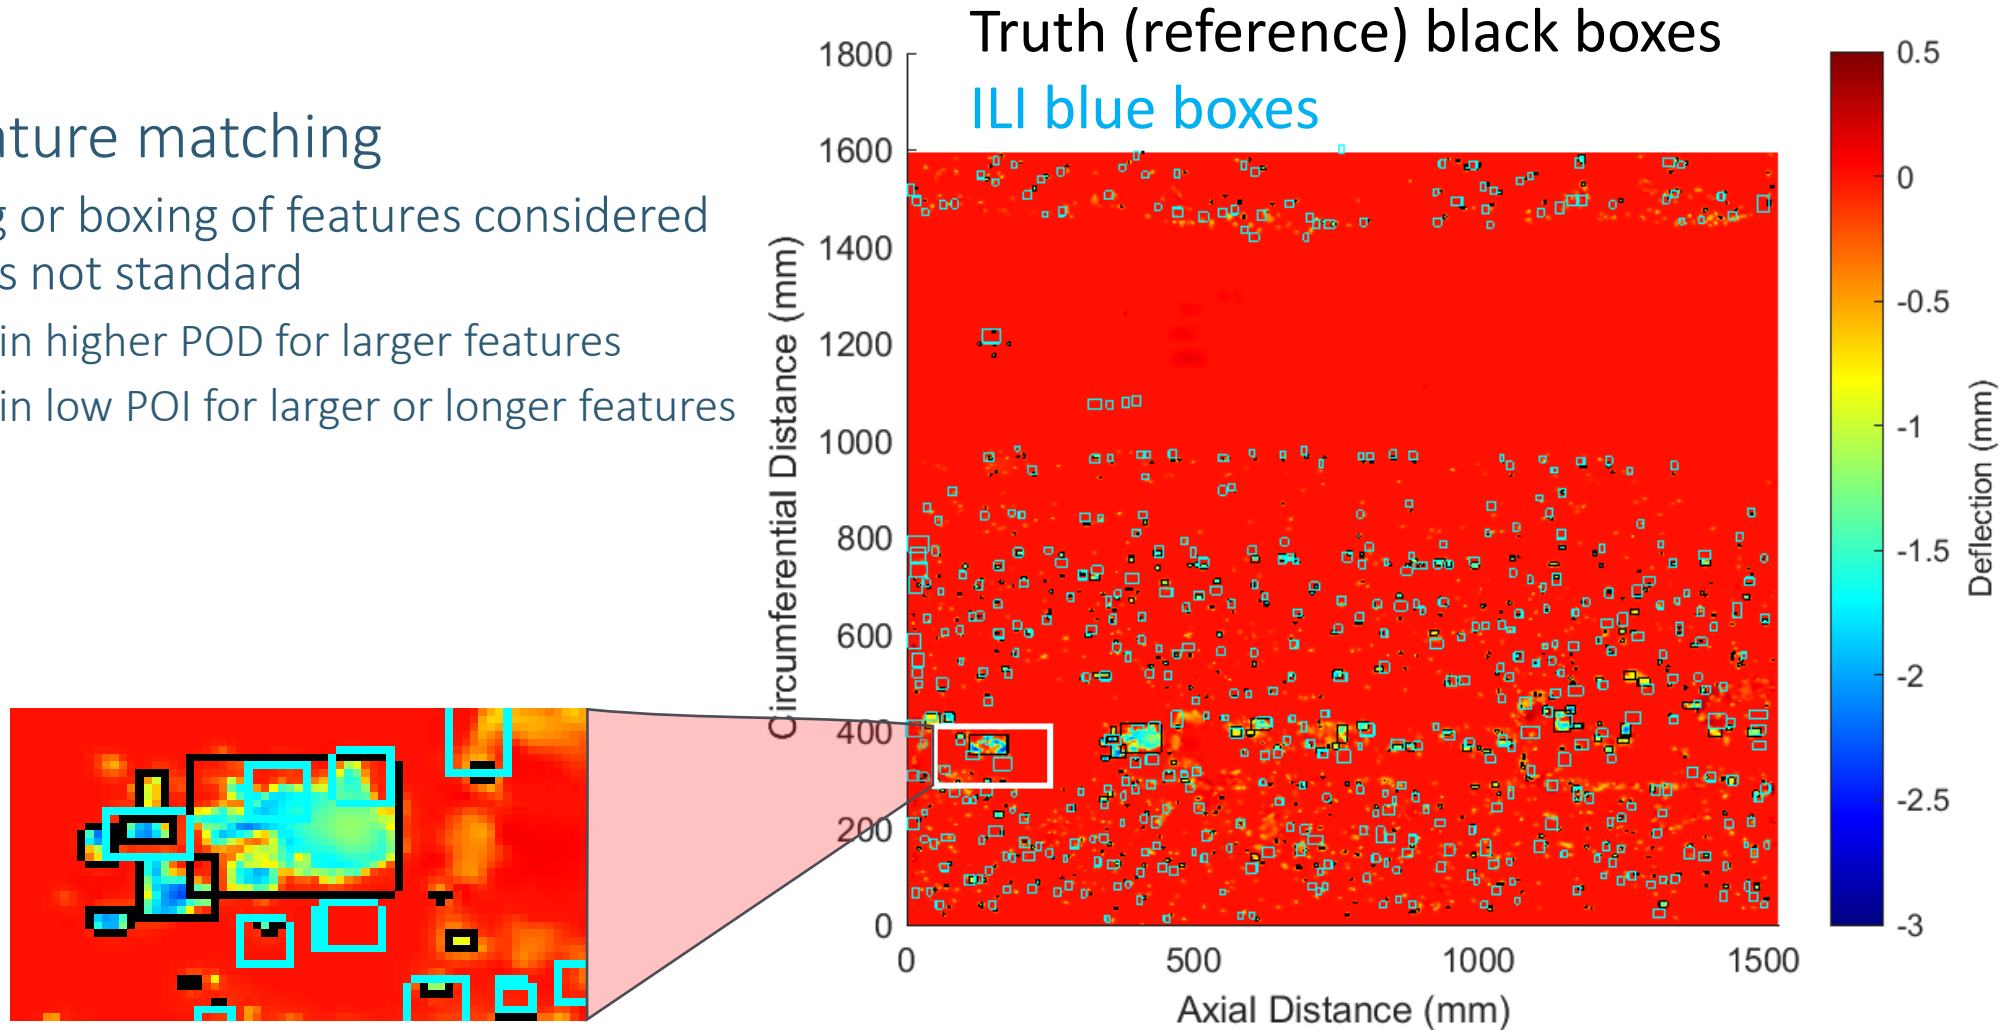
- Corrosion feature matching
 - No clustering or boxing of features considered because rules not standard
 - Resulted in higher POD for larger features
 - Resulted in low POI for larger or longer features

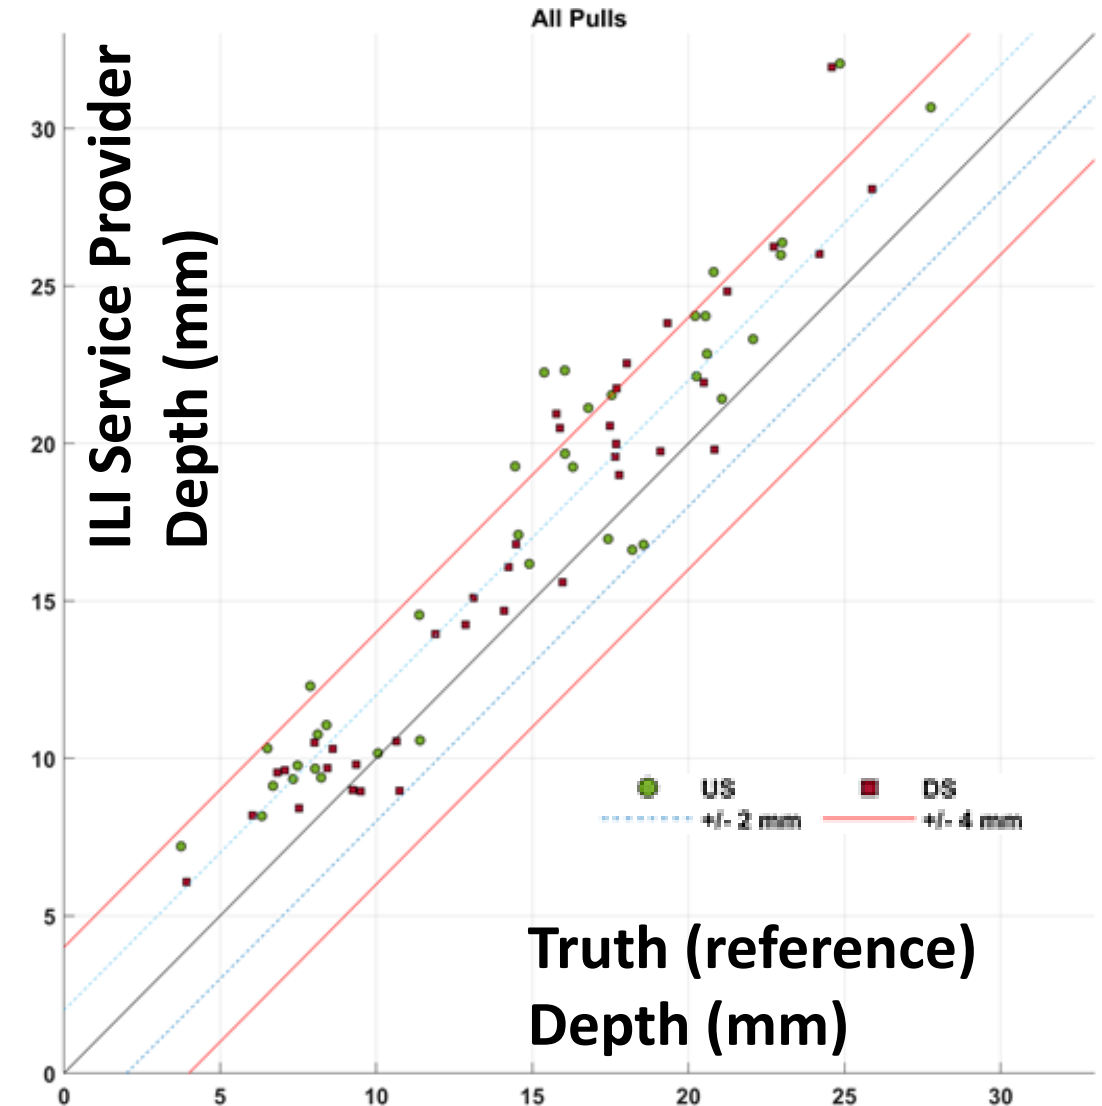
- Dent depth unity plot performance for all tests of one ILI system
 - Good overall performance
 - Most data within 4 mm of reference
 - Unity line 2 and 4 mm arbitrarily selected (not standard)
 - Small bias to call out deeper dents
 - Small amount more variability in U/S measurement

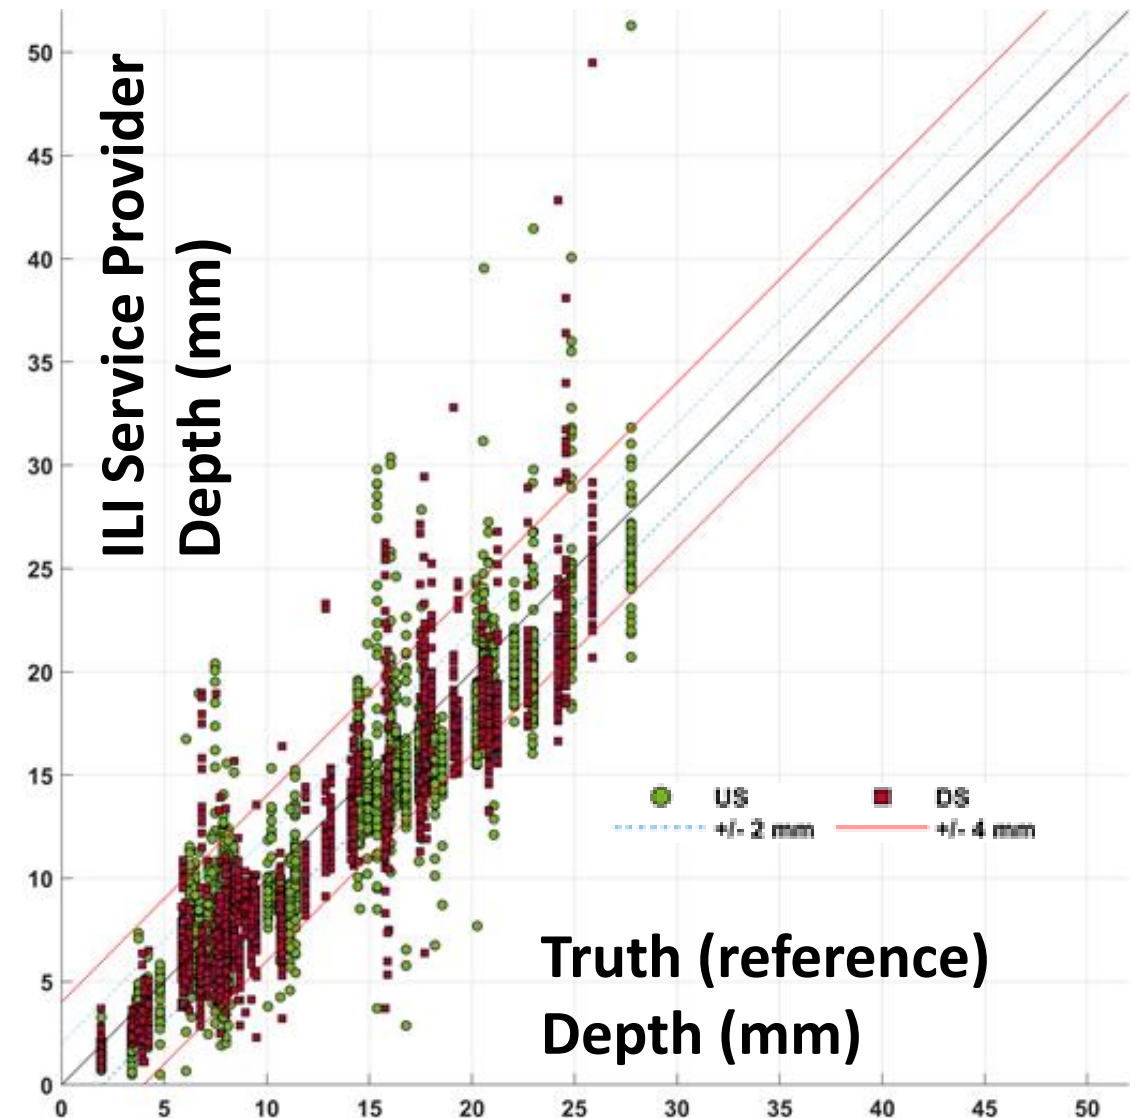
- Dent depth unity plot performance for all tests of six mechanical caliper ILI systems
 - Approx. 6,300 observations
 - Good overall performance
 - Most data within 4 mm of reference
 - Unity line 2 and 4 mm arbitrarily selected (not standard)
 - Small bias to call out deeper dents
 - Small amount more variability in U/S measurement
- Ultrasonic caliper system displayed similar performance

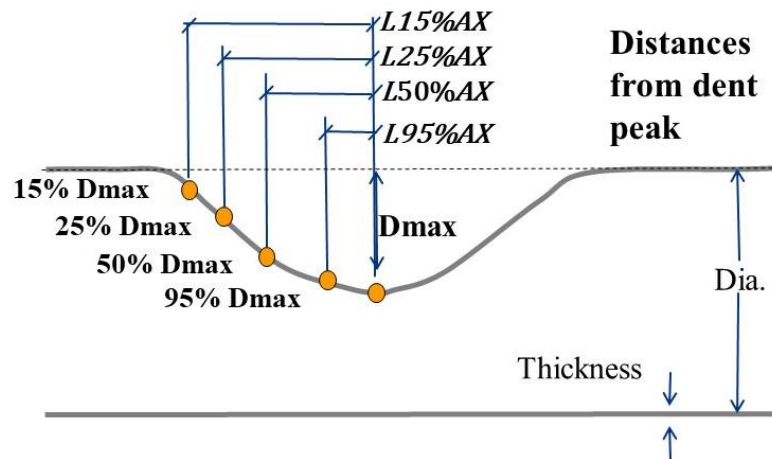
- Dent characteristic length unity plot performance for all tests of one ILI system
 - Good overall performance
 - More variation at dent shoulder (10% max depth)
 - Small bias to call out smaller lengths
 - Small amount more variability in D/S measurement
 - CW and CCW results the same

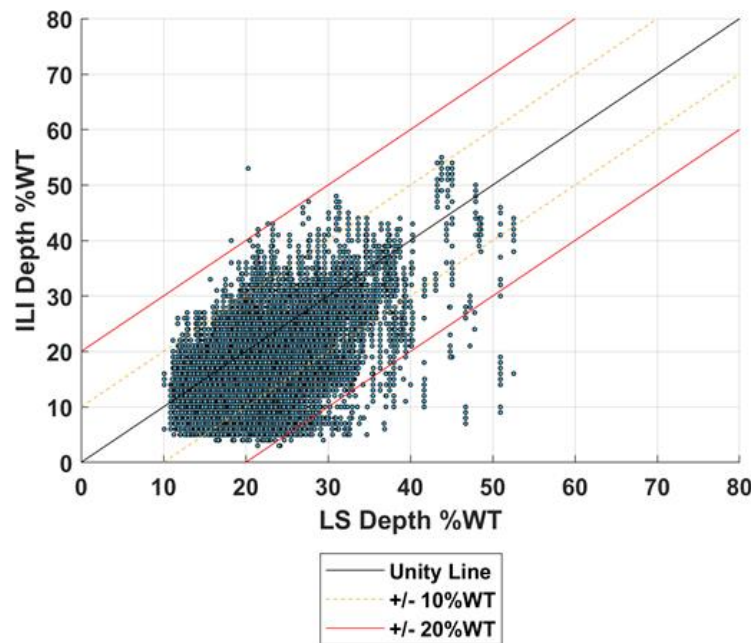
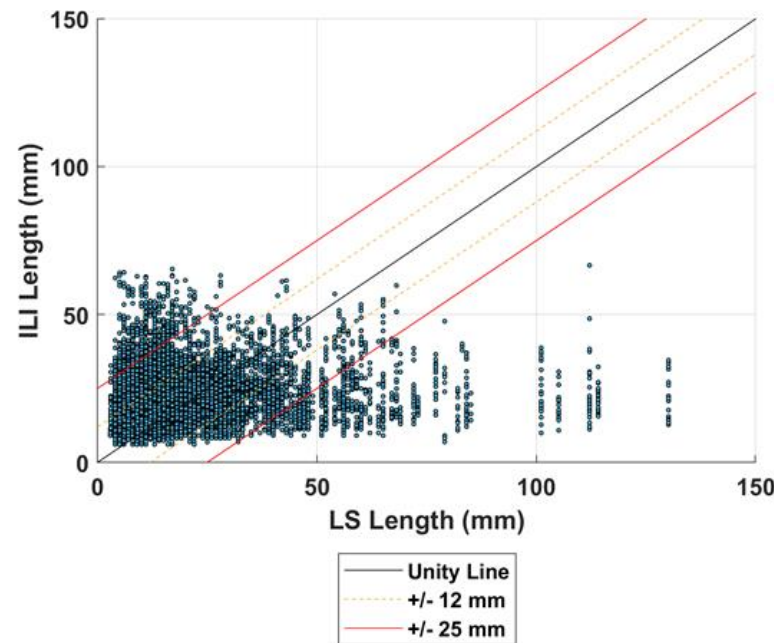
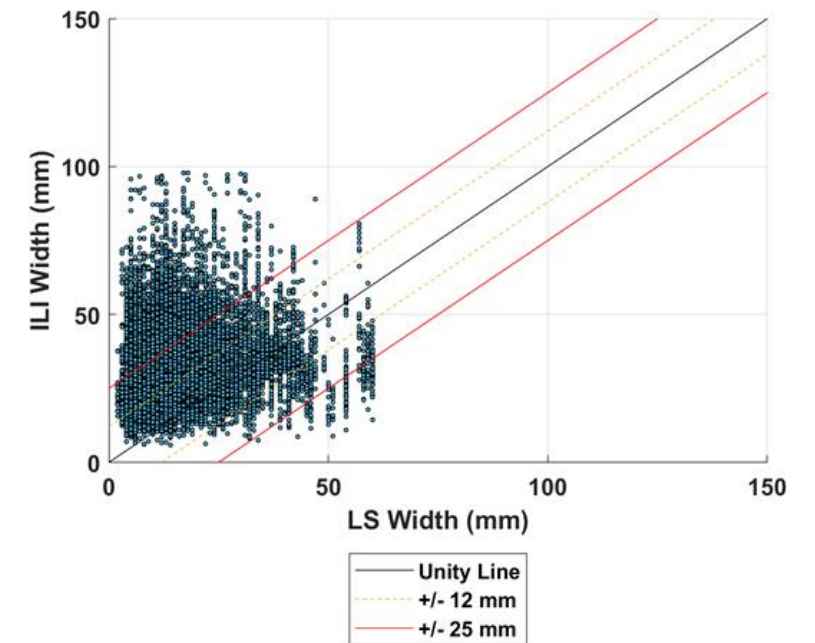
- Unity plot for all non coincident corrosion features of one ILI system
 - Good overall performance on depth
 - Small bias underestimating feature depth
 - Bias to under estimate length of long features
 - Bias over estimate width of features

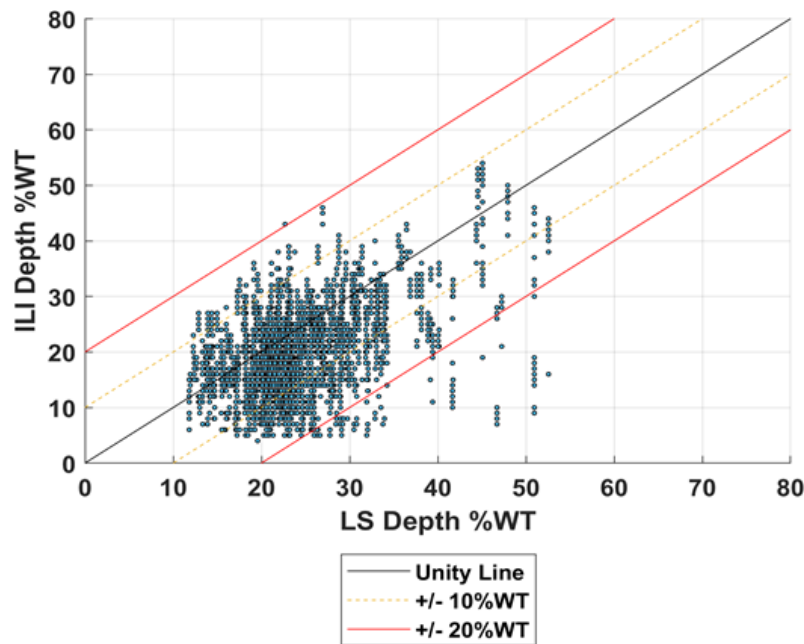
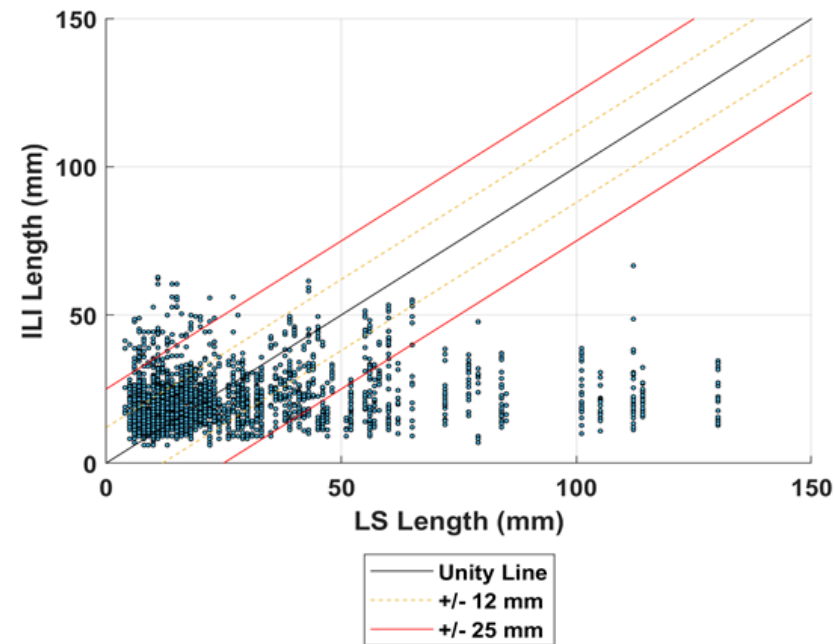
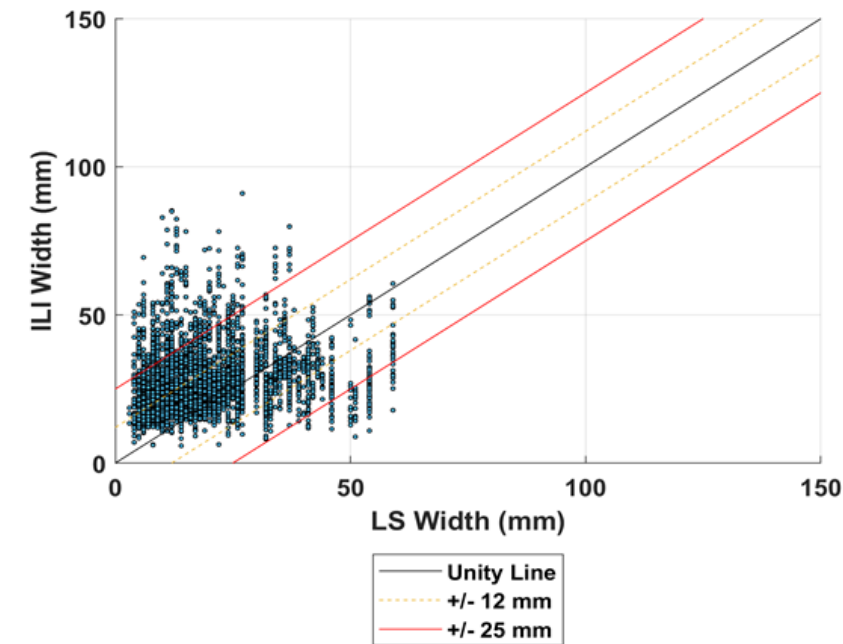
- Unity plot for all dent coincident corrosion features of one ILI system
 - Good overall performance on depth
 - Small bias underestimating feature depth
 - Bias to under estimate length of long features
 - Bias over estimate width of features

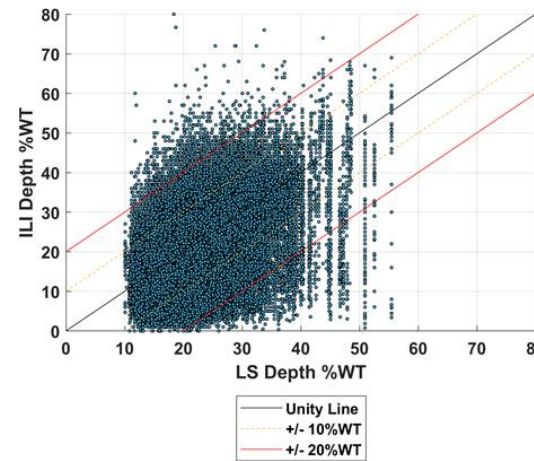
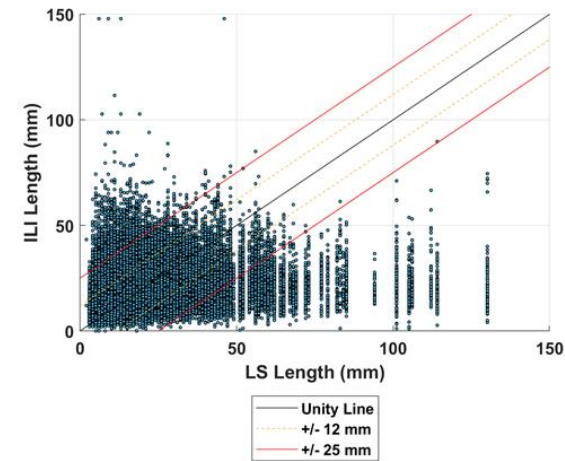
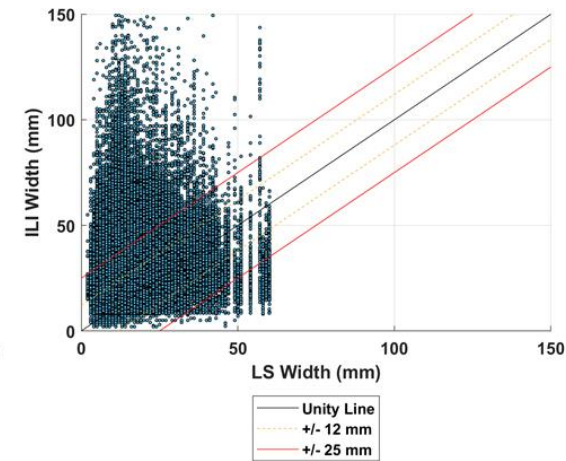
All Corrosion
Features

- Similar performance observed for six magnetic ILI systems
- Ultrasonic tool provided the same performance

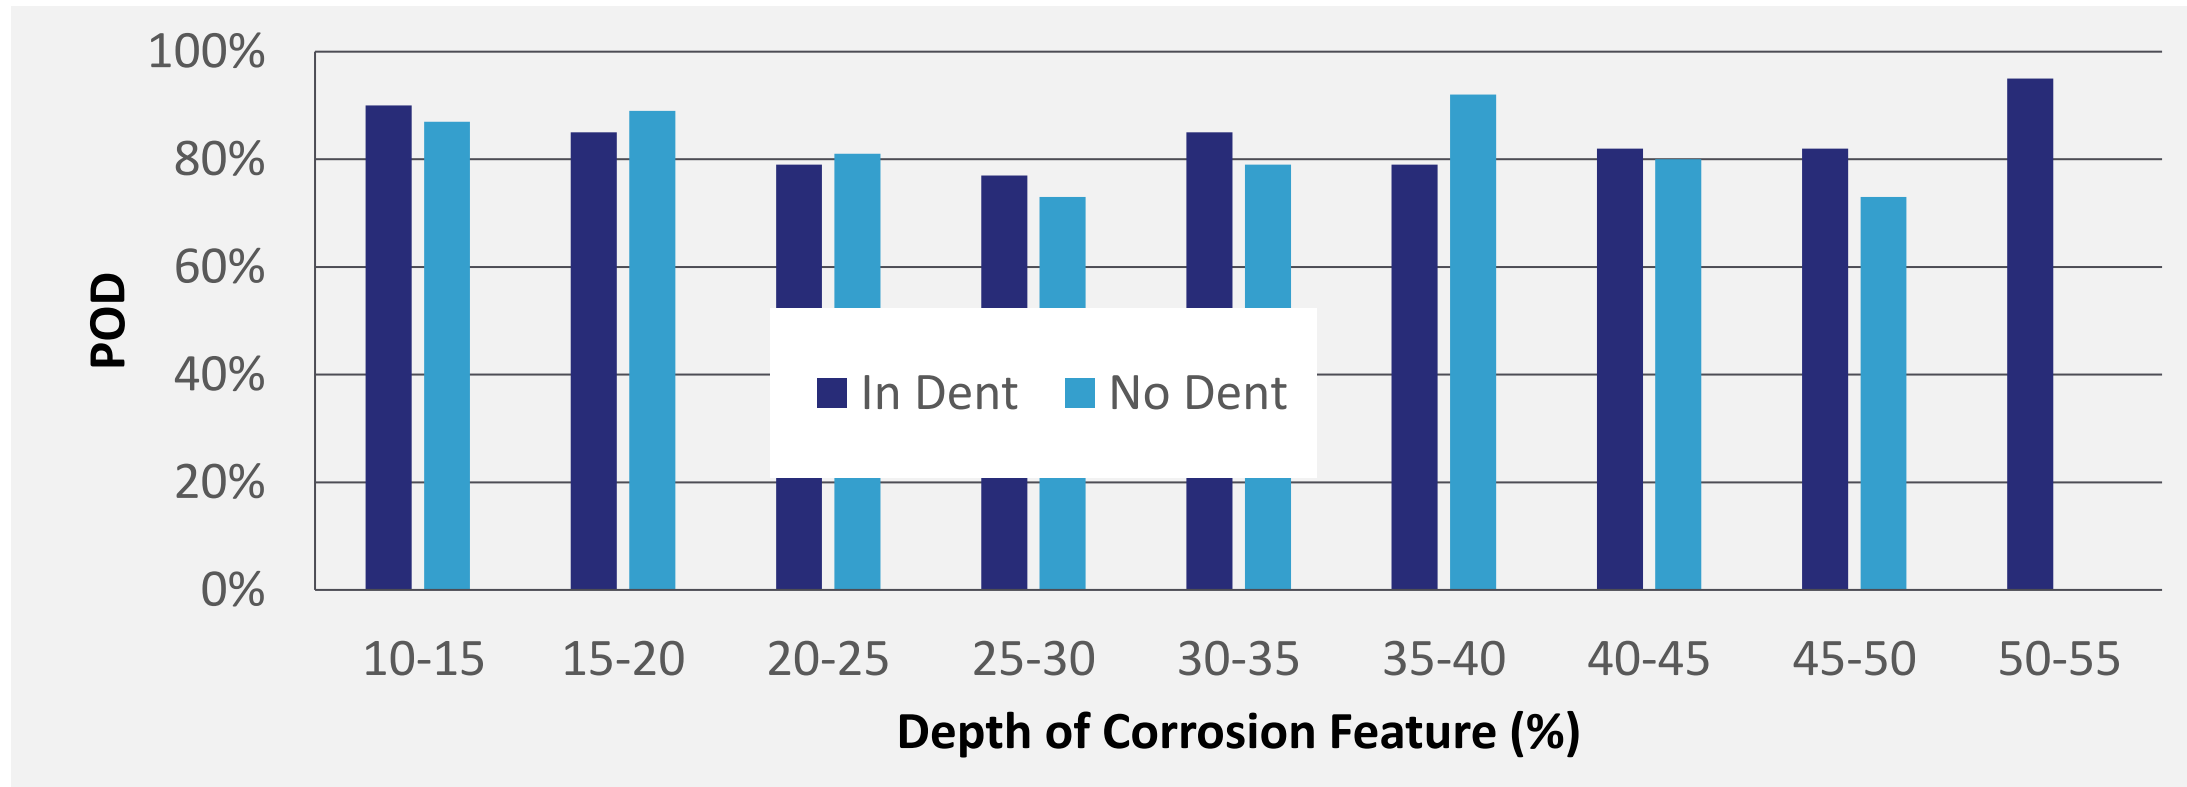
- Corrosion POD performance effect of dent coincidence for one ILI system
 - No significant impact of dent on POD
 - In future, will consider as a function of dent depth

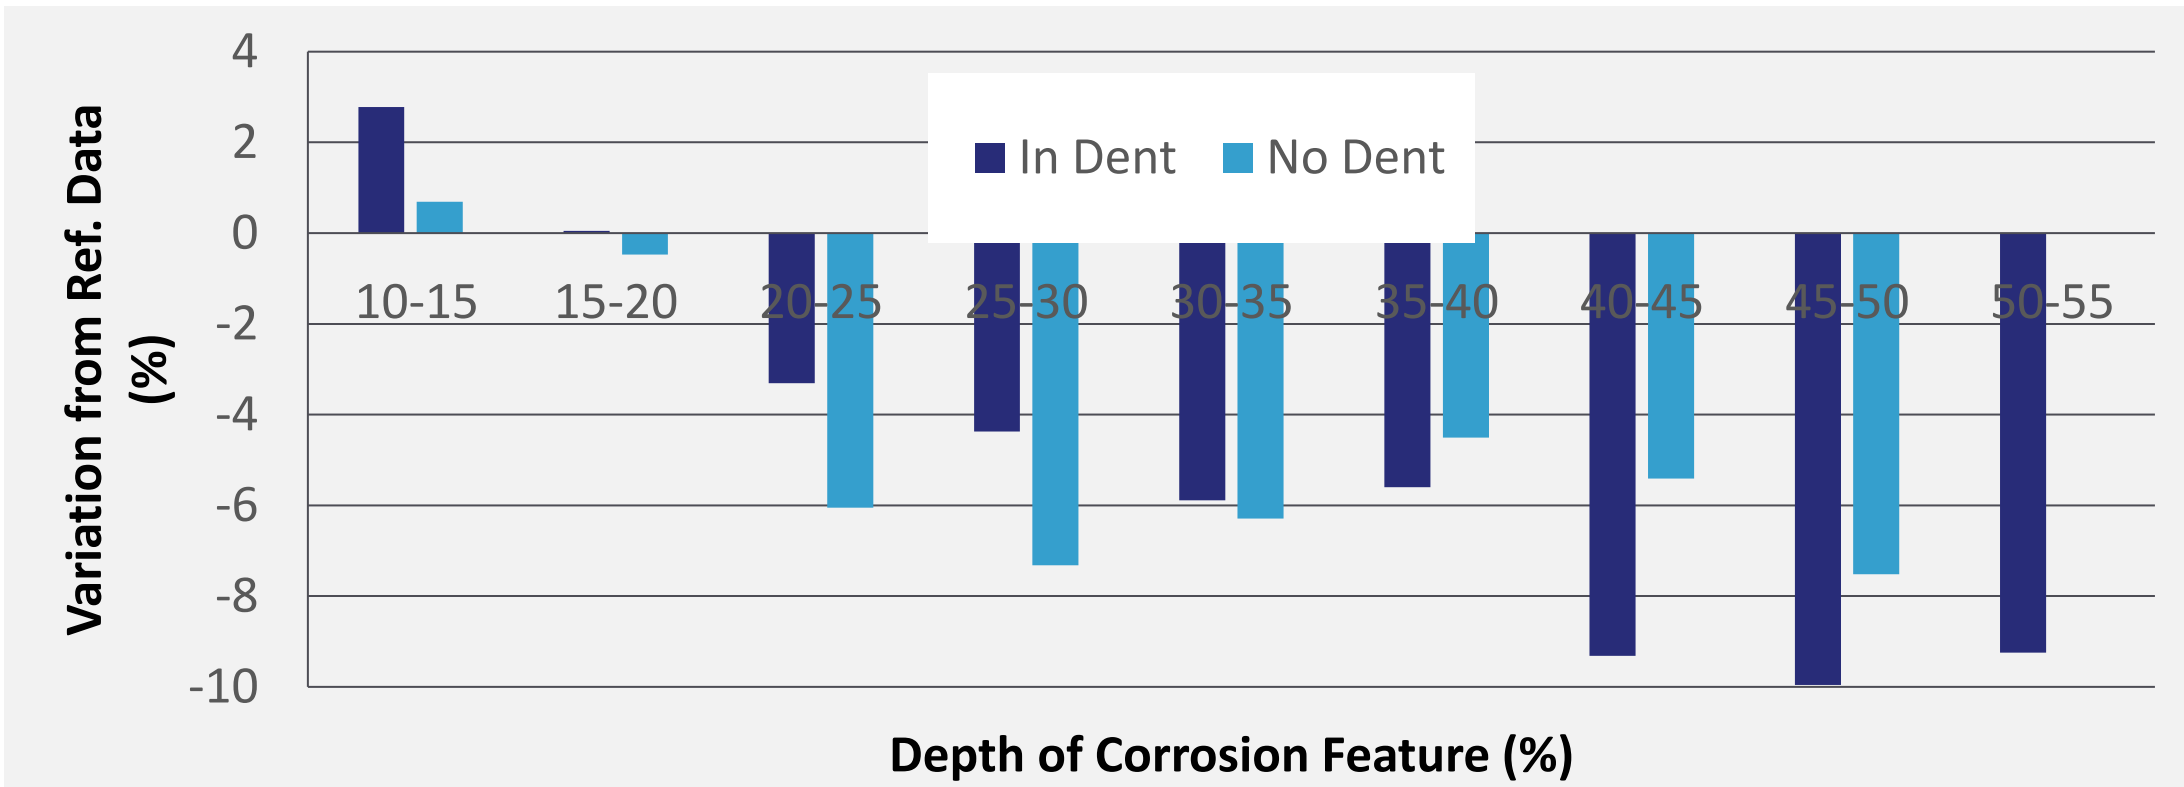
- Corrosion depth sizing, effect of dent coincidence for one ILI system
 - Small impact, if any, on average sizing variation
 - In future, will consider as a function of dent depth

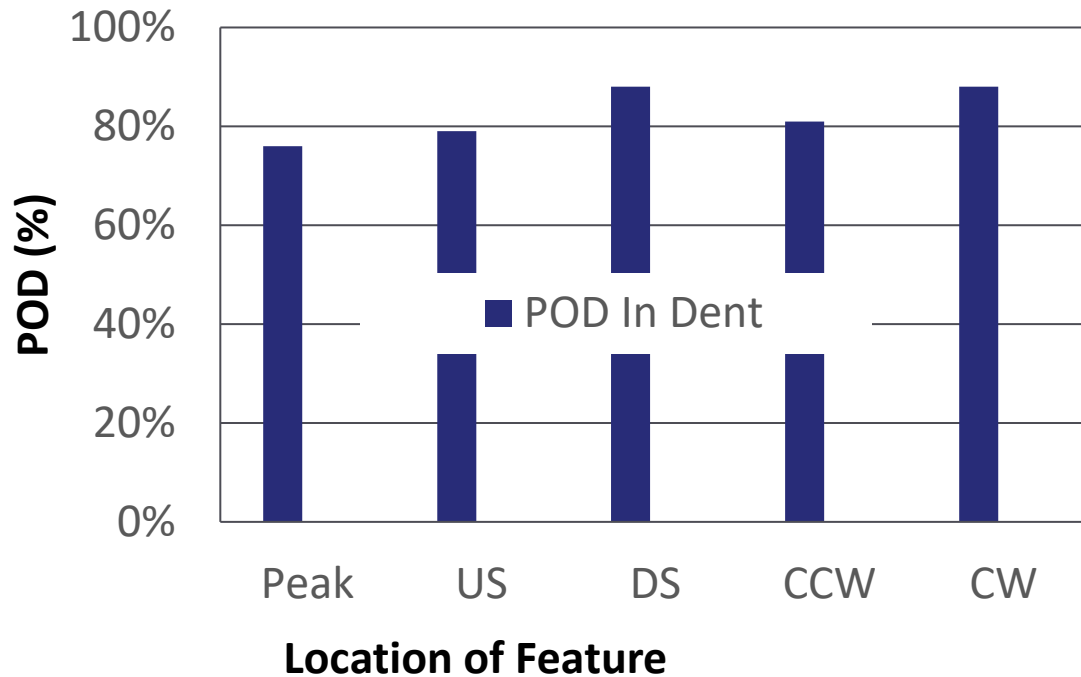
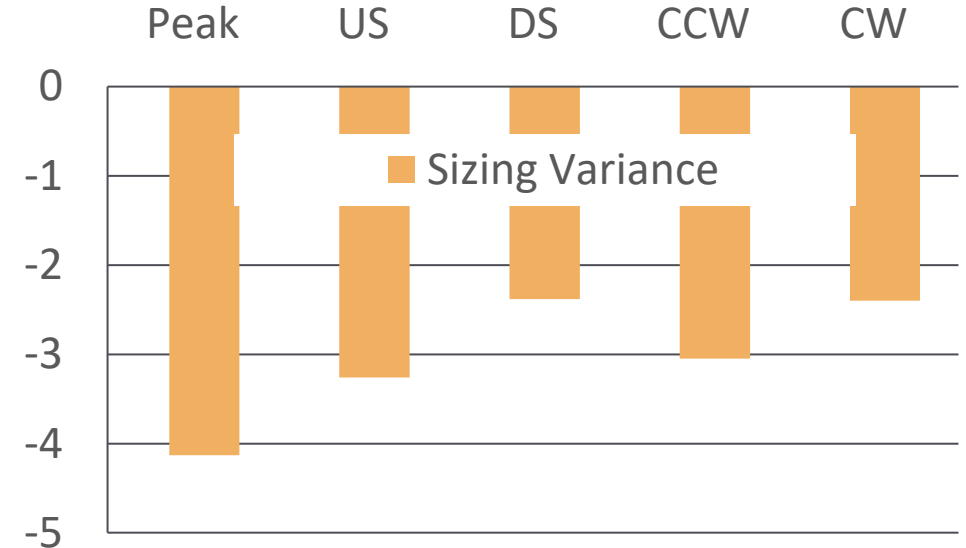
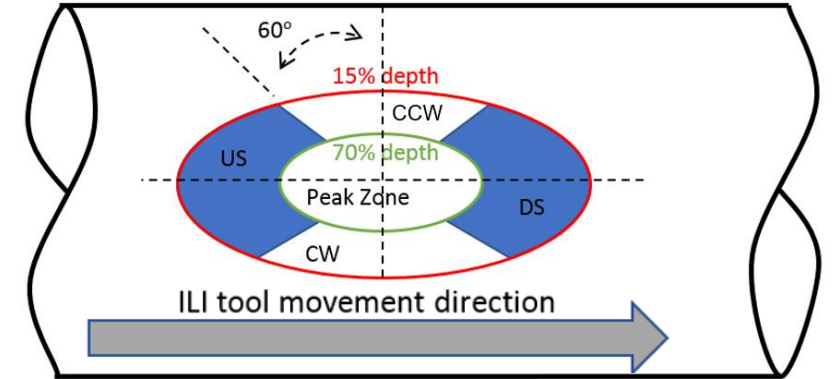
- Effect of corrosion feature location on POD and sizing for an ILI system
 - Small impact (peak zone most affected)
