EPRG-PRCI-APGA

23rd Joint Technical Meeting

PERFORMANCE OF ILI TECHNOLOGIES FOR DENTS WITH INTERACTING FEATURES

PRCI NDE-4-18 Project – Introduction

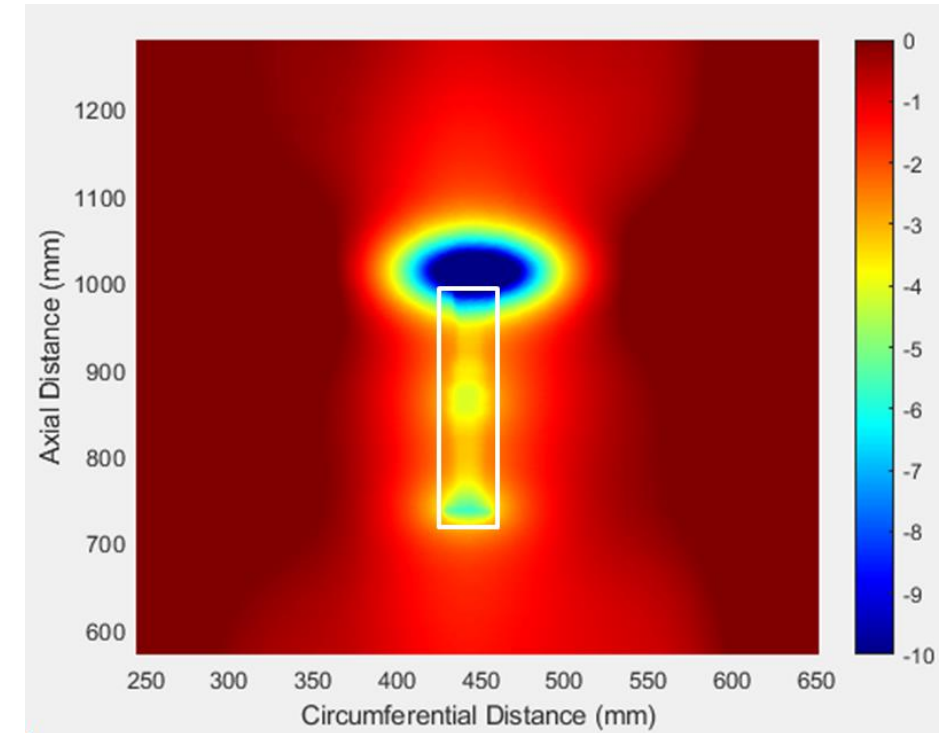
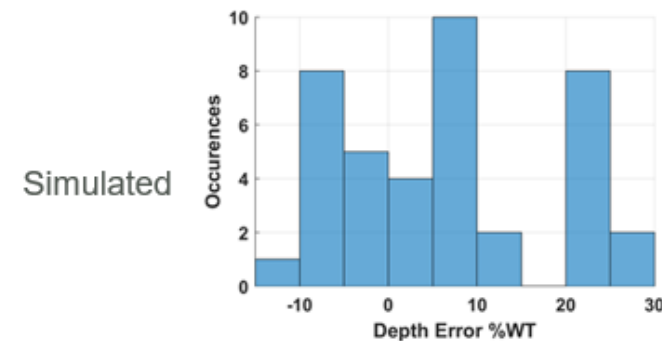
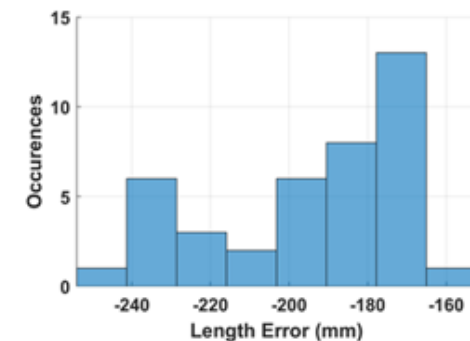
- Effect performance on small pool of gouge features for one ILI system
 - Clock position not controlled
- Two types of gouges considered as provided by EPRG Project 217
 - Simulated – back hoe tooth formed
 - Machined – dented and machined
- Laser surface scan identifies features
- For six ILI service providers
 - High POD (>90%)
 - Simulated features POI (80%)
 - Machined features lower POI (67%)
- Significant error in gouge length

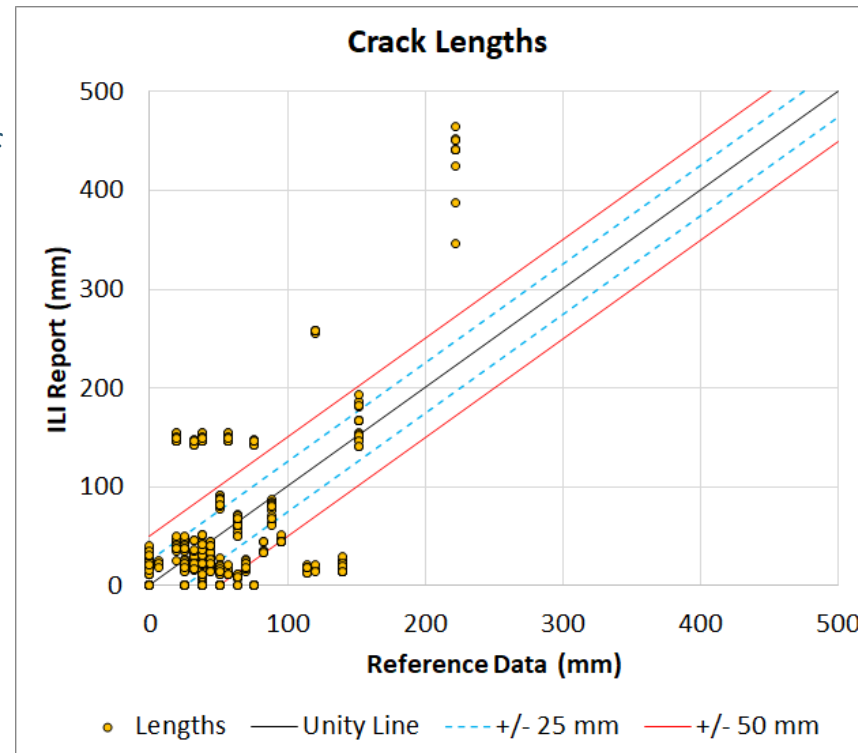
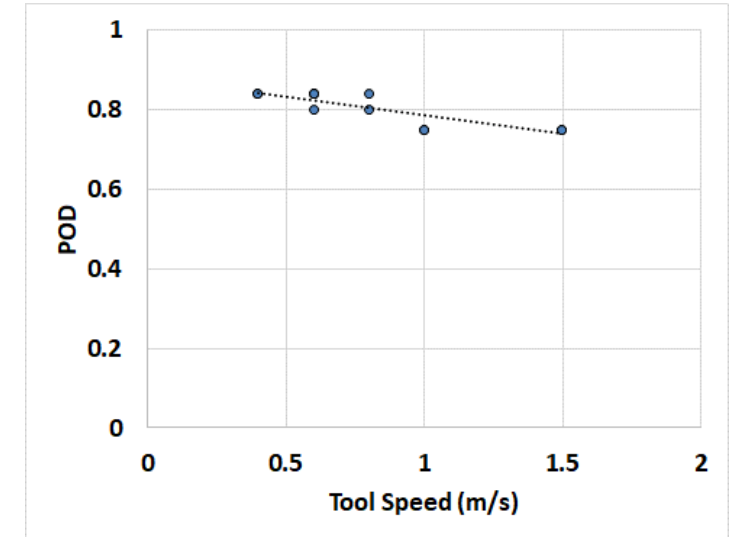
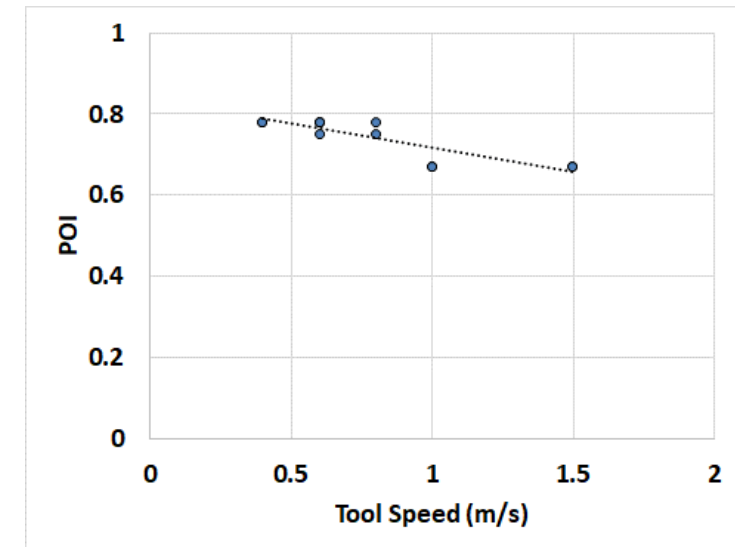
- Ultrasonic ILI tool
- All features coincident with dent
- Some features in corrosion
- Good POD not sensitive to tool speed
- POI includes identification of
 - Initiation surface
 - Orientation of the crack
