REX2024
PRCI Research Exchange

A General Engineering Critical Assessment (ECA) Procedure Framework to Manage Dent

Rick Wang, Shenwei Zhang, Jing Wang and Liam Hagel

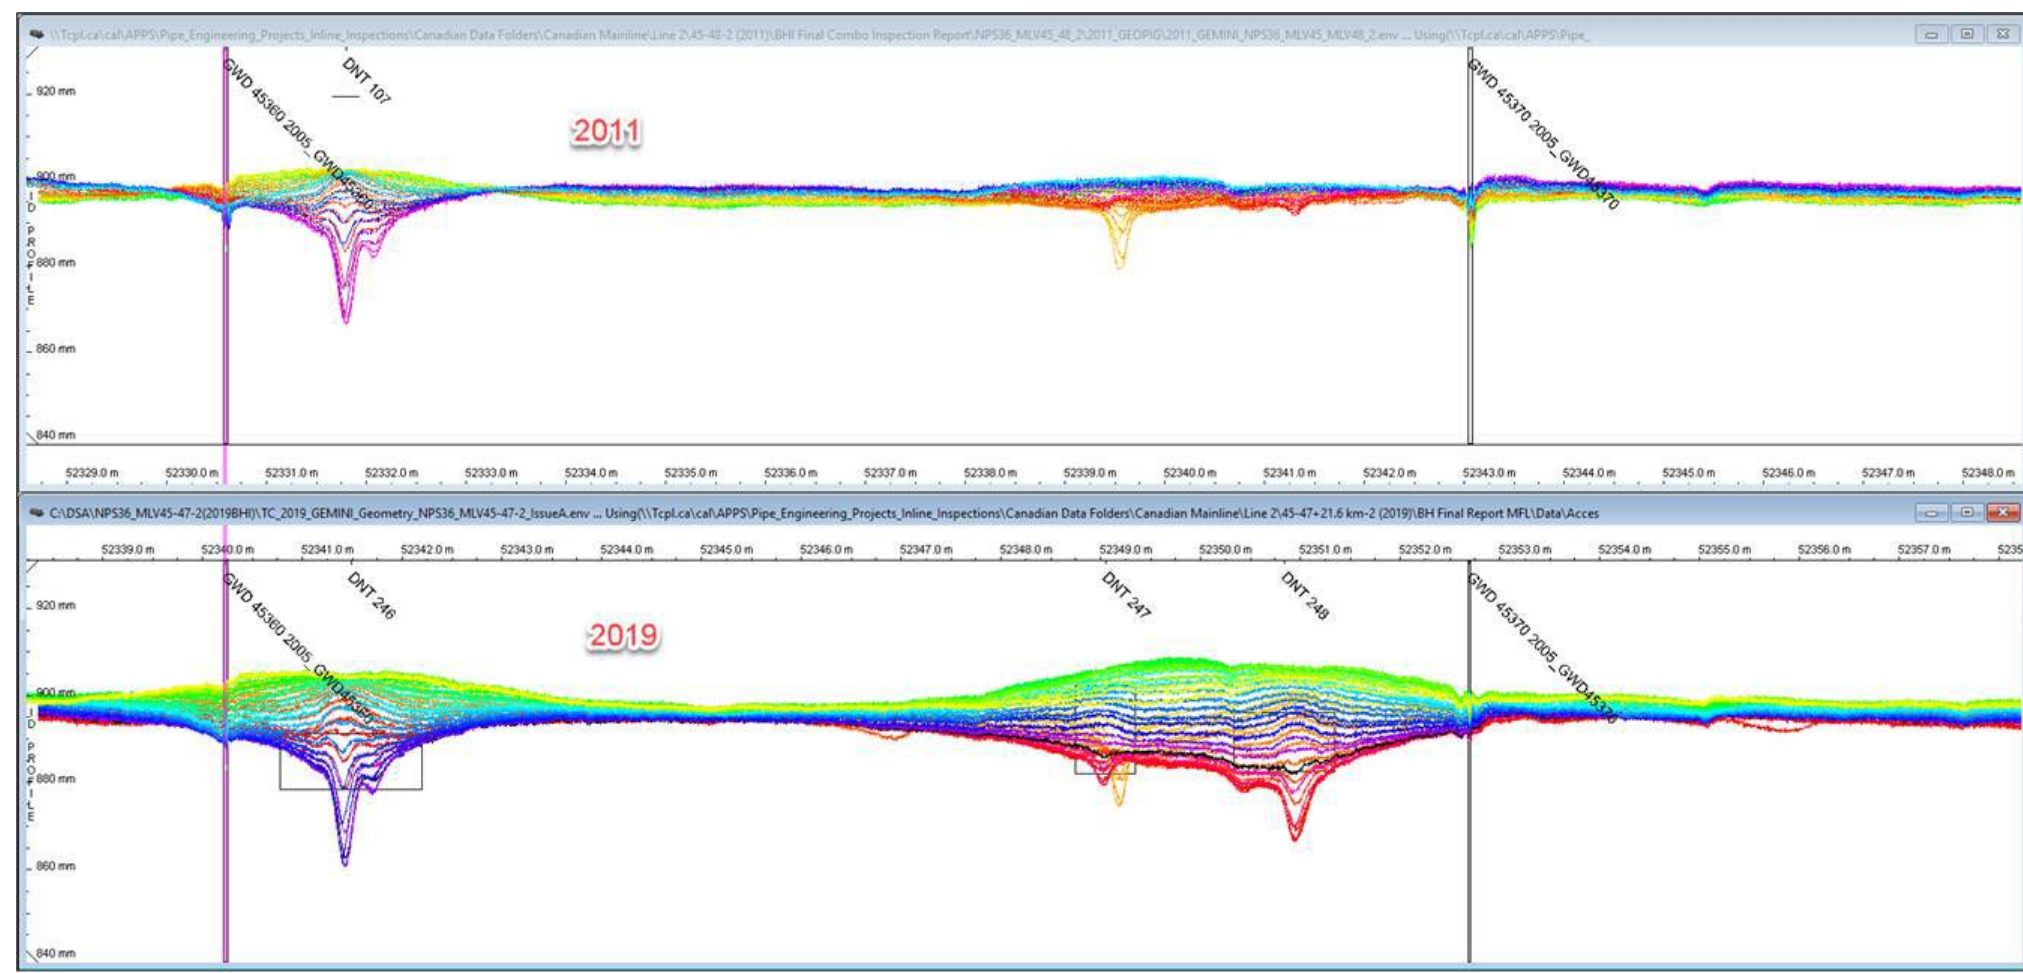
7

Example of Review Multiple Caliper Inspections

Objective: overview of any changes in depth and shape

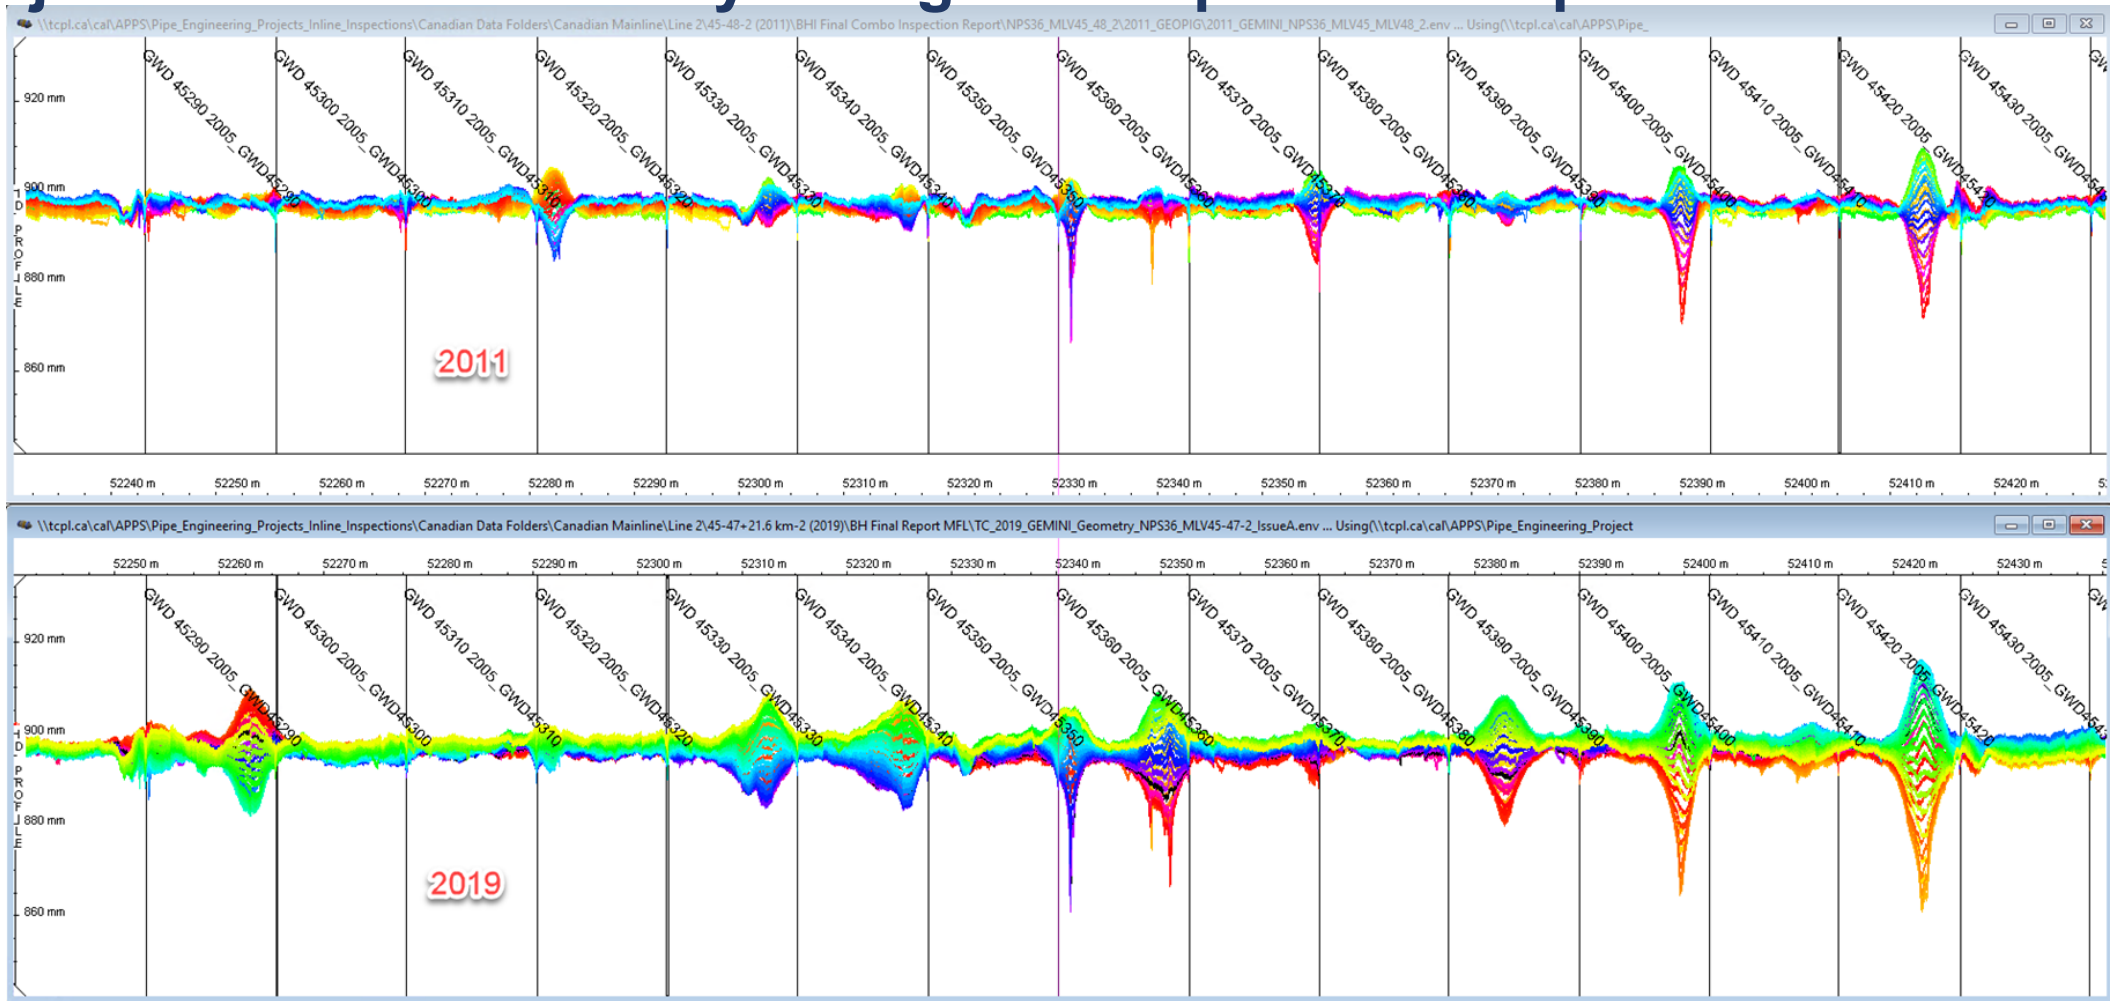
Example of Review Multiple Caliper Inspections

Objective: overview of any changes in depth and shape

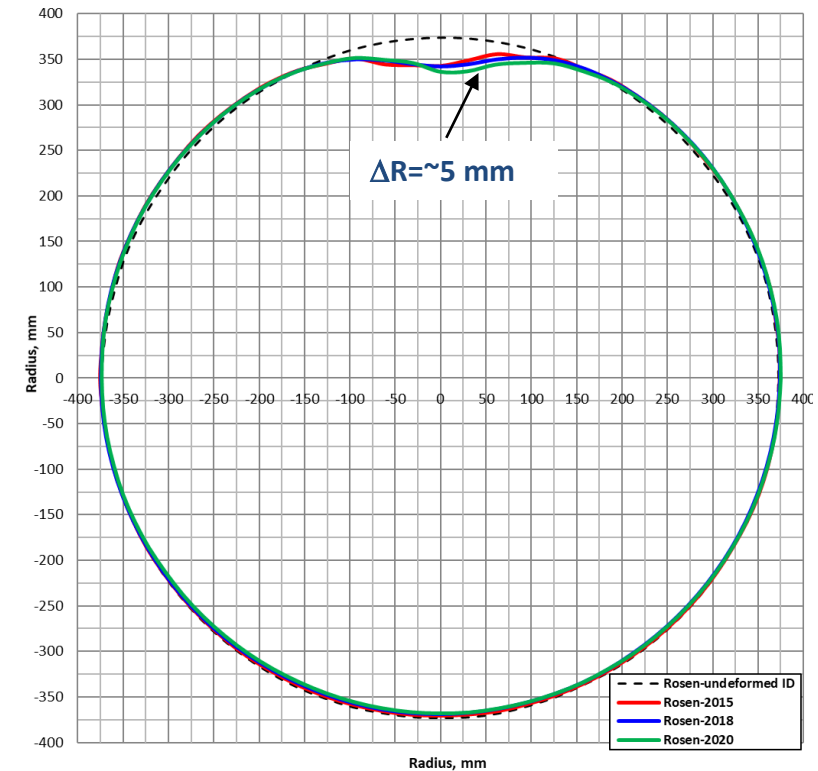
9

Detailed Comparison of Dent Profiles

Objective: detailed review of changes in depth and shape by comparing profiles

Minor change in the profile with $\Delta R \leq 0.2\%OD$ (within tool tolerance of $0.2\%OD$)

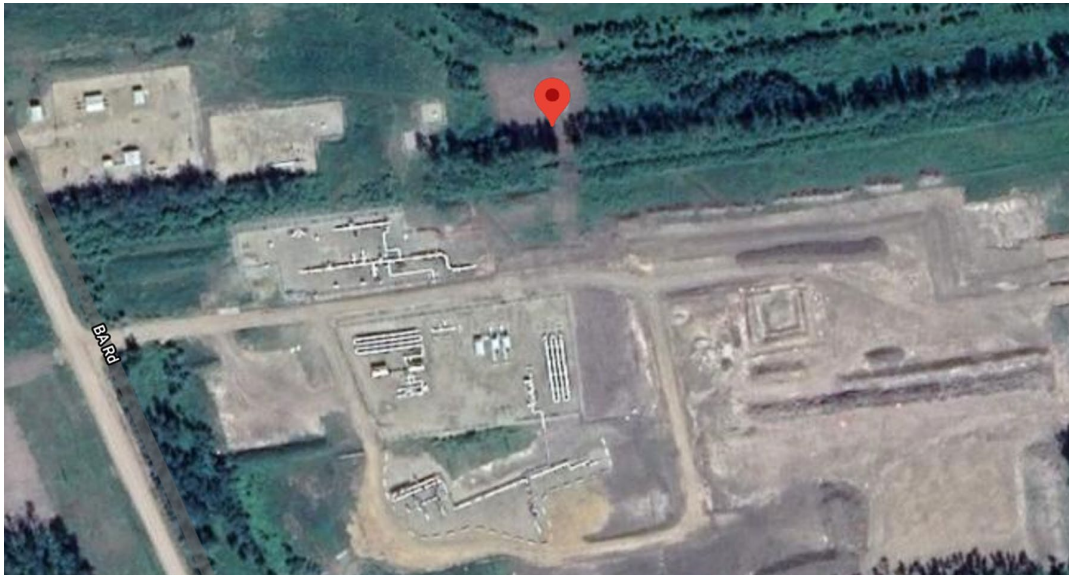
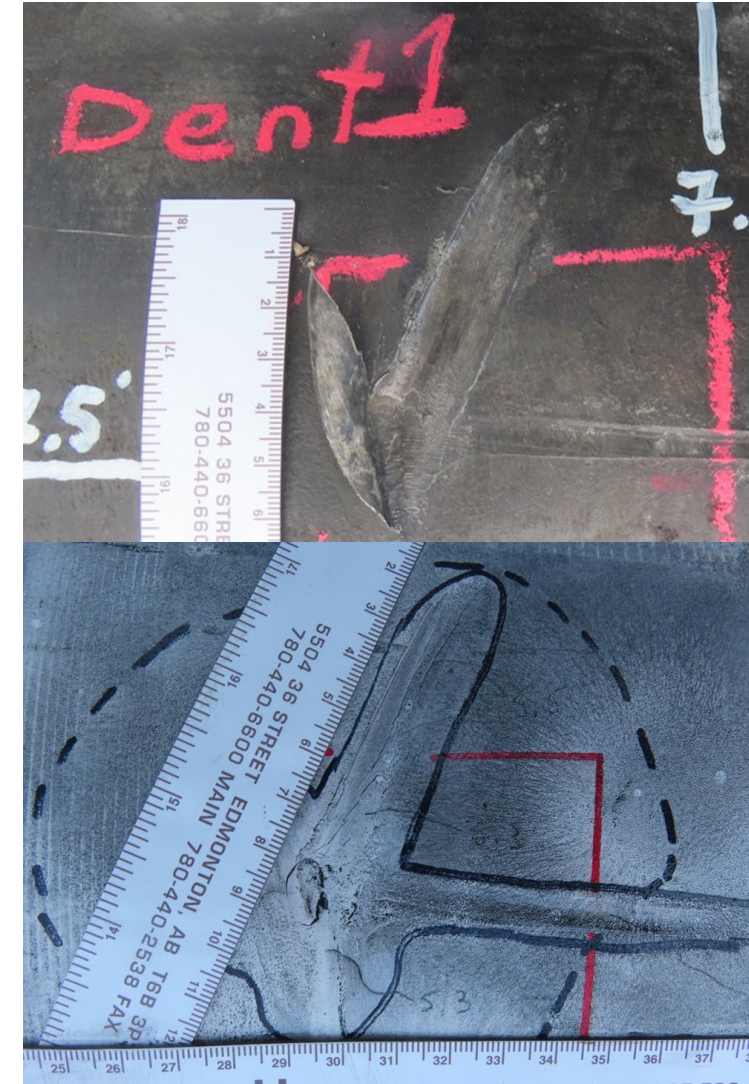
11

Example of Review Multiple ILI (e.g., MFL, EMAT, Caliper) Signal Data for Coincident Damage

- Objective: demonstrate the effectiveness of using multiple datasets
- Example:
 - 2020 ILI: top side dent 1.75%OD with 28%wt ML
 - No signal indication from 2012 MFL/Caliper and 2015 EMAT/AFD
 - MS expansion done in 2017 near this location
 - Very likely to be MD created between 2015 and 2020
 - MD was confirmed In the ditch

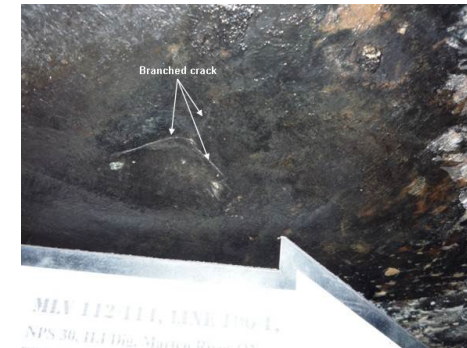
- ILI
 - Depth: 4.1%OD
 - No interactive anomaly reported
 - Bottom of the pipe
 - DFDI = 0.8
- In-ditch finding
 - Dent associated with through-wall crack

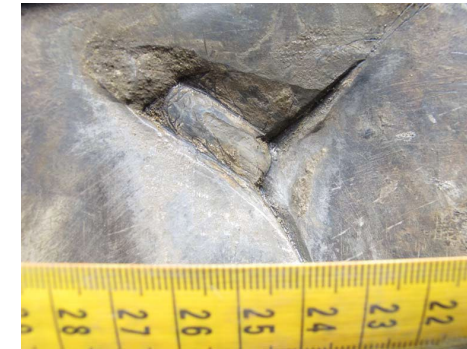
- ILI
 - Depth: 2.7%OD
 - 76%wt ext. ML
 - Bottom of the pipe
 - DFDI = 1.0
- In-ditch finding
 - Dent associated with branched non-through-wall crack

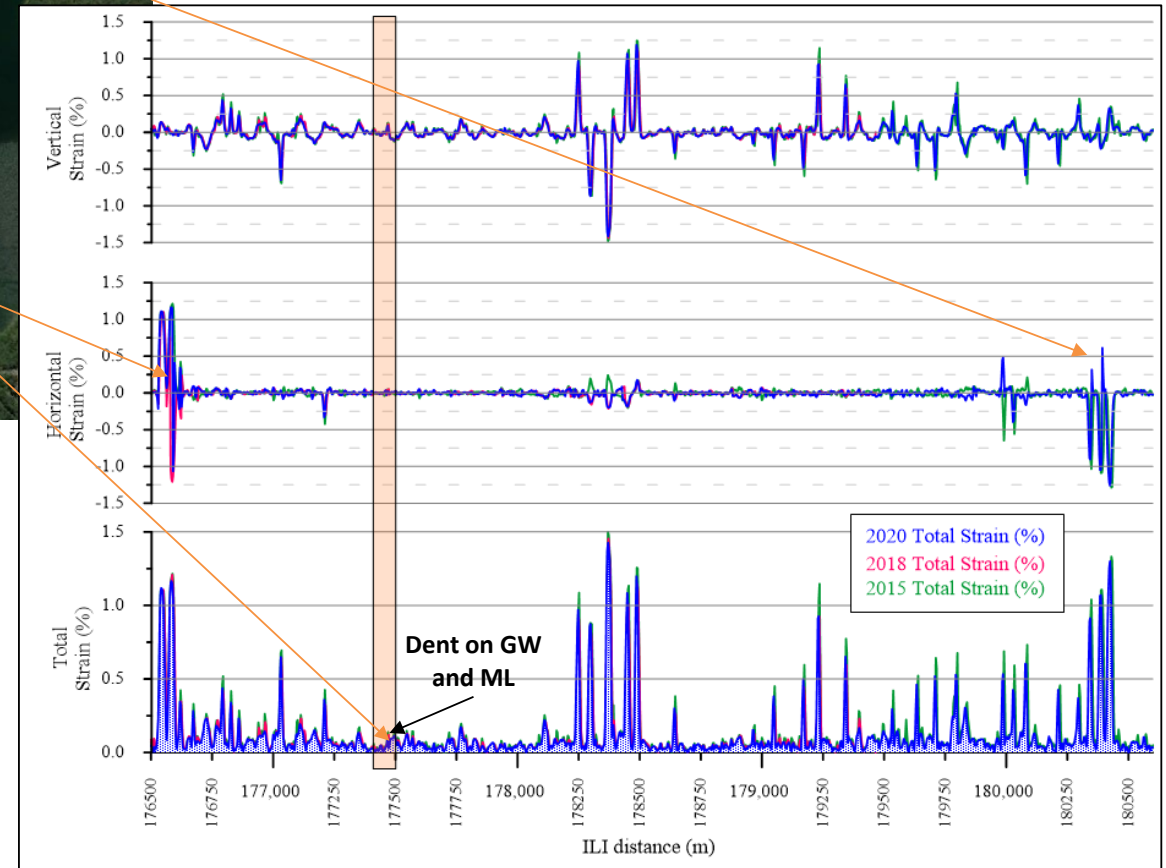
14

Objective: identify external loads at the dent location

- IMU strain is comparable between the ILI runs
- No significant change in IMU strain at the dent location, indicating no evidence of pipe movement (no large external load).

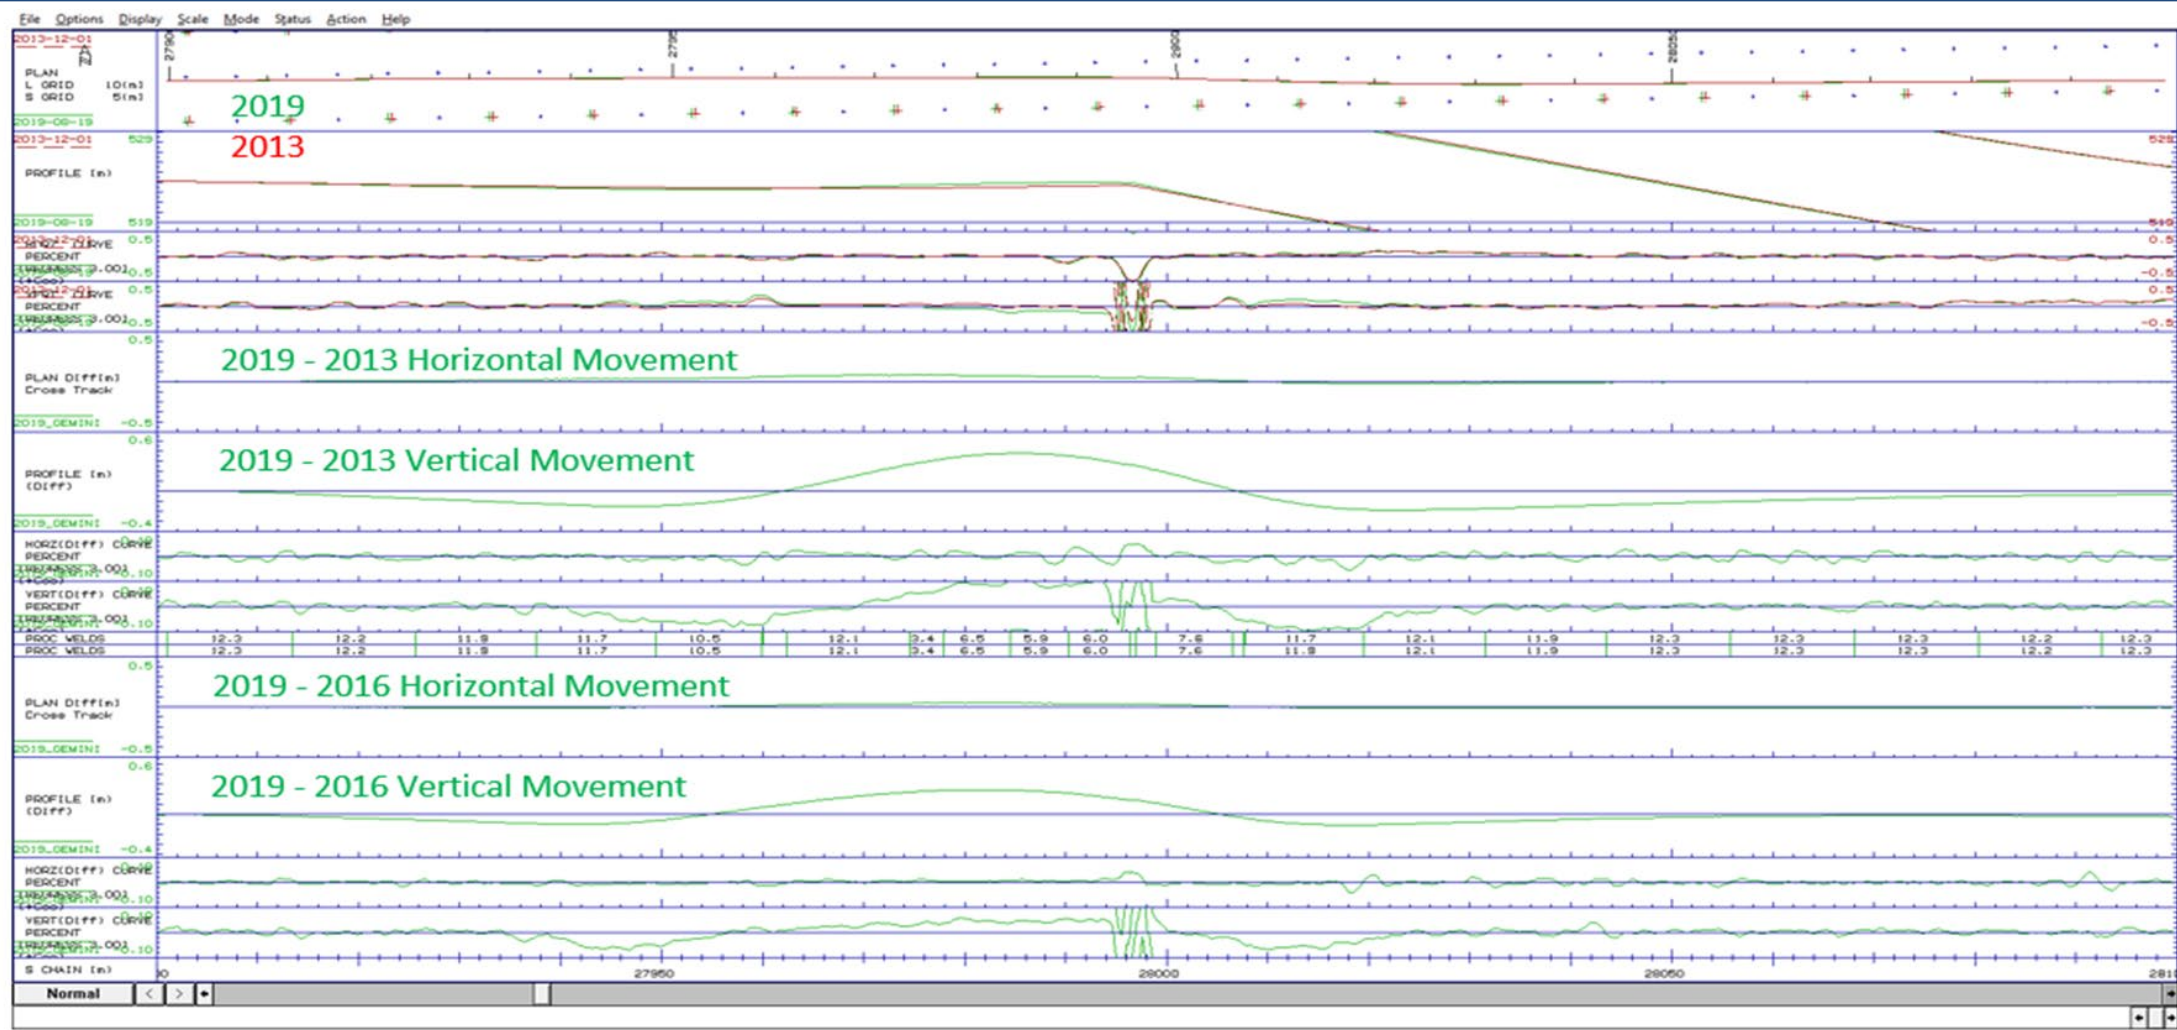
15

Large vertical movement from 2013 to 2019

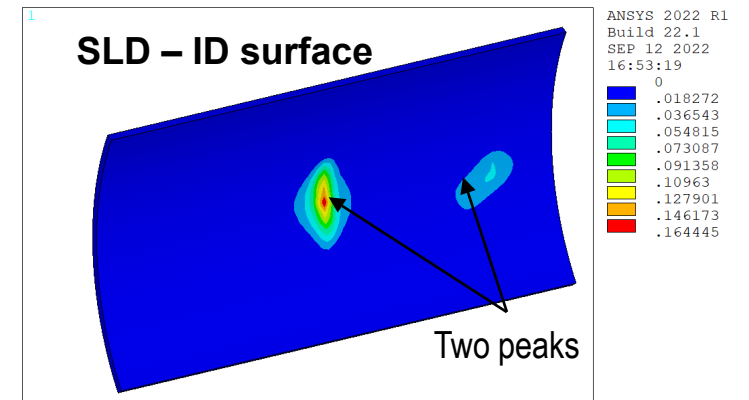
FEA model

FEA for Strain Assessment

Objective: evaluate Stress/Strain, DFDI and SLD

Condition	Maximum Plastic Equivalent Strain	Maximum DFDI				Maximum SLD
		$\epsilon_0 = 0.3$	$\epsilon_0 = 0.4$	$\epsilon_0 = 0.5$	$\epsilon_0 = 0.6$	
Dent depth = 2.5%	5.27%	0.19	0.14	0.12	0.10	0.16
Dent depth = 2.7% (w/ tool tolerance)	5.32%	0.20	0.15	0.12	0.10	0.17

DFDI < 0.6 and SLD < 1, indicating it is not susceptible to cracking.
