REX2024
PRCI Research Exchange

Case Studies in Corrosion Trends taken from Liquid Pipelines Experiencing Increased Operating Temperatures

**James Gibeault, Mengshan Yu, Yanping Li, Trevor Place,
Karmun Doucette**

*San Diego, California
February 27, 2024*

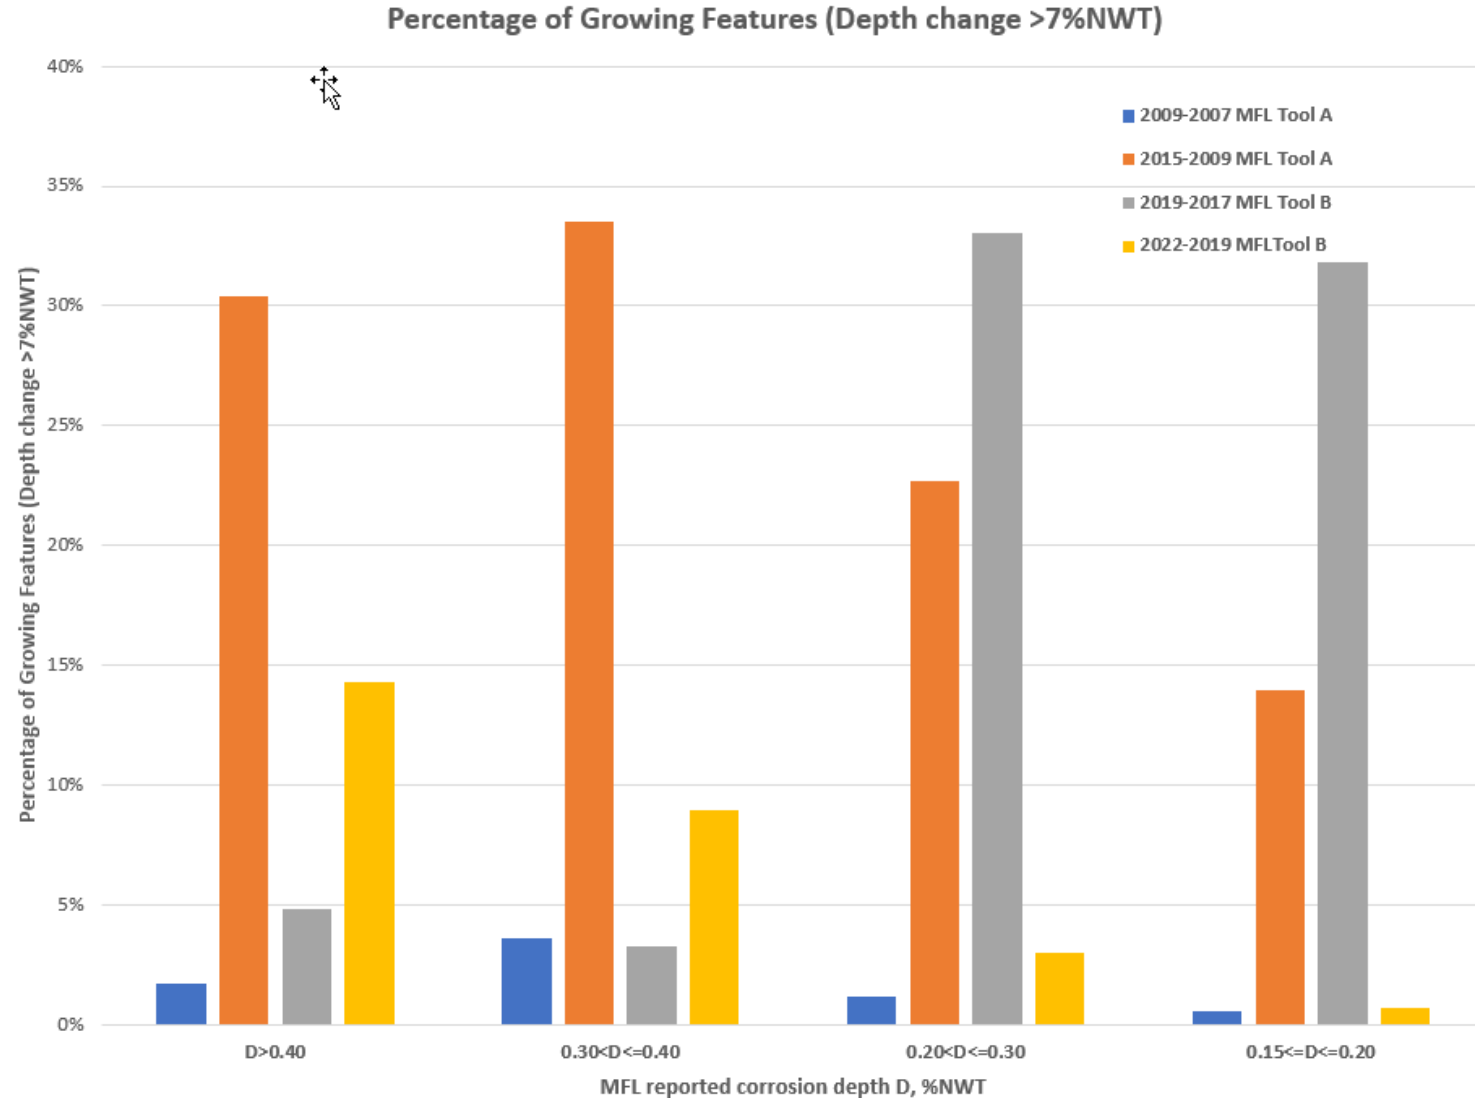
RunCom CGRs by MFL

- Growing features
- Depth bins

Expected higher CGR,
more growing features
and thus more corrosion
digs are not observed

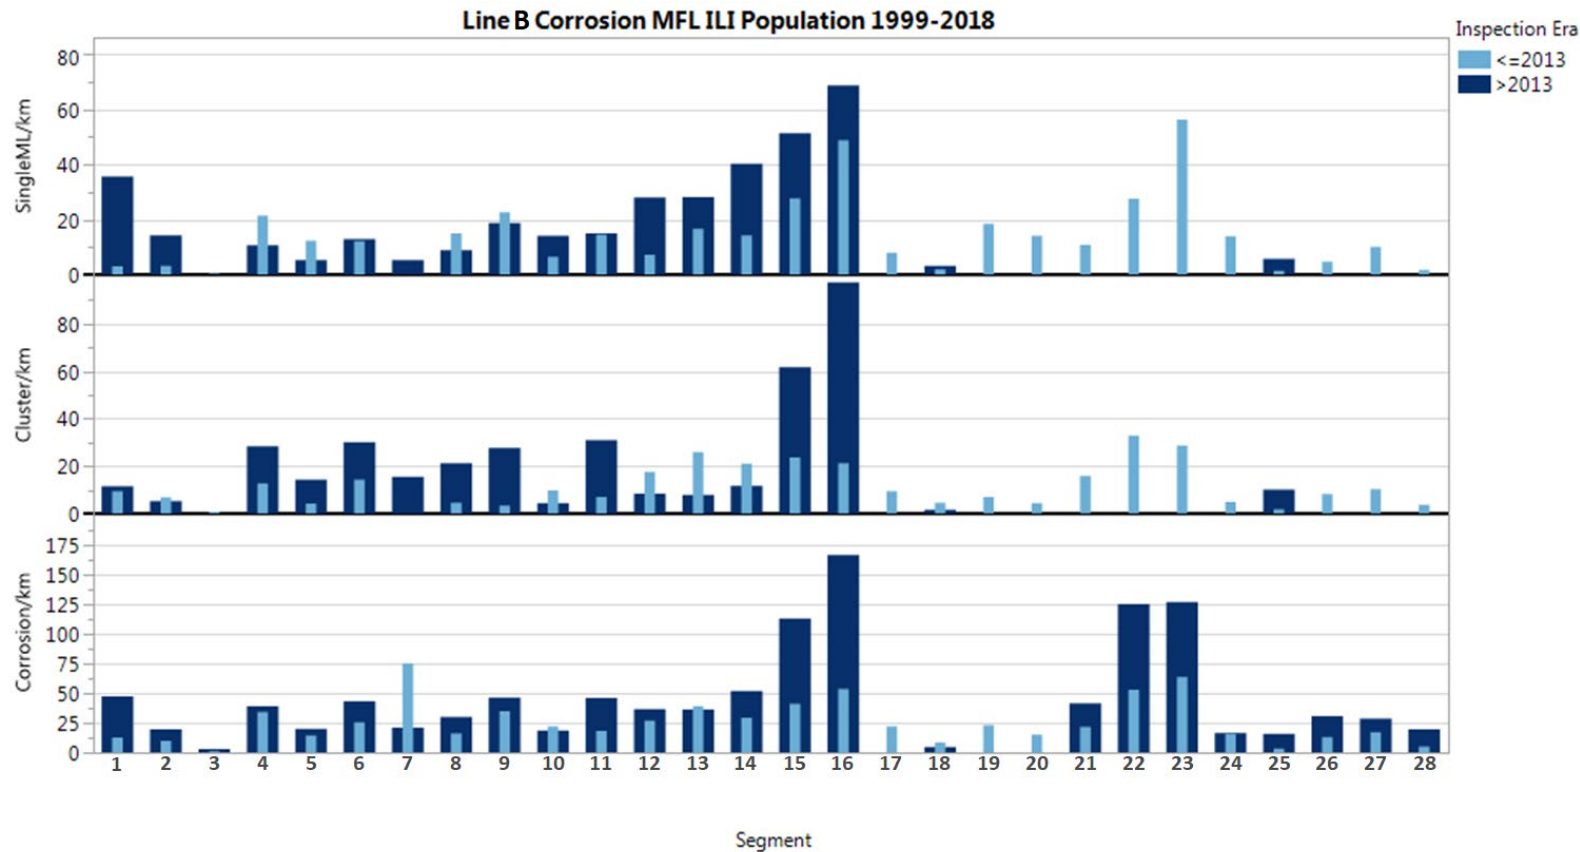
- **Line B: ILI Population Density**
 - No consistent correlation between temperature and corrosion population density

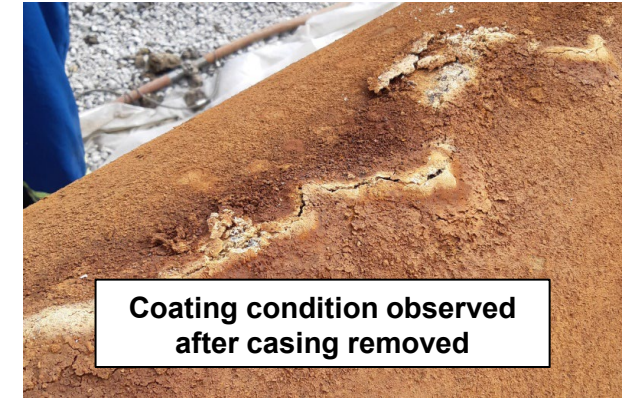
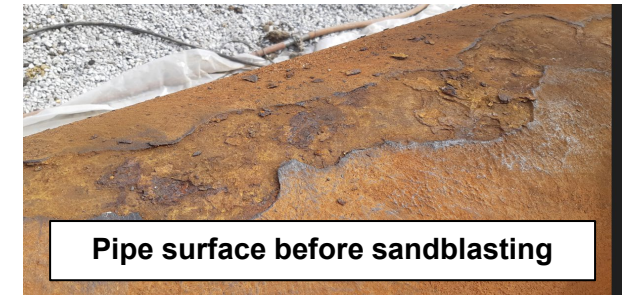
- **Corrosion process believed to have occurred:**

- Moisture entered the casing
- Elevated temperatures caused the available moisture in the casing to be cycled from a liquid state to a vapor state resulting in a relative humidity within the casing to be close to saturation
- Cold surface of the casing inside wall promoted condensation of moisture which dripped onto the carrier pipe

- **Corrosion process (continued):**
 - Persistent water permeated imperfections in the coating (pores, cracks) causing corrosion
 - Buildup of corrosion product assisted coating degradation by mechanically spalling the coal tar away from the pipe and creating an area to hold moisture at the pipe wall;
 - Crevice corrosion accelerated corrosion both laterally and through wall
 - Continuous dripping of condensed water can create a new cycle of corrosion at some locations by washing away the oxide

- This conclusion was drawn after eliminating other possible corrosion mechanisms such as:
 - Cathodic protection deficiency
 - Stray current interference
 - AC corrosion
 - Microbiologically influenced corrosion
 - Chemical accelerants
