REX2024
PRCI Research Exchange

Aerial Right of Way Patrol using Automated Threat Detection

Kent Schoenroth
Asset Integrity and Reliability - TransGas
San Diego, California
February 28, 2024

ROW-3-1 Airborne Automated Threat Detection System

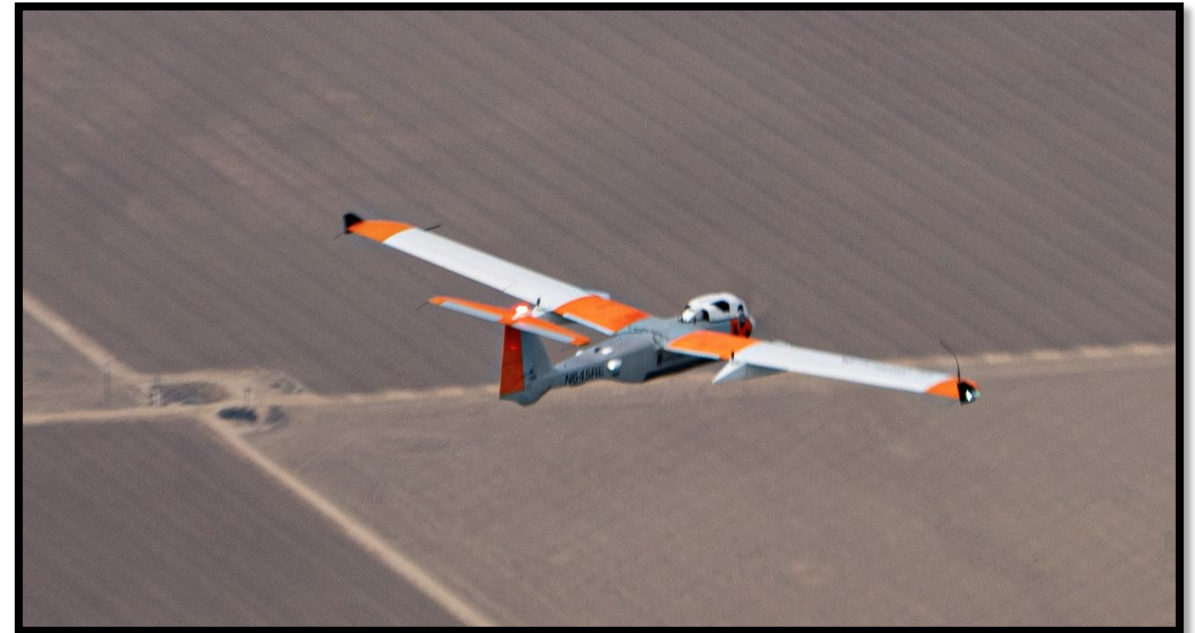
AiRanger UAS in flight

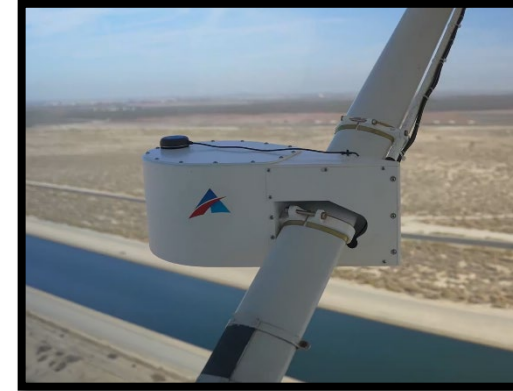
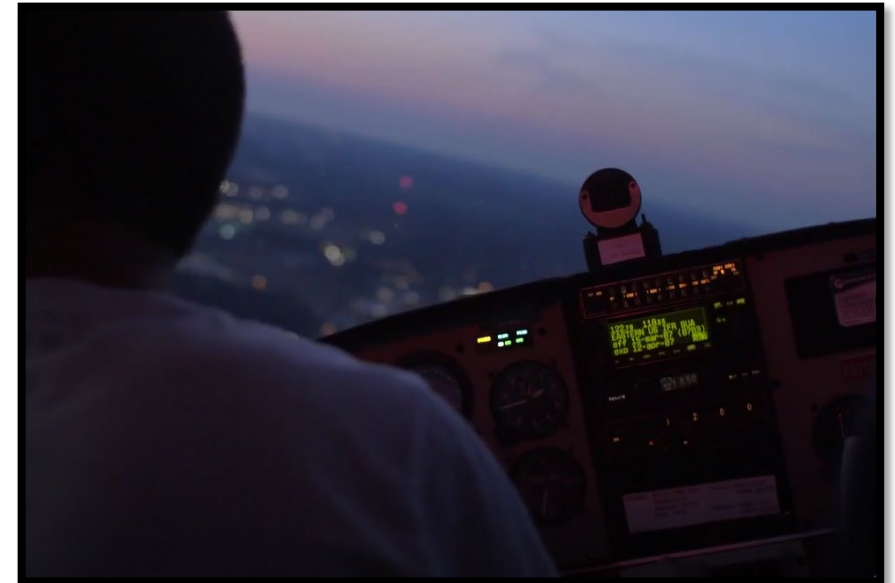
Implementation of the Research

- Easier due to integration with existing Aerial Patrol inspections
- Cost is lower due to integration with existing Aerial Patrol inspections
- The pilot and spotter continue to notify operations of extreme threats
- Annual inspection to supplement
- Integration with the company GIS system allows for extra value

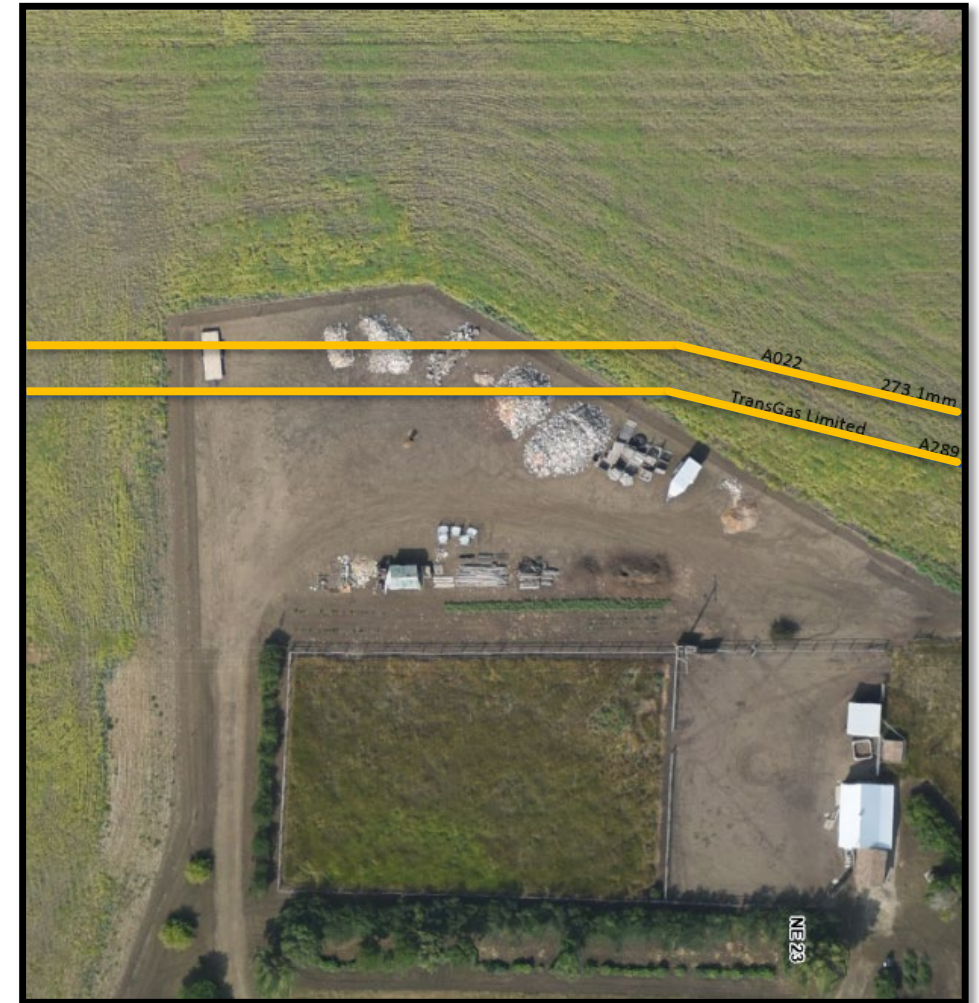
Improved Threat Detection

- Better identifications where pipeline alignment is not obvious
- There seems to be a perception that old threats are not reportable
- Automated threat detection reports findings unnoticed in the past
 - Expansion of Urban Areas
 - Animal activity / erosion
 - Excavators

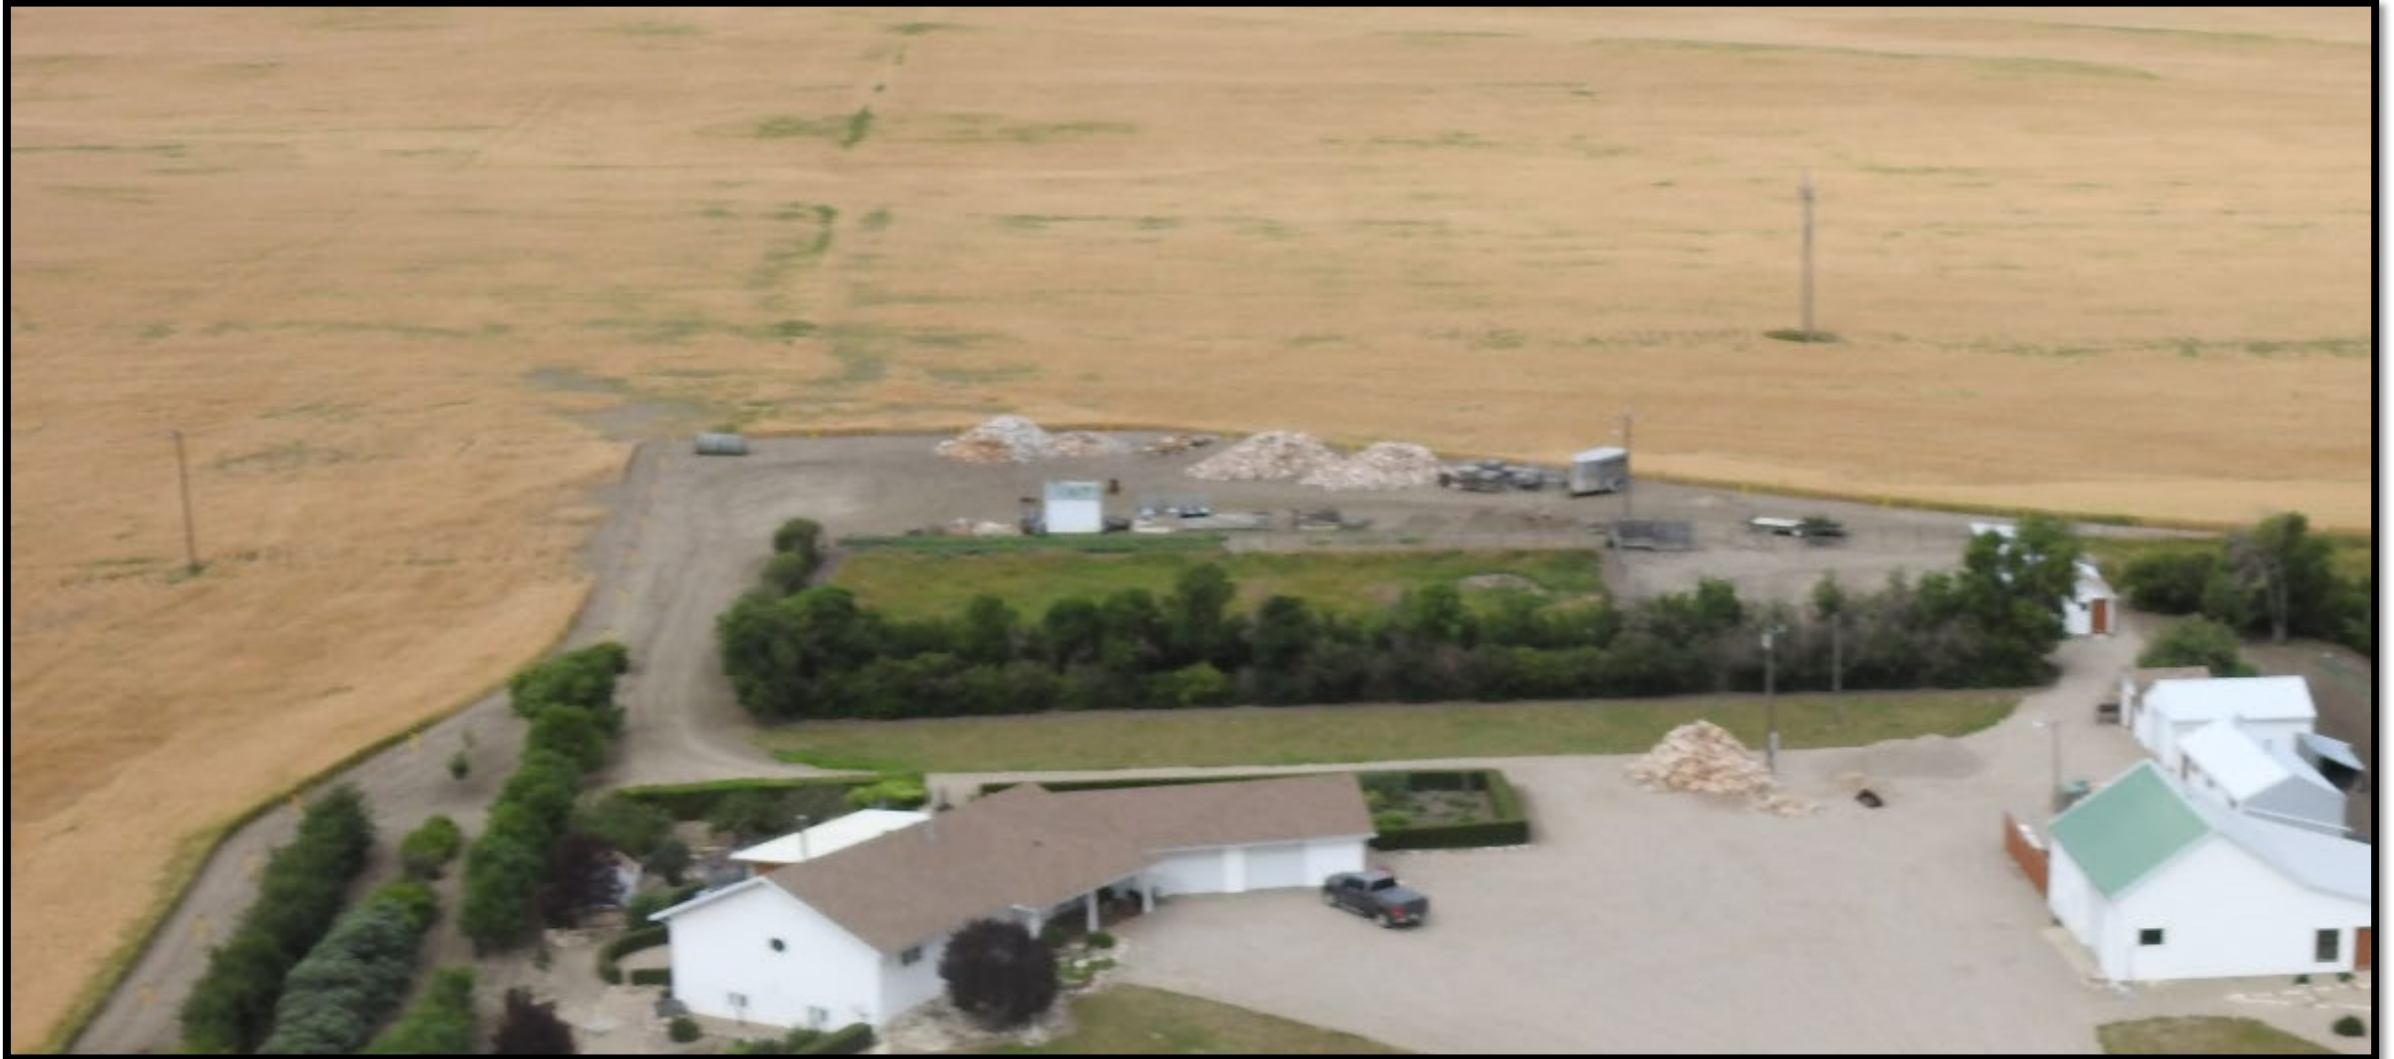
Aerial Pipeline Patrol / Encroachment Control Report

#	Dir Name	File Name	Condition	Severity	Latitude	Longitude	Description
20	202307191545	HR1500	OT	Low	52 0 27 N	106 58 51 W	Agriculture to Commercial

ROW Image

Zoomed Threat

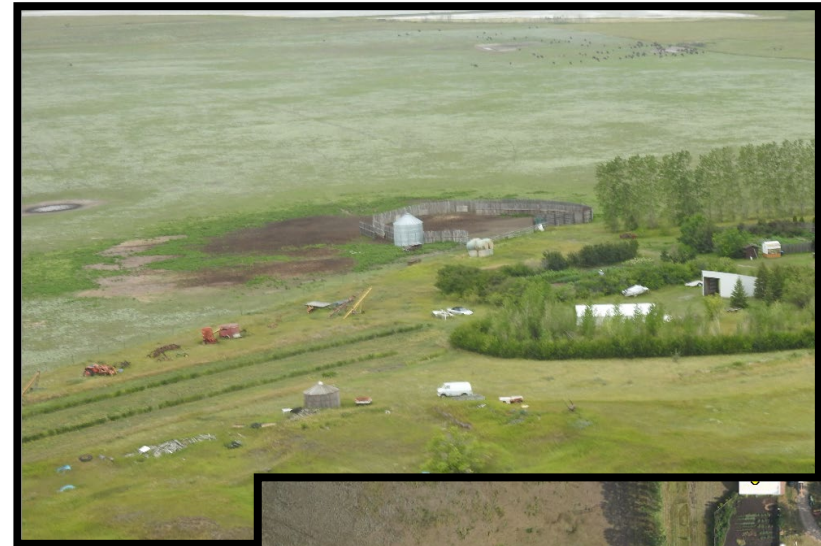
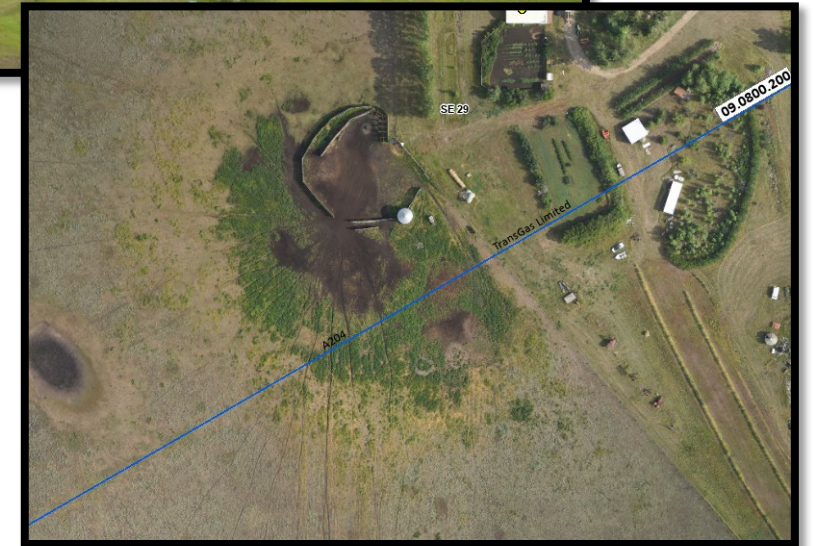
Improved Threat Detection

- Better identifications where pipeline alignment is not obvious
- There seems to be a perception that old threats are not reportable
- Automated threat detection reports findings unnoticed in the past
 - Expansion of Urban Areas
 - Animal activity / erosion
 - Excavators

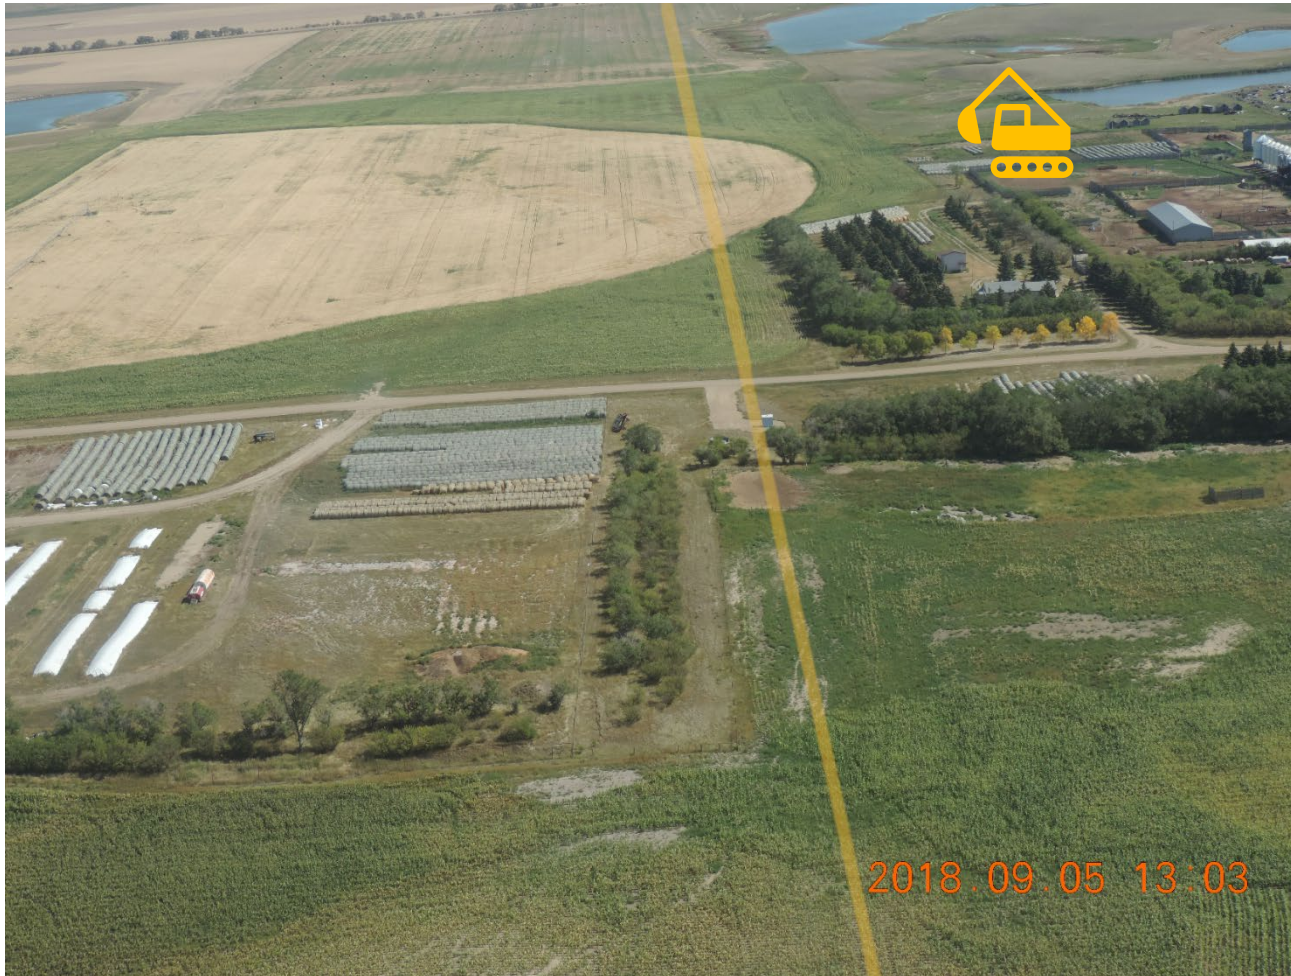
Aerial Pipeline Patrol / Encroachment Control Report

#	Dir Name	File Name	Condition	Severity	Latitude	Longitude	Description
70	202307192102	HR1500	EQ	Low	49 56 31 N	107 27 22 W	Equipment

ROW Image

Zoomed Threat

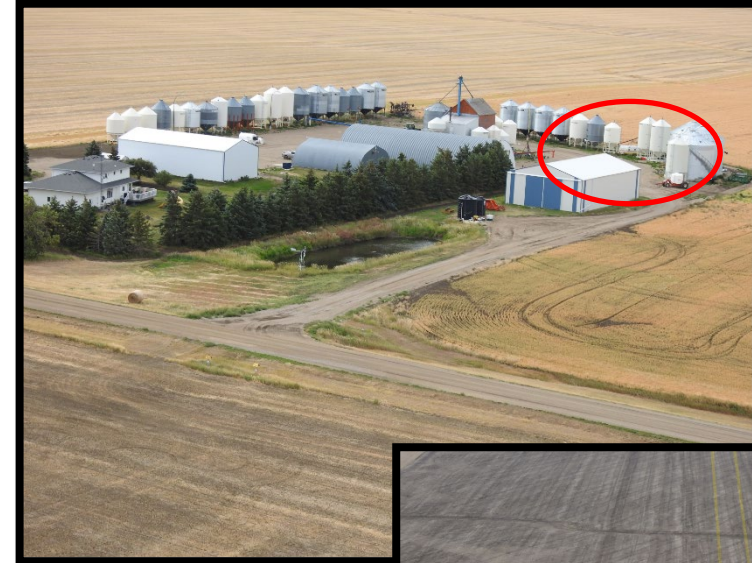
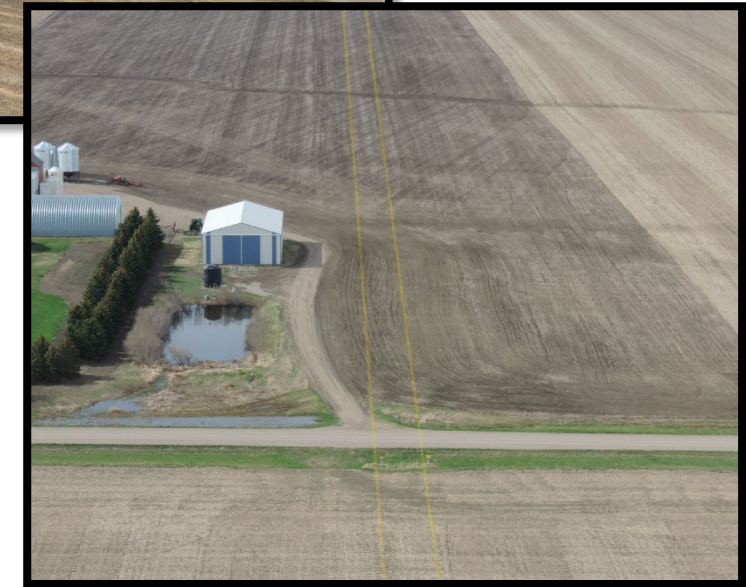
Encroachment Monitoring

- **Monitoring developments for 10 yrs. with annual aerial photos**
- **Follow up inspections added for higher risk encroachments and new developments**
- **High resolution imagery improves desktop assessments**
- **Pipe location shown by Aerial Marker**
- **Crossing process is improved for proposed developments**

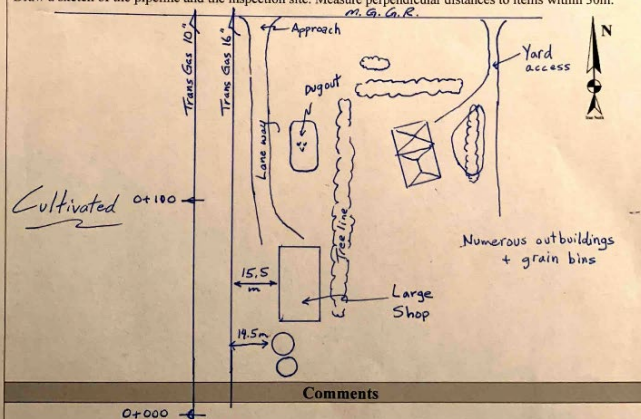
Encroachment ID	549	OD	273.1 m 406.4 m	Pipeline #	10 th 15 th 0100189 14-23-0450.100	Location	NW 8-21-15-W3M
Investigator	J. Hopper P. Mack	Date	Dec. 19 2018	TGL or MIPL(C/L)?	T.G.L.		
Land Use (definitions on back of form)		Questions					
Remote uninhabited		Are there any encroachments on the ROW?					
Parkland or grazing land		Are there any safety concerns? Describe in comments					
Cultivated agriculture Land	<input checked="" type="checkbox"/>	Does the landowner have permits?					
Low density residential or commercial		Depth of Cover Survey - 10'					
Medium density residential or commercial		Perform a Depth of Cover Survey in 10m intervals and record data on the back of this sheet. Label on map where the start point is located (use back of form if required)					
High density residential or commercial							
Alignment Markers		0 10 20 30 40 50 60 70 80 90 100					
No identifying markers or structures on surface		1.32 1.40 1.59 1.45 1.45 1.35 1.45 1.45 1.86 1.96 1.9

Locate and Label existing Markers on the photo:		Class Location (use back of form if required)					
<ul style="list-style-type: none"> • Danger signs with "D" • Aerial Markers with "AM" • Any other markers, barriers, fences, indicating ROW with description 		Number of dwellings in 200m corridor on both sides of pipeline, up and down stream for 200m from encroachment					
		← 20					
Structure Offset							
Draw a sketch of the pipeline and the inspection site. Measure perpendicular distances to items within 30m.

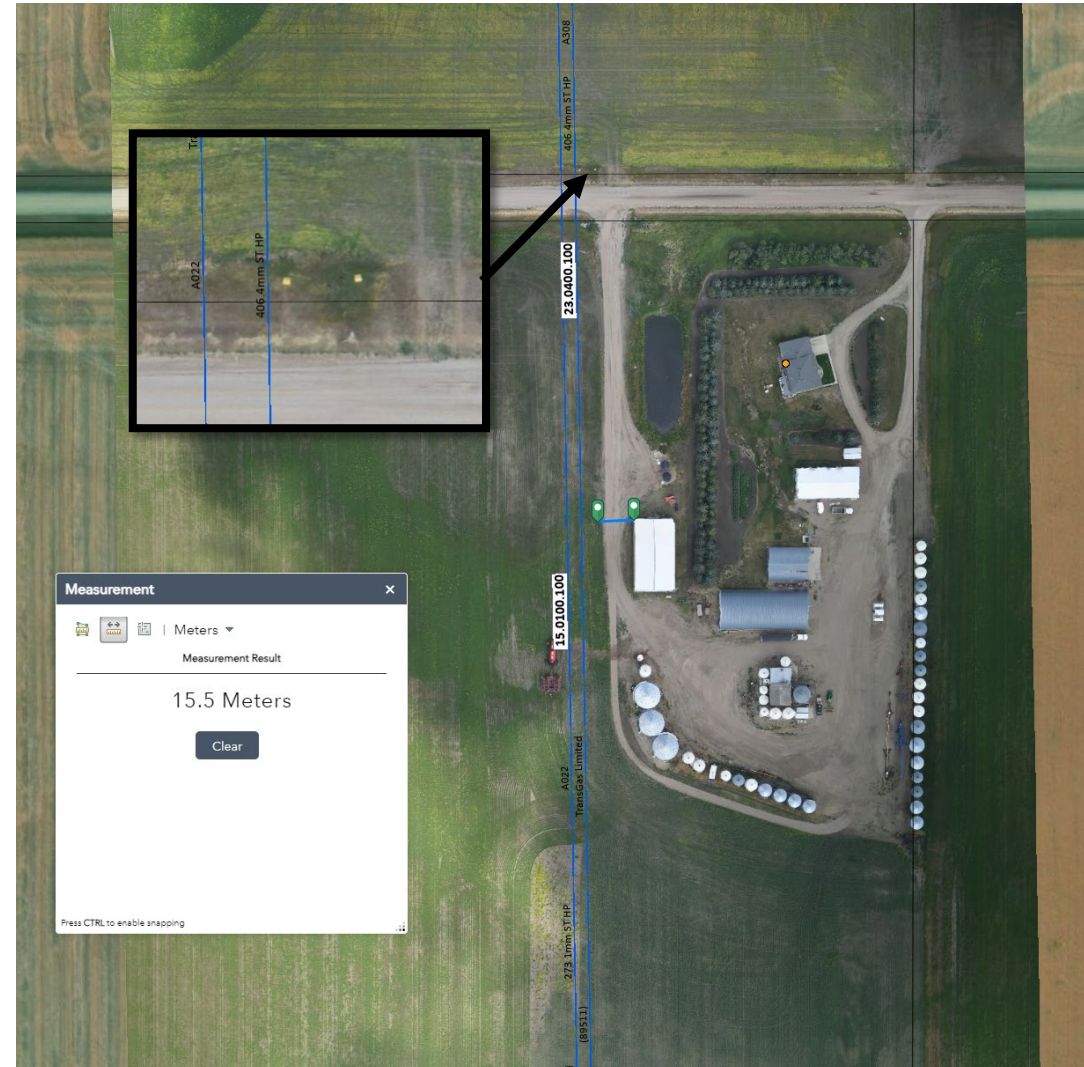
Encroachment Monitoring

- Monitoring developments for 10 yrs. with annual aerial photos
- Follow up inspections added for higher risk encroachments and new developments
- High resolution imagery improves desktop assessments
- Pipe location shown by Aerial Marker
- Crossing process is improved for proposed developments
