# PRCI- REX 2024-073: Enbridge's Experience of Managing Hard Spots on Natural Gas Transmission Pipeline System

*San Diego, California*  
*February 28, 2024*

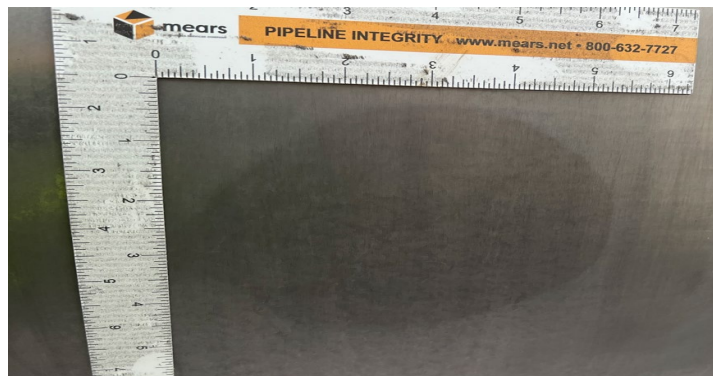
ECT Scan and Etching of AO Smith Pipe Body Hard Spot (338HB).

- **Hard Spots** are manufacturing defects of localized high hardness due to inadvertent quenching during final hot rolling of steel plates.
- **API 5L criteria** for hard spot: >327 HB and larger than 2" in any direction.
- **Enbridge Criteria:** Hard Spot > 280 HB without any length restriction.
  - Conservative criteria considers ILI tool tolerance of  $\pm 50$  HB.
- **Injurious Hard Spots:** Pipe body features with through-wall hardness > 300 HB, martensitic microstructure, prone to hydrogen embrittlement.
- **Hard Spots** with relatively lower hardness, intact coating, and isolated from exposure to corrosion or excessive CP generally remain stable and non-injurious.

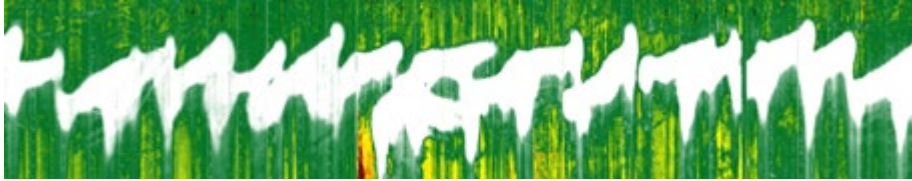
- a) Typical saw tooth pattern, ID dominant

Eddyfi scans revealing various hard spot types.

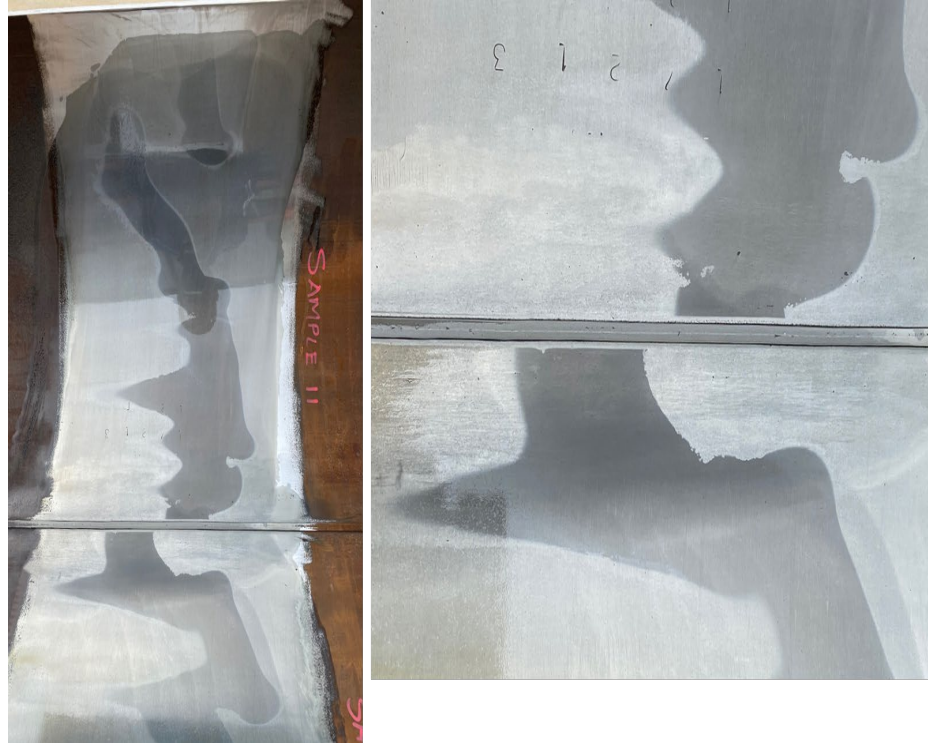
CMAs revealed from ID etching, corresponds to item a) saw tooth pattern in ID. Pattern discontinuous across seam weld.

- CMAs are generally considered non-injurious:
- Found to contain bainitic microstructures instead of martensitic in conventional hard spots.
- Less susceptible to hydrogen embrittlement
- Generally recorded to have lower hardness values~ 250-300 HB
- PHMSA seems to be in agreement that CMA's are non-injurious

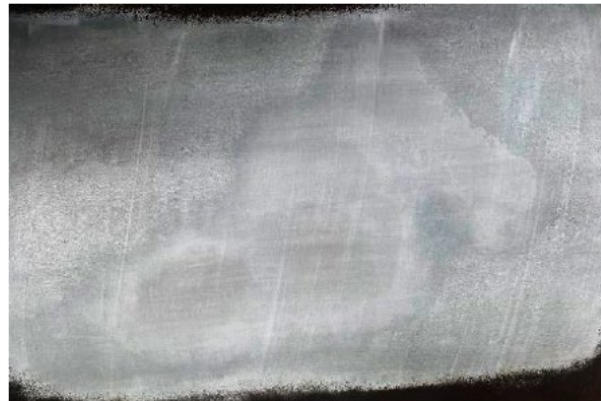
•Of the 205 features shown, 28 Hard Spot features had hardness  $\geq 280$  HB (13.7%)

- A.O. Smith (FW) – 17 Hard Spots
- National Tube (DSAW) - 4
- Consolidated Western (DSAW) - 3
- Republic - 3
- Kaiser - 1
- Bethlehem - 0

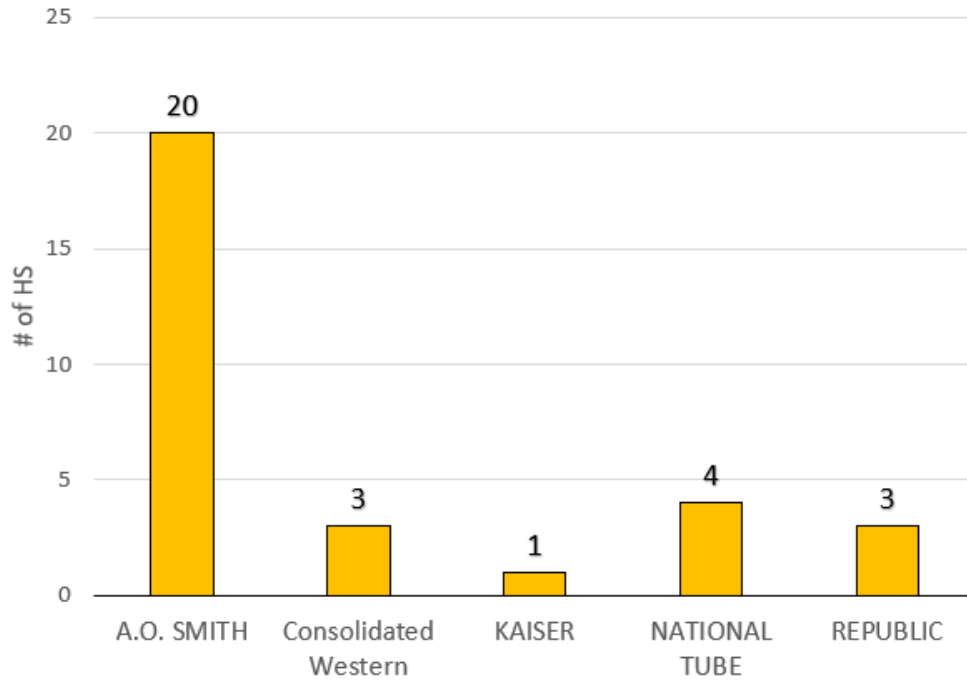
Type 2 & 3 HS  $\geq$  280HB

- More than 290 digs performed since 2019
- 115 HS Features examined with positive etch.
- 31 features had field-confirmed hardness > 280 HB.
