EPRG-PRCI-APGA
23rd Joint Technical Meeting
Edinburgh, Scotland
6-10 June 2022

EFFECTS OF CATHODIC OVER PROTECTION ON RESIDUAL STRENGTH OF DAMAGED PIPES

PAPER NUMBER: 22

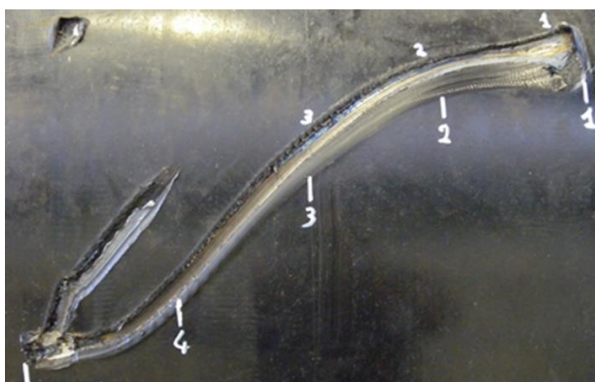
Figure 4: Damage from Simulator (left) and damaged surface (right).

An example of damage produced for the present projects is shown in Figure 4 (left), together with the pipe external surface appearance in the gouge (Figure 4, right). The blue color indicates the high temperature reached by the pipe material (estimated in the range from 290°C to 330°C) during the damaging process and caused by the friction between the pipe steel and the impacting tooth.
