REX2024
PRCI Research Exchange

Reduction of Landslide Impact on Pipelines using Geobuffer *Field Installation*

Ali Fathi, PhD PEng, Integrity Specialist, Enbridge
San Diego, California
February 27, 2024

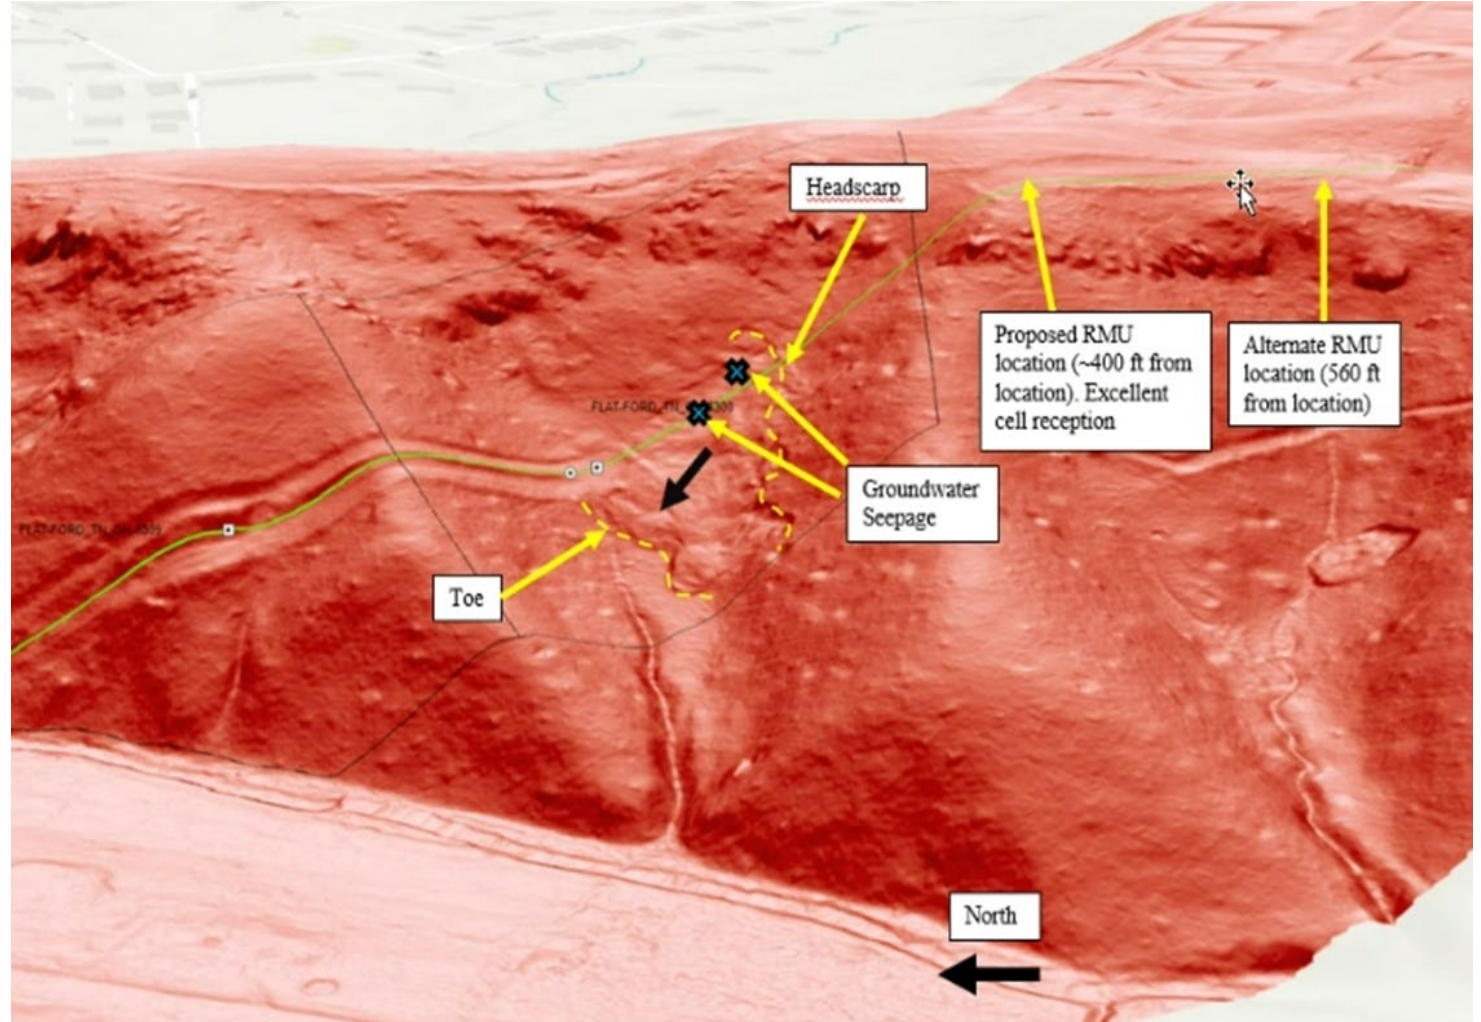
LiDAR Change Detection 2016- 2020

- Landslide identified in 2021 during LiDAR review
- Around 140 feet of intersection with pipeline
- Axial (upper slope) to oblique (mid-slope) direction of movement

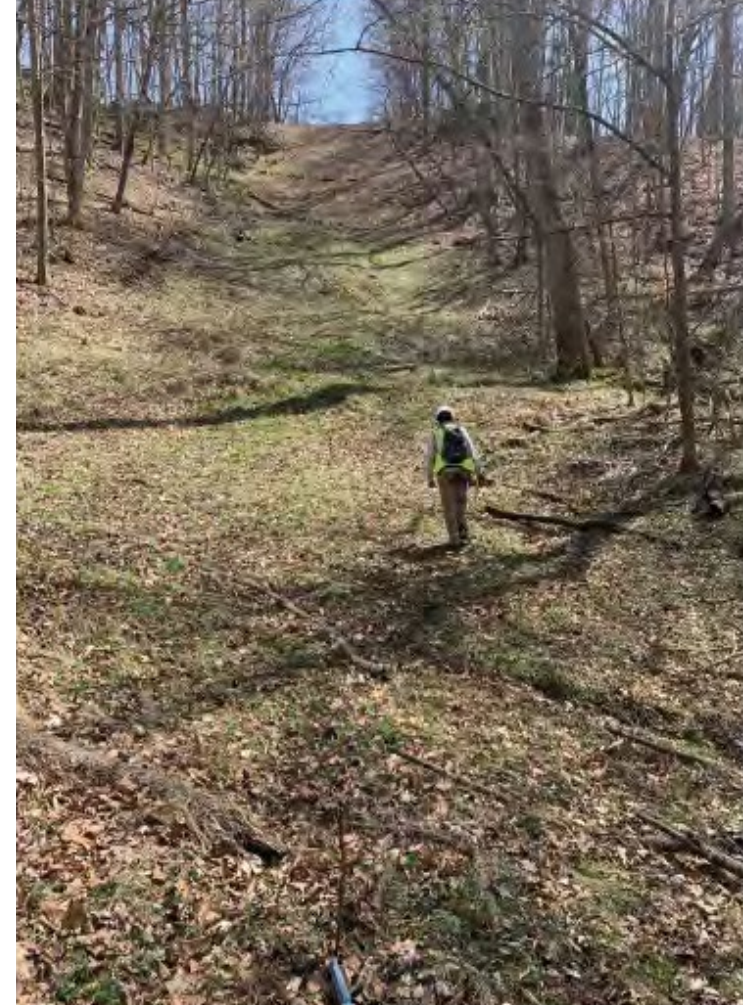
- **NPS 8"**
- WT 0.188"
- Grade 42
- Installed 1962
- MOP 706 psi
- Non-piggable
- ~10 mile length
- **On Steep Slope (16°-28°)**
- **Single pipe on ROW**

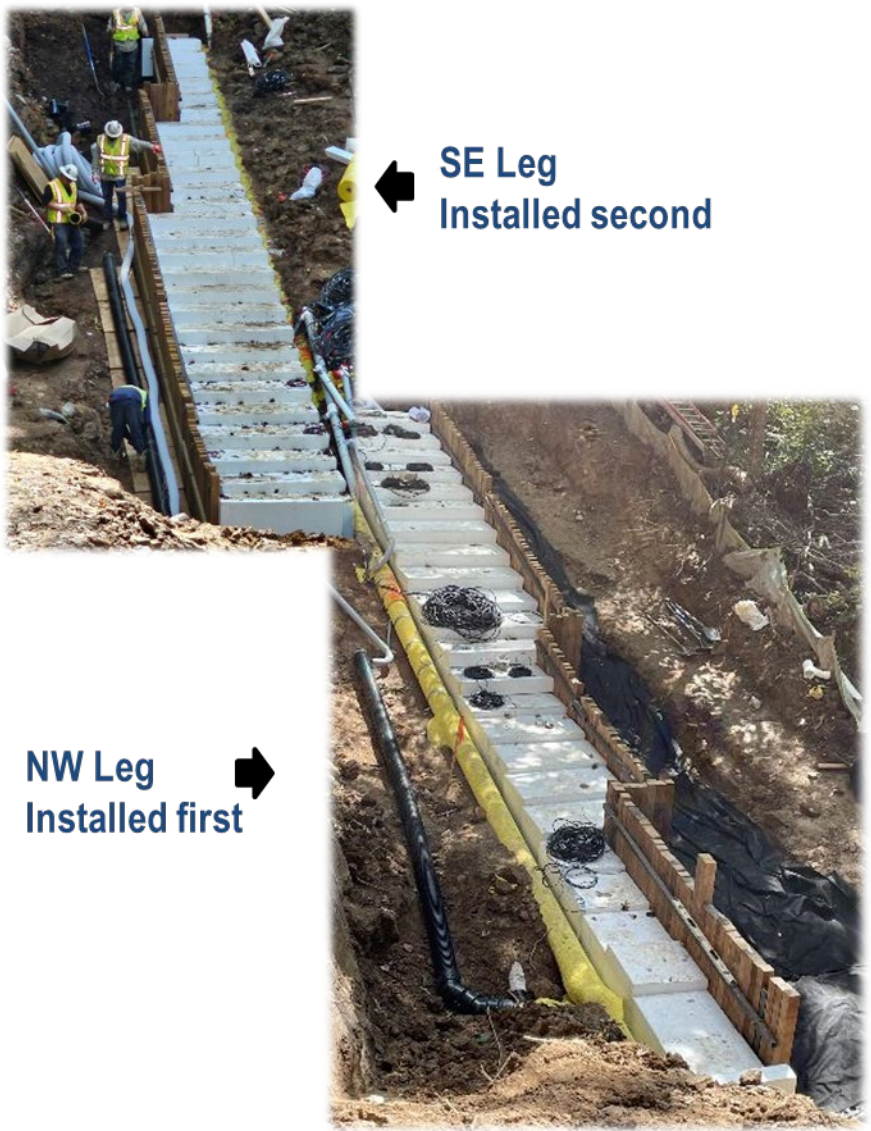
Full Installation

SE Leg
Installed second

NW Leg
Installed first
