PRCI-REX2024-055: Modernizing Aerial Patrol - Real Life Remote Sensing for Liquid Leak and Threat Detection Along the Right of Way

*First Detection Demonstrations of a Real Pipeline Seep Leak,
Encroachments, and Exposed Pipes using a Traditional Aerial
Patrol Plane*

Paige Chenevey¹, Alexandre Thibeault², Joshua Beard¹, Eric Bergeron²

¹Marathon Pipe Line, LLC., ²Flyscan Systems Inc.

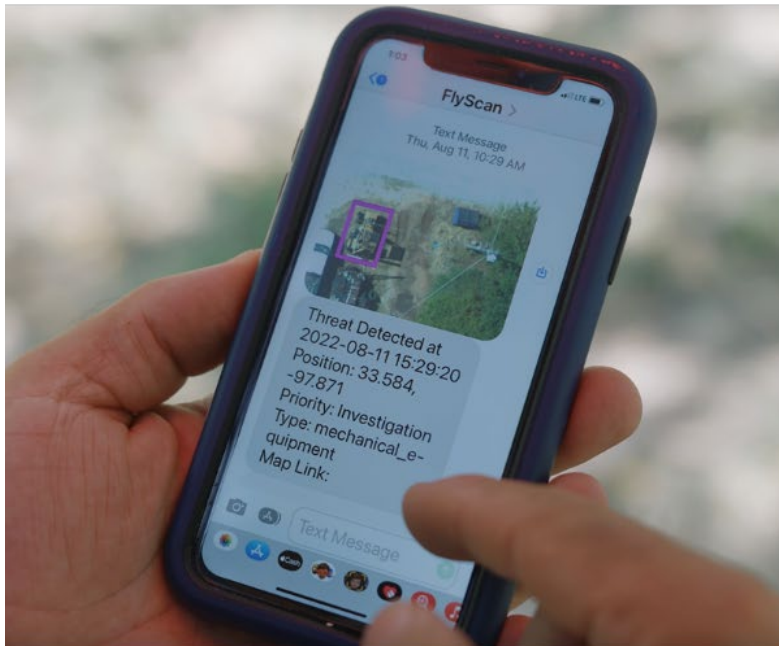
Real-time Notifications During Flight

Notifications via text, email and/or integration with ticket applications

Threat description, GPS and Photo included

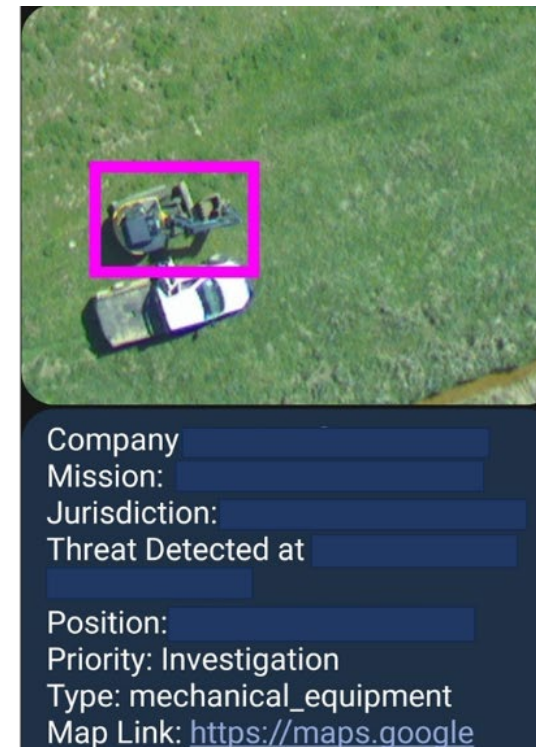
Real-time notification example

Real “encroachment” detected

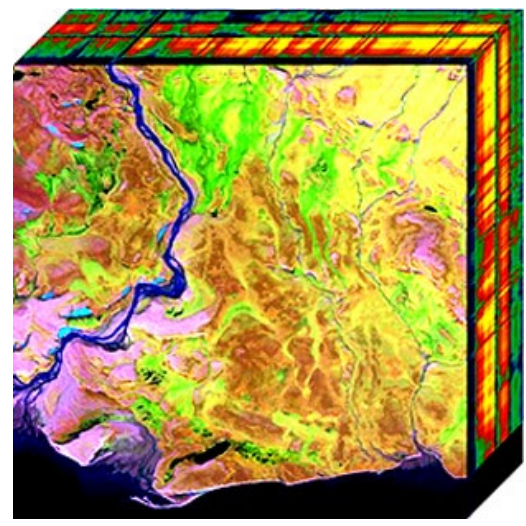
1. This passive system uses the sun's power

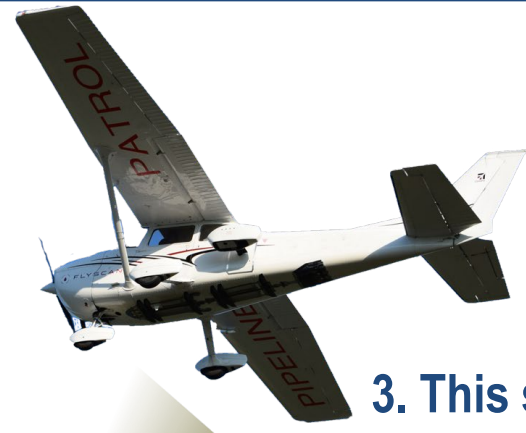
3. This signature is detected using sophisticated algorithms to detect

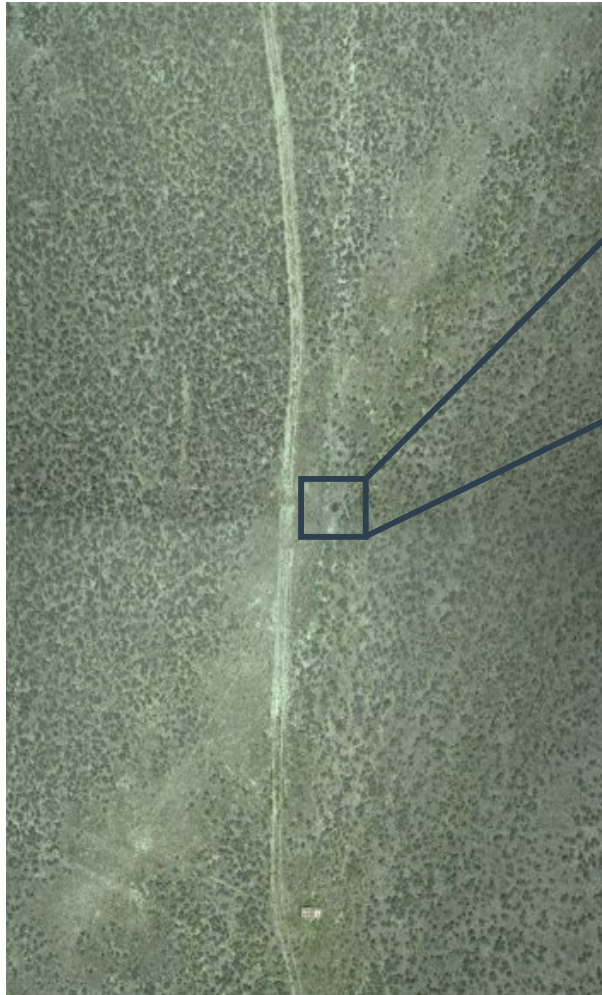
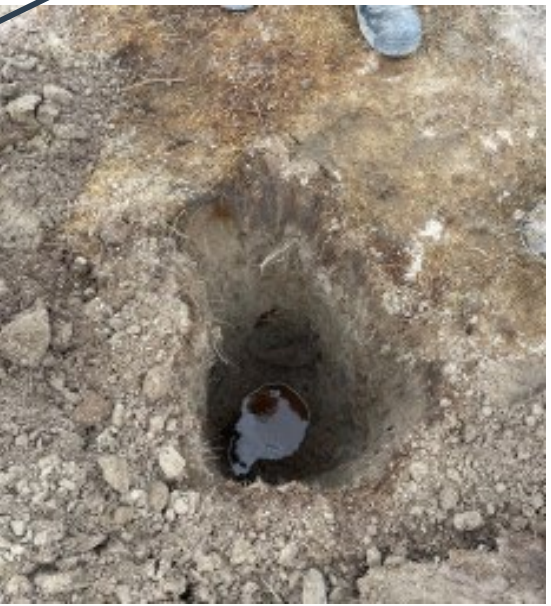
Real Seeper Leak Detection – Diesel Pipeline

Size: 2.2 m²
Detection score: 93.25
Estimated volume: 54 bbls*
Estimated leak rate: <0.1 BPH
Possible cause: Corrosion

Slow leak over several months
well below CPM sensitivity

Hyperspectral
Detection

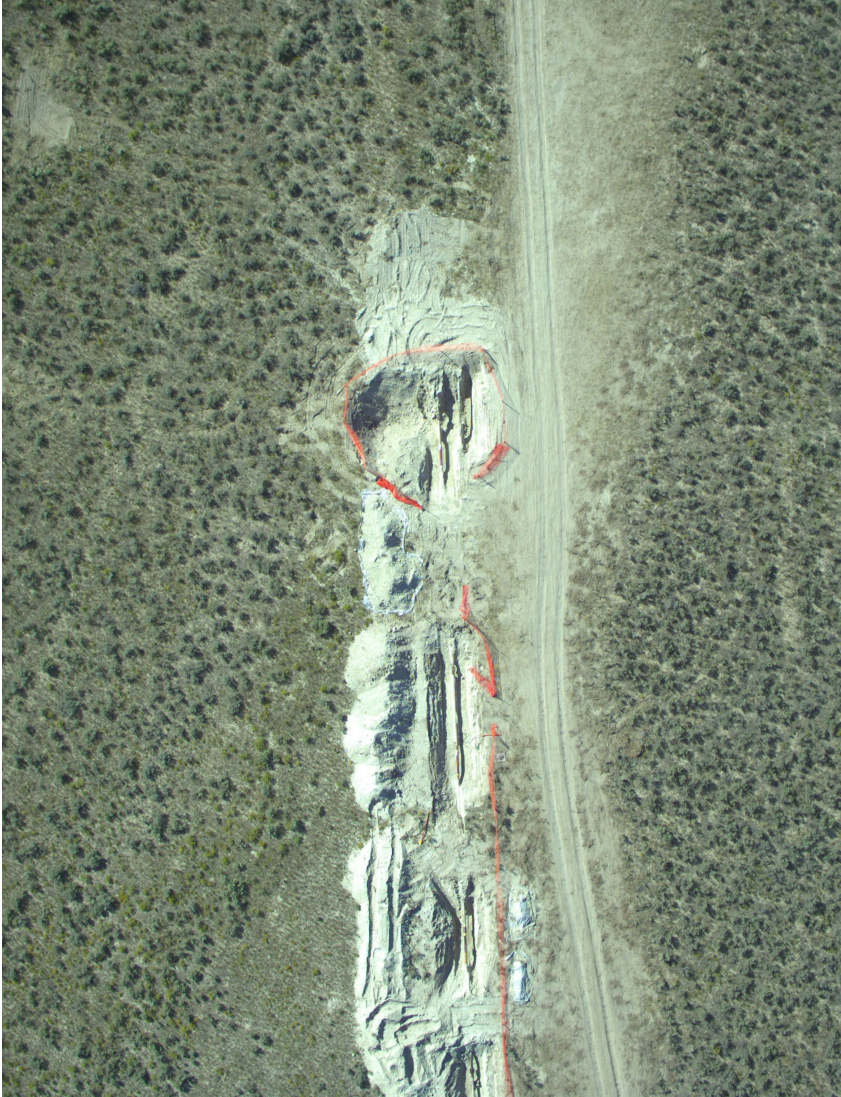
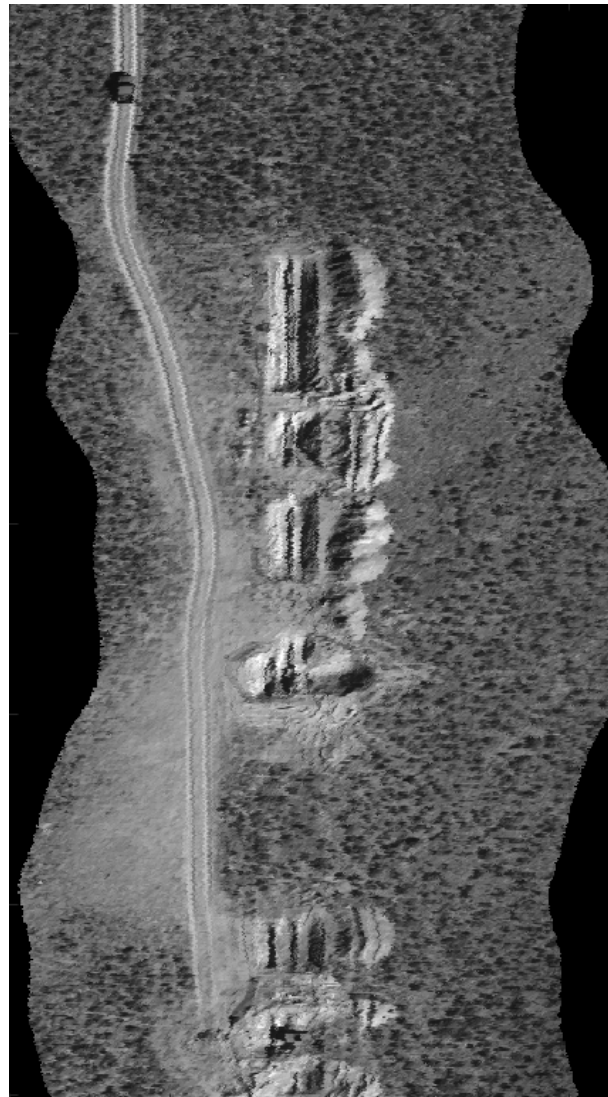
Repair and Clean-up Documentation

After site clean-up, no
hyperspectral detection of
liquid hydrocarbons

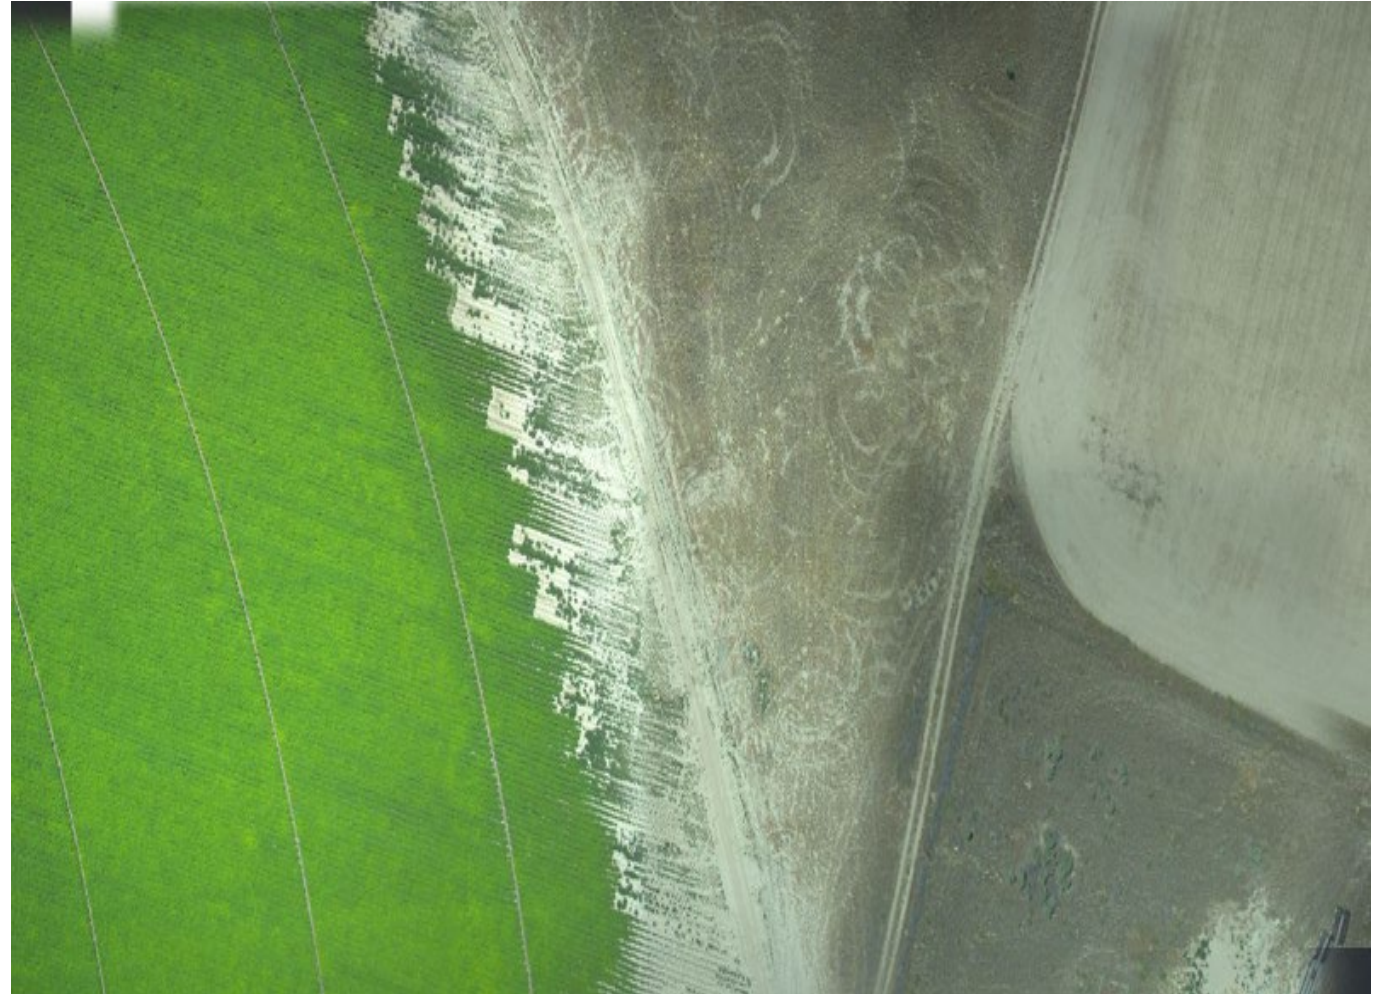
Diesel Contamination NOT caused by the pipeline

Picture shows pilot's view at 550 feet

No visible sign of diesel at the surface

Observation affected by:

- Speed of flight
- Navigation
- Communications
- Fatigue

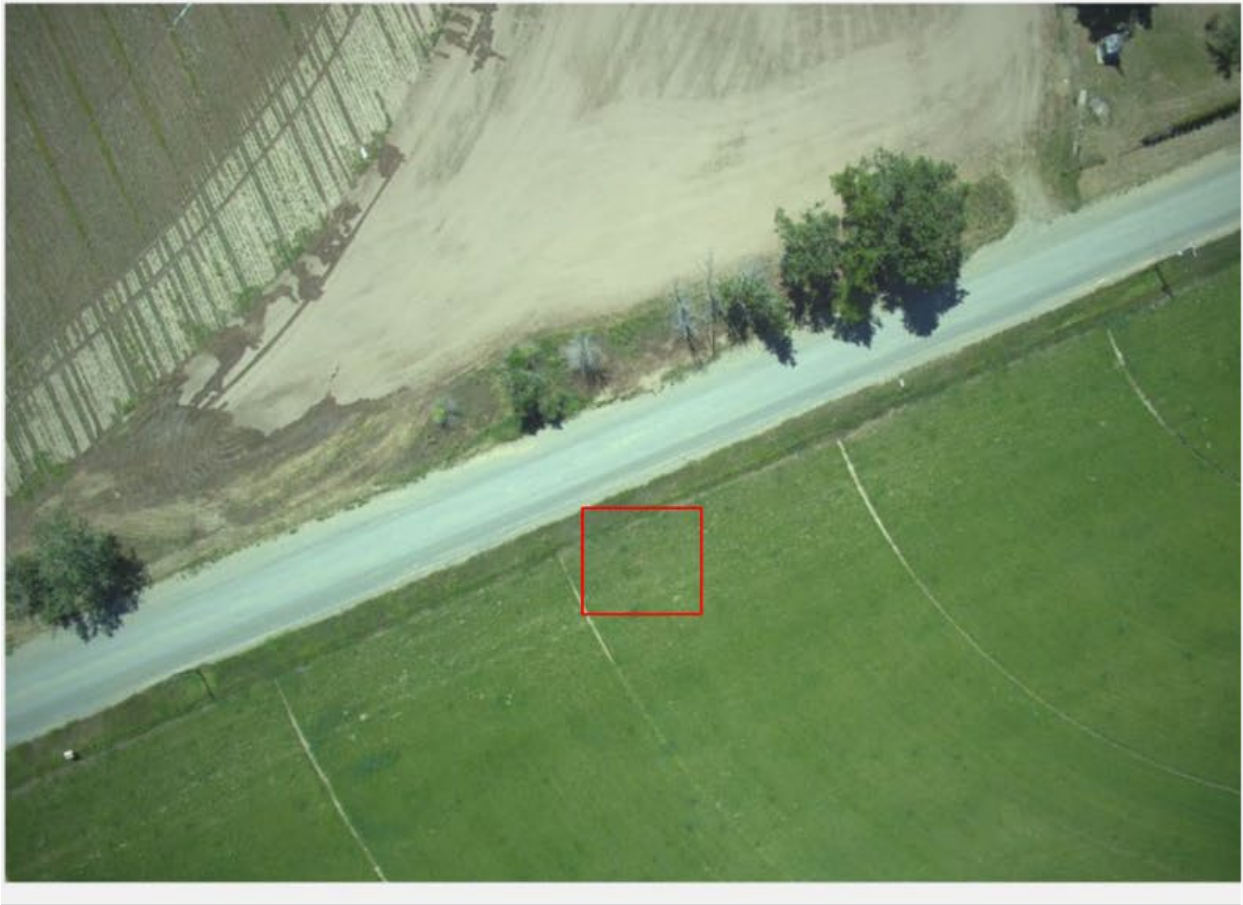
Diesel Contaminated Vegetation

As seen from the plane

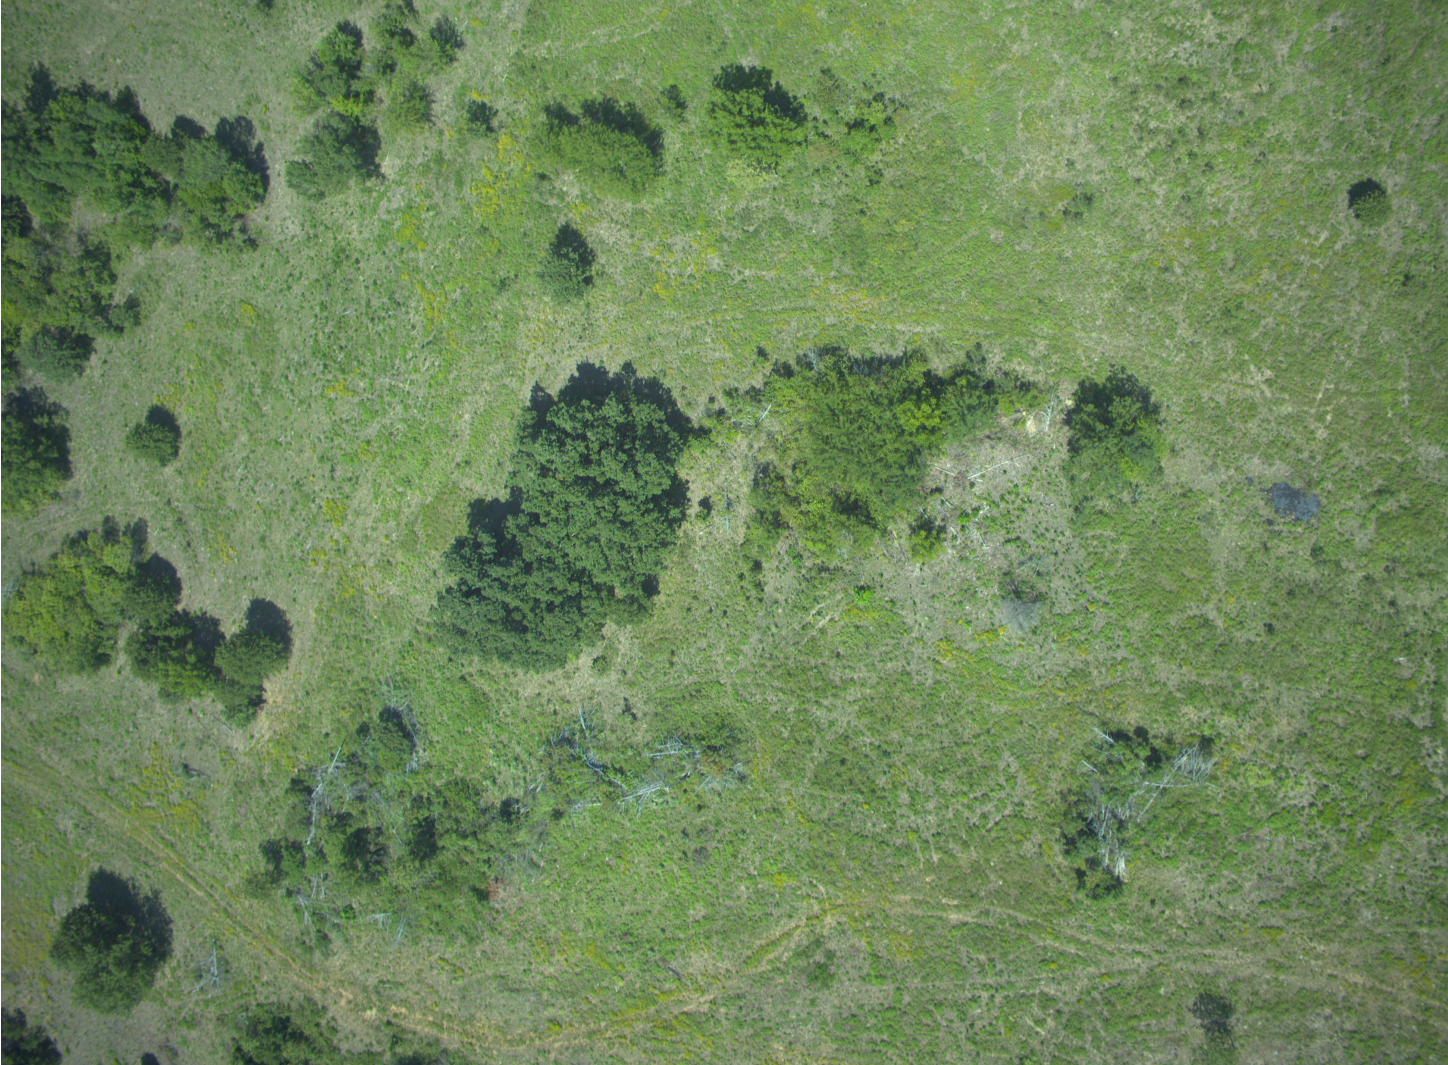
Crude Oil Pool Detected

- Picture shows pilot's view at 550 feet
- No visible sign of crude at the surface

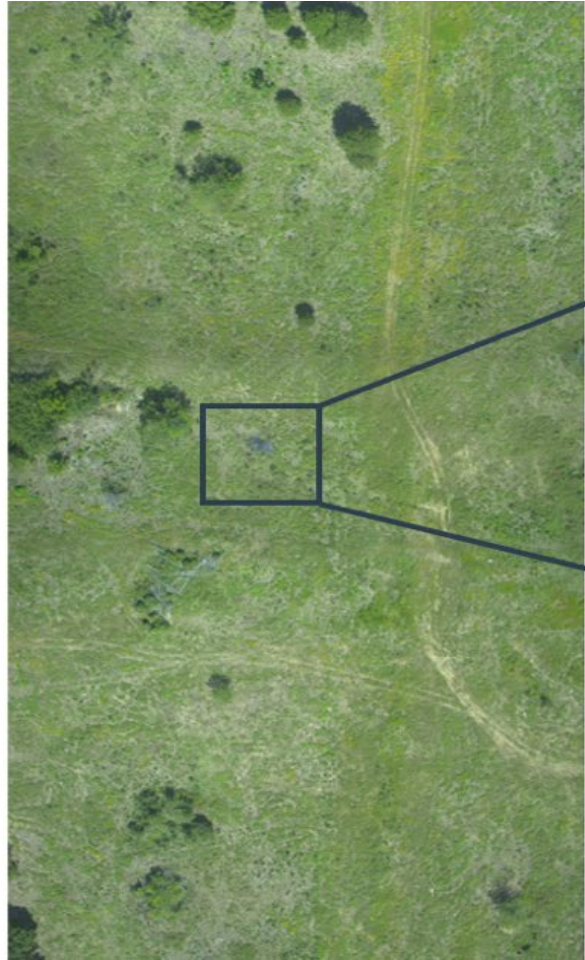
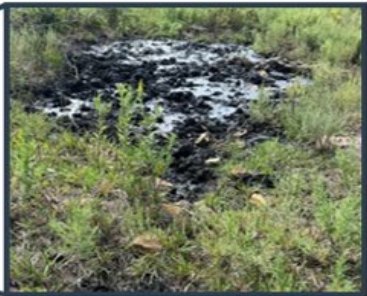
Crude Oil Pool Detected

Automatic detection
using the **hyperspectral**
algorithm

Crude oil pool on
the surface

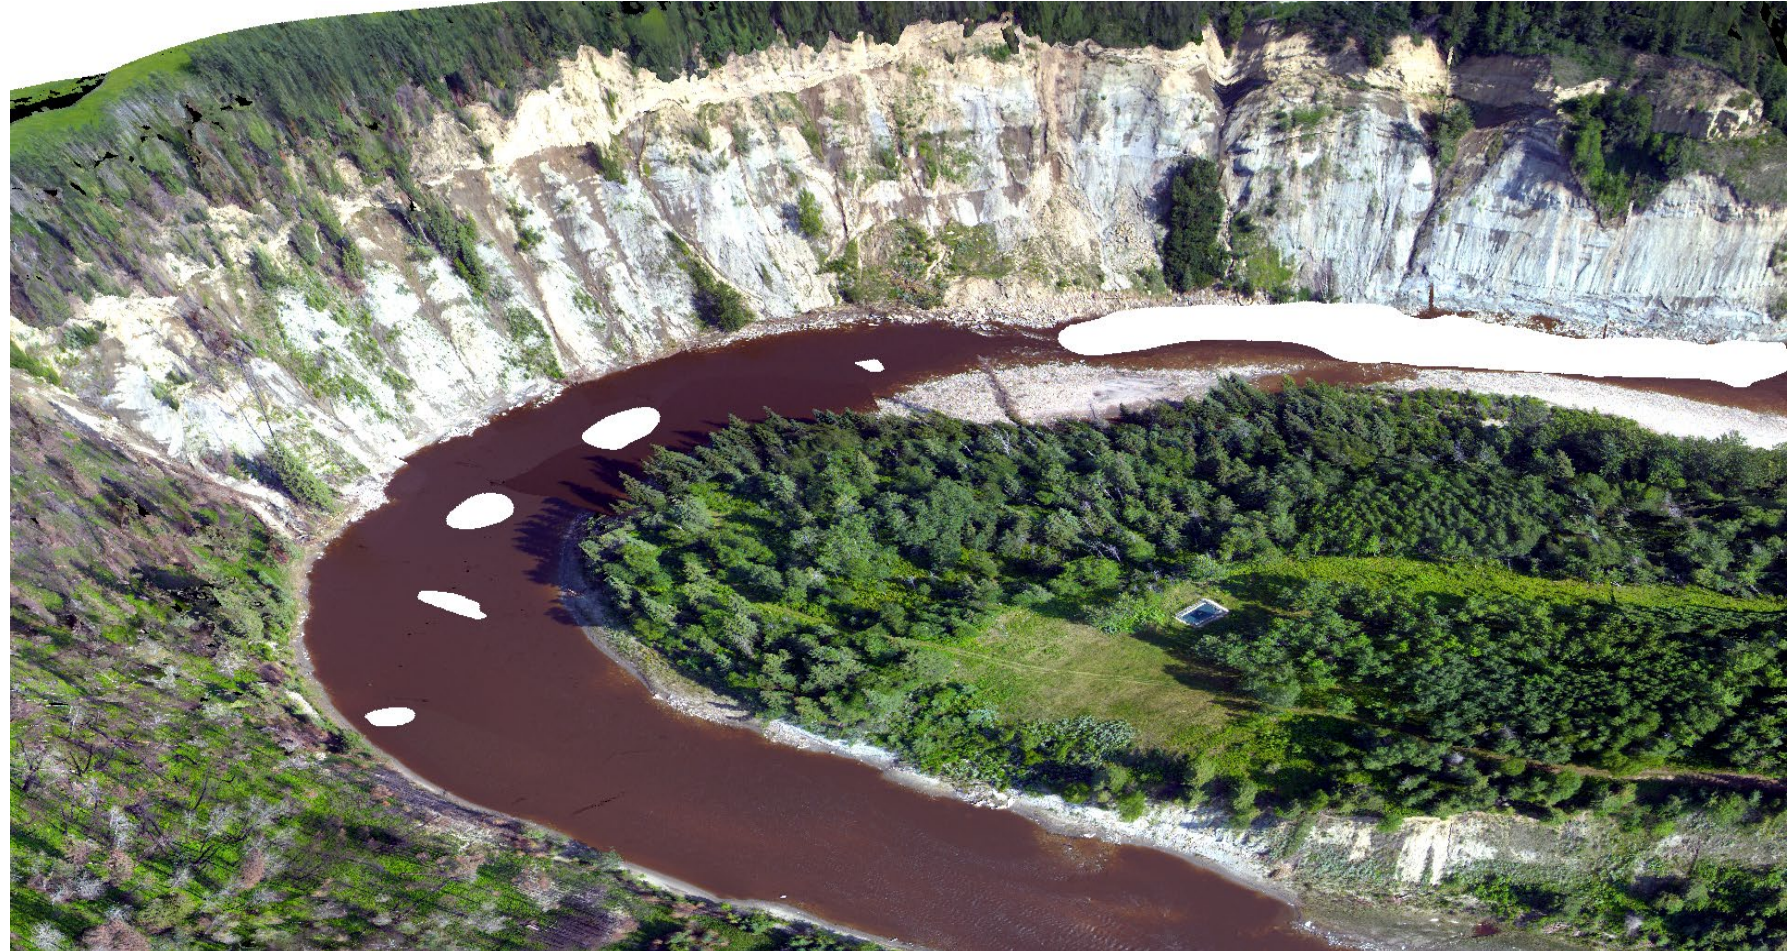
2D Orthomosaics and 3D Rendering

**Landslide
reconstructed
with a high
resolution
orthophoto
mosaic overlaid
on its
corresponding
DSM**
